STRUCTURAL INVESTIGATION OF THE NEW YORK WORLD TRADE CENTER COLLAPSE

DR. W. GENE CORLEY

Construction Technology Laboratories, Inc., Skokie, IL, USA
Leader, FEMA and SEI/ASCE Building Performance Study Team for the World Trade Center

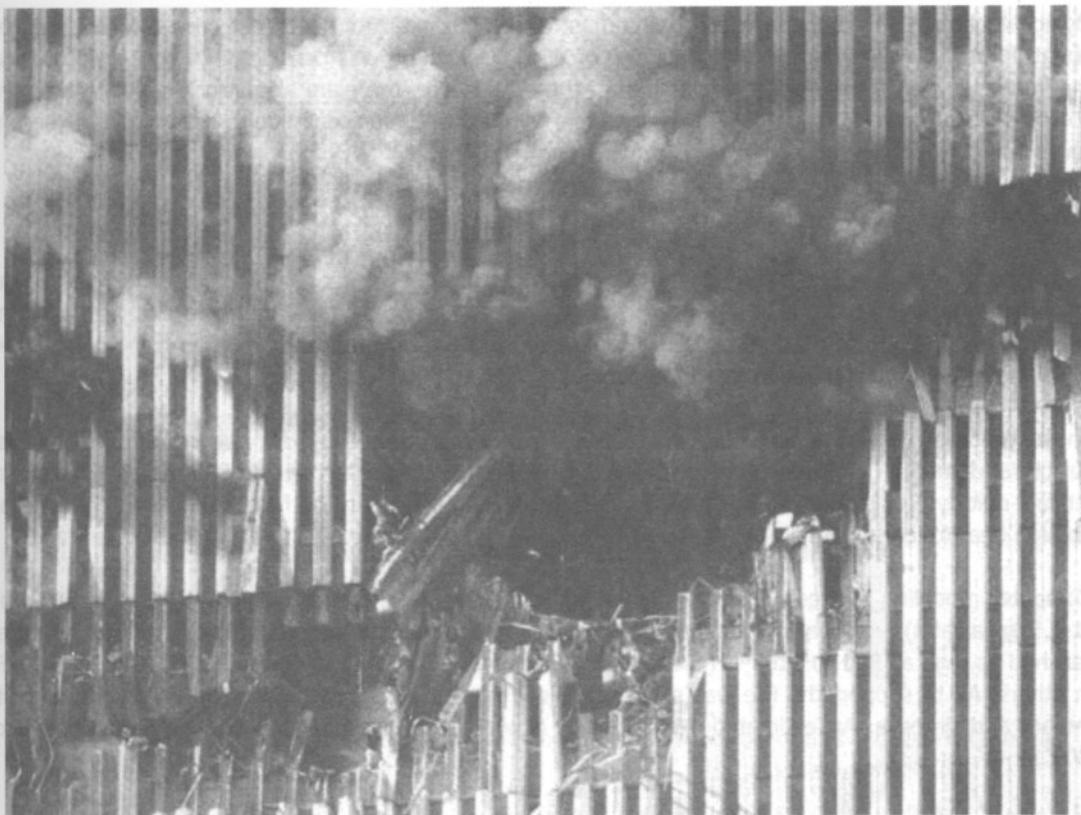
There was additional damage where the jet's wings hit the wall, with 31 to 36 columns destroyed over a four-story range (Figs. 2 and 3), leading to partial floor collapse over a horizontal-length of about 65 ft. Some damage to steel framing at the center core also was apparent. Eyewitnesses described evidence of partial floor collapse closer to the building interior, including areas on the 91st floor that were blocked by debris from higher floors.

Fig. 2. Impact damage to the north face of WTC1

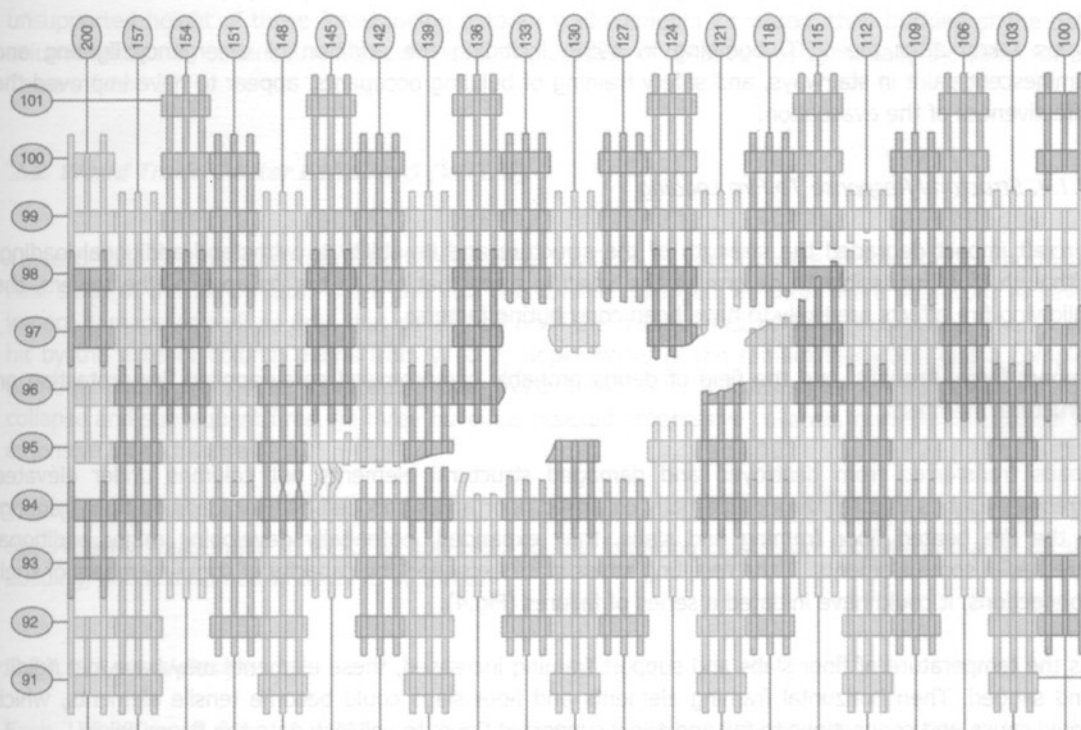
Fig. 3. Impact damage to exterior columns on the north face of WTC1

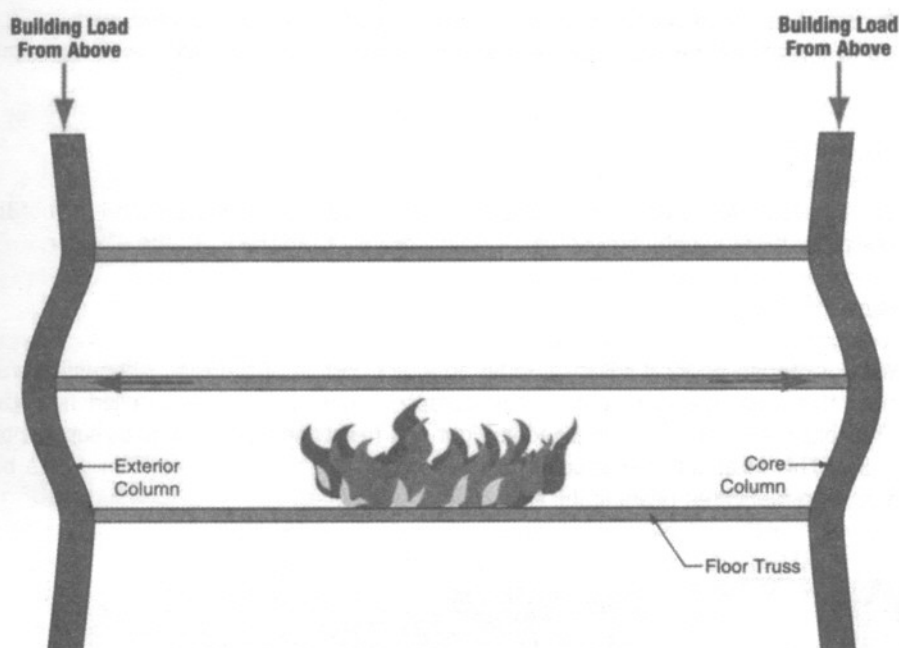
Loads transferred from destroyed and damaged structural elements put columns under elevated stresses. Debris that fell through partially collapsed floor areas imposed heavier loads on floor framing. As the fire heated floor framing and slabs, they expanded, potentially developing major additional stresses in some elements. If the resulting stress state exceeded the capacity of some members or their connections, it could have initiated a series of failures (Fig.4).

As the temperature of floor slabs and support framing increased, these elements may have lost rigidity and sagged. Then horizontal framing elements and floor slabs could become tensile elements, which could cause end connections to fail and allow supported floors to collapse onto the floors below.

Fig. 4. Expansion of floor slabs and framing results in outward deflection of columns and potential overload

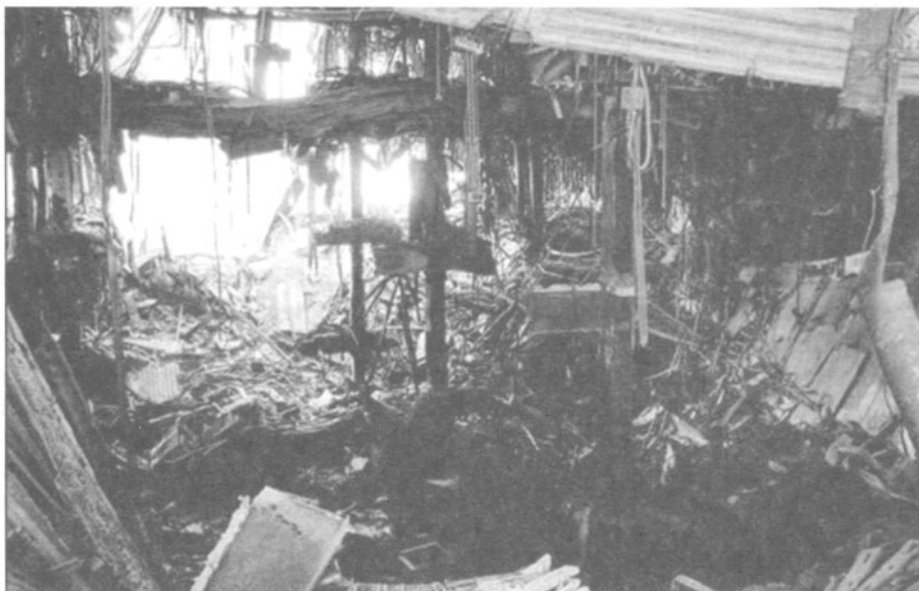
Two areas in WTC 5 experienced local collapse under an intact portion of the roof. Although there was debris impact near this area, the symmetry of the collapse suggests that uncontrolled fires caused these failures. The columns in this area remained straight and freestanding, which lends support to this theory (see Fig. 5). This local collapse appears to have begun at the field connection where beams were connected to shop-fabricated beam stubs and column assemblies.

Fig. 5. Internal collapsed areas in WTC5

The structural collapse of portions of WTC5 seems to have resulted from excessive shear loads on bolted connections and unanticipated tensile forces due to the beams' catenary sagging. High shear loads, probably due to collapsing floor loads from above, were evident in many of the column-tree beam stub cantilevers.

Fire also apparently weakened the steel, contributing to large shear-induced deformations in several of the cantilever beams. The shear failures observed at connection ends in several of the beam web samples suggest the magnitude of tensile forces that developed.
