ROLE OF FIRE RESISTANCE ISSUES IN THE COLLAPSE OF THE TWIN TOWERS

V.K.R. KODUR

Institute for Research in Construction, National Research Council, Ottawa, Canada

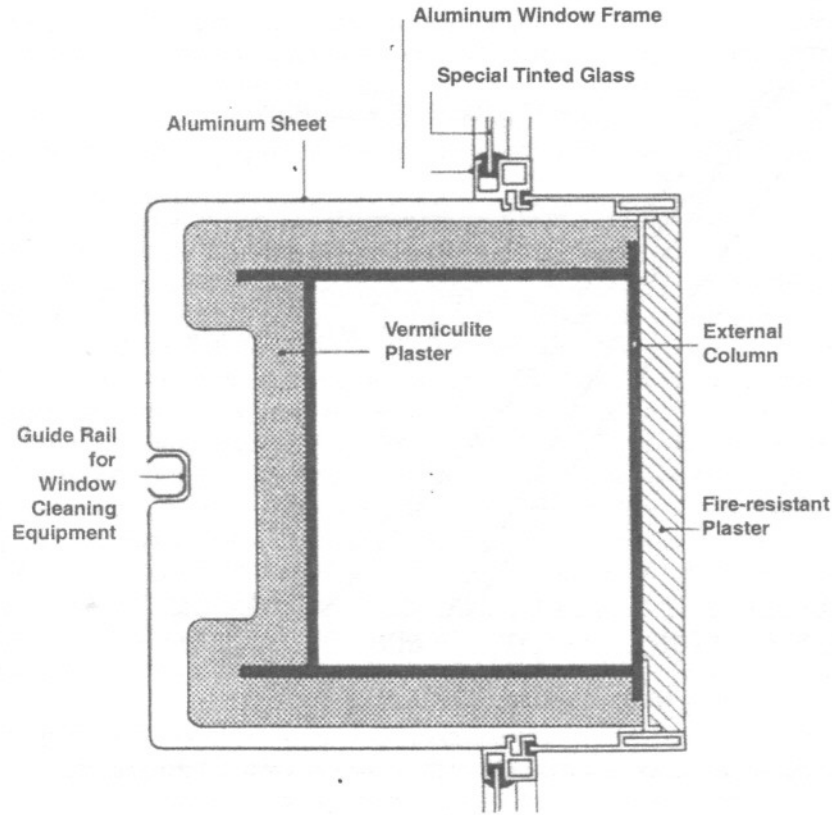
Fig.2 Fire Protection for typical Exterior Columns in Twin Towers

The passive fire protection to structural members followed the requirements of the 1970 New York City building code (FEMA 2002, Morse 2002). Cement plaster was used to protect the interior face of the perimeter columns, between spandrels, to achieve 3-hour fire resistance ratings. The exterior faces of the perimeter columns as well as the spandrels, floor joists, and core framing were protected with spray-applied insulation materials with thickness sufficient to achieve the required 3-hour fire resistance ratings. Figure 2 shows structural fire protection for a typical column. The fire protection on trusses which initially consisted of spray-applied fire proofing of $\frac{3}{4}$ inches, was enhanced in 1990's to 1- $\frac{1}{2}$ inches on certain floors of WTC 1 and WTC 2.

Steel-framed buildings depend on fire proofing for its ability to resist the impact of fire (Kodur and Harmathy 2002). The durability (adhesion and cohesion) of sprayed fiber and, to a lesser extent, the cementitious materials, is a problem when subjected to significant impact loads (Morse 2002). In the twin towers the impact of aircraft mechanically damaged much of the spray-applied fire protection, originally present on the structural steel frame, to an extent that much of the steel in the immediate fire area was unprotected (FEMA 2002, Glover 2002). This was especially true in the case of light-weight bar joist trusses and the floor deck since the impact of jets led to partial collapse of ceilings and must have scraped most of the spray-on fire-proofing. The intense fires on several floors, that followed the impact, weakened the bare steel.

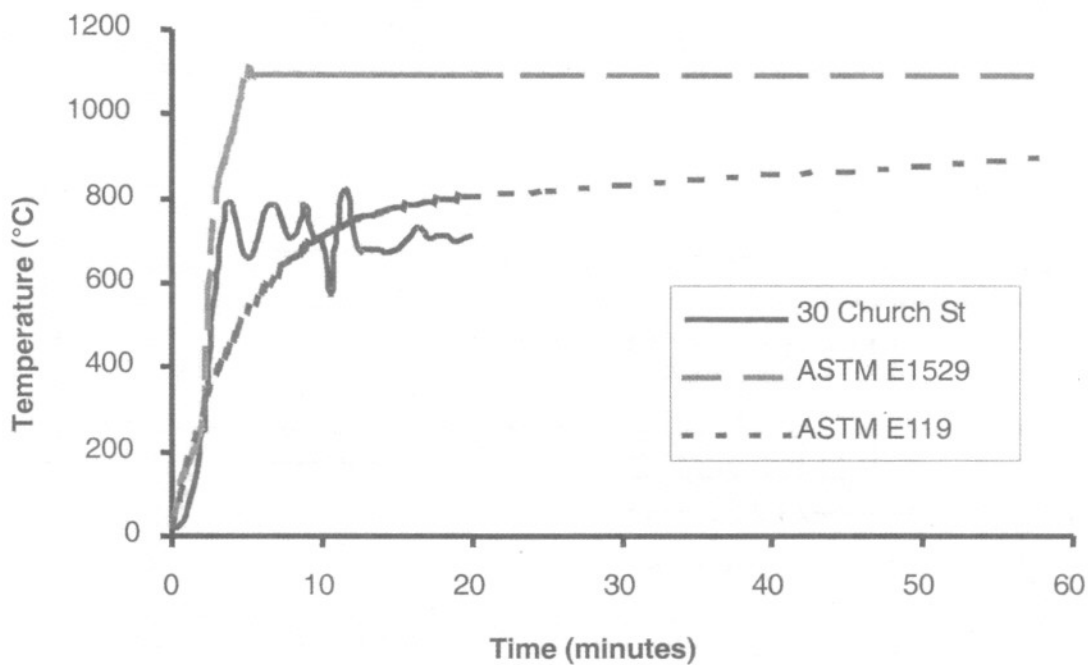
Figure 3 Time-Temperature curves from two standard tests and temperature measurements (DeCicco, et al., 1972) in the Hudson Terminal Building

The large quantity of jet fuel that spread across several floors of the building ignited much of the building and aircraft contents. This caused simultaneous fires across several floors at the same time. This generated fire conditions significantly more severe than those anticipated in typical building fires (Yong and Kodur 2000, FEMA 2002). The maximum fire temperatures attained in the WTC fires were in the range of 1,000° to 1,100°C. These temperatures were not significantly different from other typical office building fires. However, the rise in fire temperatures was much faster than those in typical building fires and represented typical hydrocarbon fires with temperatures reaching about 800°C in the first 3 to 4 minutes (ASTM 1993).

In Fig.3 the time-temperature curves from two standard tests and typical building fires based on temperature measurements acquired in experiments involving office furnishing conducted by DeCicco, et al., (1972) in the Hudson Terminal Building (30 Church Street, New York), is compared. Temperature development in the WTC fires in the initial stages is likely to be closer to the ASTM E-1529 curve.

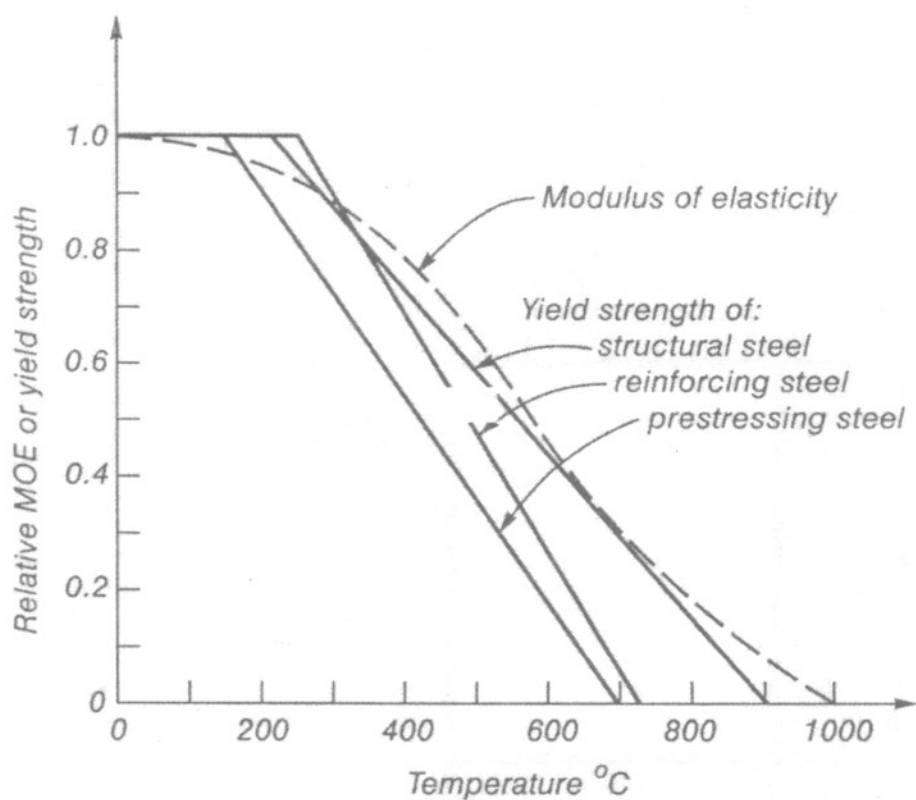
Figure 4 Variation of strength and Modulus of Elasticity of Structural Steels of with Temperature

Steel loses its strength and stiffness when subjected to high temperatures. A typical steel structural member loses its load-carrying capacity (or about 50 percent of its original strength) at 538°C (1,000°F) when exposed to an ASTM E-119 standard fire (Kodur and Harmathy 2002). An unprotected steel member subjected to an ASTM E-119 standard heating environment is able to maintain its structural integrity for about 20 minutes. To limit this loss of strength and stiffness, external fire protection (fire proofing) is provided to the steel structural members to achieve required fire resistance ratings. Figure 4 illustrates the variation of strength and stiffness in steel as a function of temperature.
