Lessons from Hurricane Andrew

Leighton Cochran* & Marc Levitan**

At dawn on 26 August 1992 Hurricane Andrew made its first landfall on the Louisiana coast at Point Aufer Island. This category four storm had already caused 16,000 M\$ of insured losses [Ref.1] in southern Florida before it hit a rural region of southern Louisiana near Morgan City, 115 km west of New Orleans. The winds caused by Hurricane Andrew effected the built environment of coastal Louisiana in various ways that depended on the level of designer input and the construction quality control. A variety of commercial buildings, dwellings and engineered structures were examined by a United States National Science Foundation funded disaster team and a summary of their findings is presented here; along with some useful design suggestions for hurricane or cyclone-prone areas.

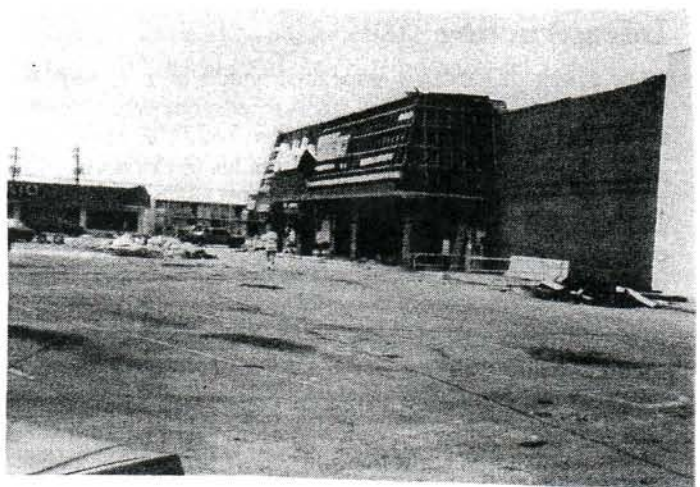
Figure 4: Delchamps Supermarket in Patterson, on Highway 90, lost most of its cladding on the front of the building creating large internal pressures.

The Delchamps Supermarket at Patterson (Figure 4) lost much of its entrance facade. This precipitated the loss of much of the roof sheeting and the structural failure of an unreinforced blockwork wall at the rear of the building due to an increase in internal pressure (Figure 5). The failure of unreinforced, unfilled concrete blockwork walls via this mechanism was common in the commercial buildings of coastal Louisiana.

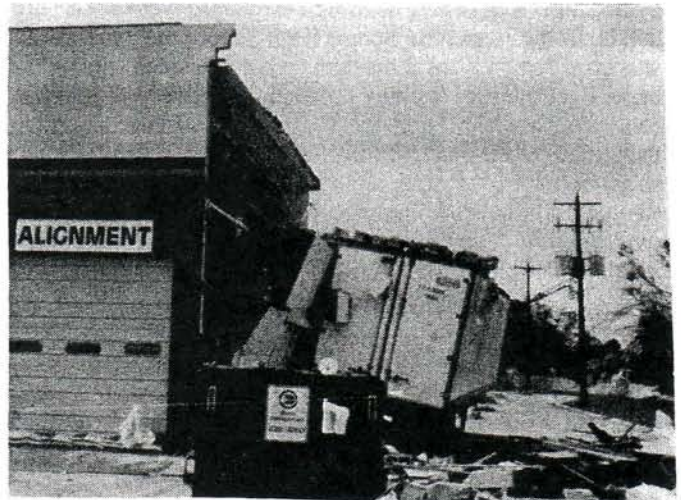
Figure 5: Unreinforced blockwork wall blown out when the front facade failed on the Patterson Delchamps Supermarket.

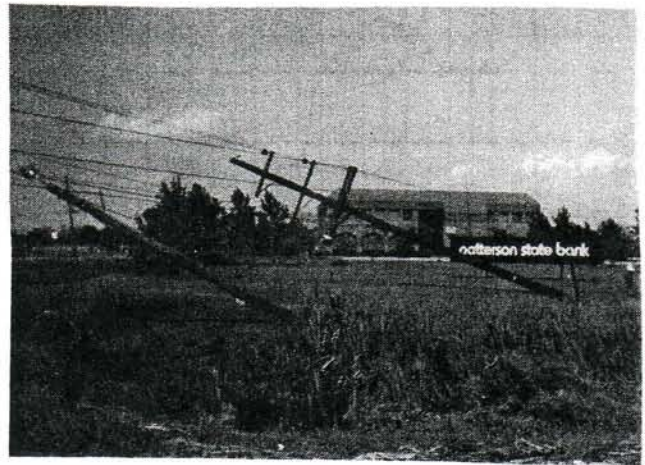
Figure 6: The Patterson State Bank was apparently undamaged by gusts of up to 56m/s, but thousands of power poles were laid over around the whole region.

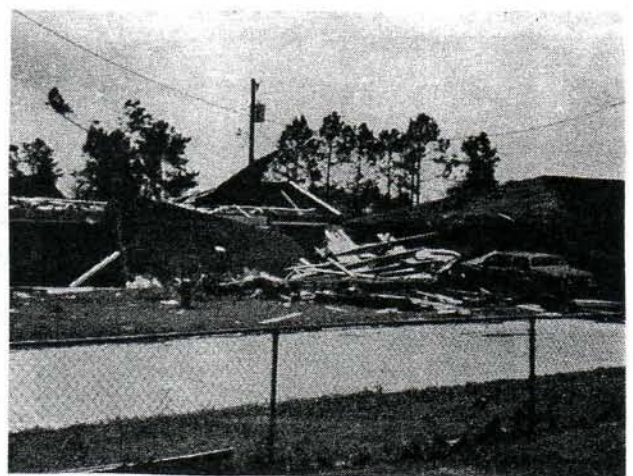
The damage to homes ranged from none to total destruction, with neighbouring homes often performing quite differently (Figure 7). The level of architectural and engineering design input is typically minimal and so the owner must rely on the integrity of the builder and his adherence to the Louisiana building codes. The construction quality and the adequacy of inspection varied widely; resulting in the disparity of destruction.

The Collins Square Apartments (Jeanerette) in Figure 8 became seriously water damaged when the gable roof end failed. Frequently the structural integrity of the gable roof was compromised, but the equivalent hip roof survived. In fact, Figure 7 shows just such a comparison. The hip roof on the right was largely unscathed, while the gable roof in the centre suffered severe roof damage. Given similar construction quality the hip roof seems to weather the storm better for two reasons:

- (i) The shape offers less obstruction to the wind and so the uplift pressures are generally less [Ref.10] and
- (ii) The complexity of the carpentry in the three-slope intersection of a hip roof produces added strength and increases the redundancy to resist wind loads.

Figure 7: Some homes in Patterson were seriously damaged while the neighbouring homes survived. Comparison between the performance of hip and gable roofs is seen in this photograph.

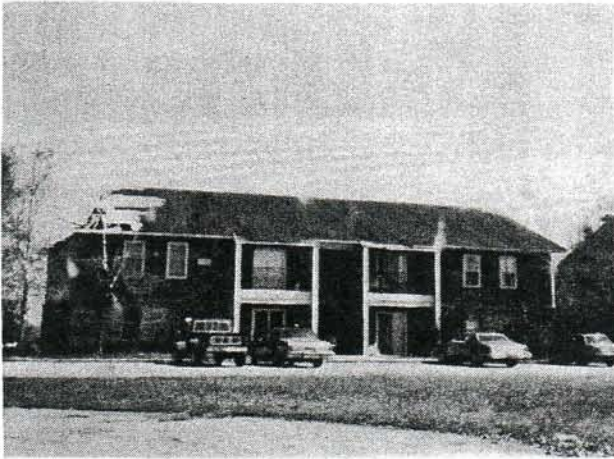
Figure 8: Gable roof failure at the Collins Square apartment complex, Jeanerette LA.

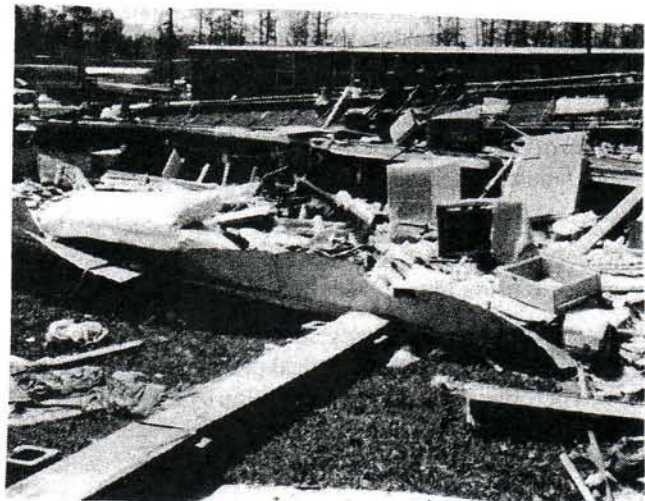
A common type of low-cost housing in Louisiana is the mobile home (also called a manufactured home in North America). They are built in a factory environment (with the potential for better quality control) and shipped to the owners site for semi-permanent installation. These designs generally have far less redundancy than conventional homes, and when some structural component fails the rest of the building usually follows (see Table 1). In fact, it was uncommon to see a mobile home only partially damaged by the wind. They were usually found either relatively unscathed or totally destroyed. One example at Shady Grove, Patterson, is in Figure 10 where the dwelling was rolled over twice and completely destroyed.

A common mechanism for this failure is an inadequate method of holding the building down. One popular technique

Figure 10: Mobile home park at Shady Grove, Patterson LA.

is to use soil augers attached to galvanized, 25 mm wide straps that wrap over the roof of the mobile home from side to side and attach to the frame. In this design one must account for the reduced soil strength when it is saturated by the heavy rains that accompany a cyclone or hurricane. During the inspection of mobile home parks in Patterson and Bayou Vista the galvanized straps were often seen broken by fatigue failure [Ref.13] and occasionally the auger ground anchors were pulled out of the saturated soil. The clean, new ground anchors in Figure 11 were found where the mobile home in Figure 10 used to be. The owner had obviously procrastinated on the installation of ground anchors just one week-end too long.

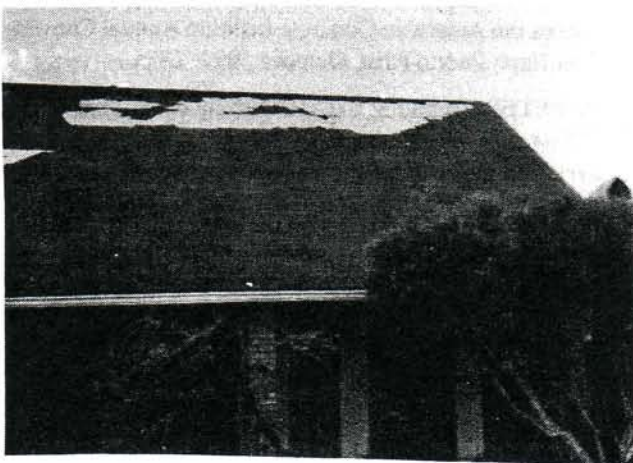
The failure of individual shingle and tile elements was common. Figure 9 shows the asphalt shingles selectively removed by the ridge vortex formed in the strong wind [Refs.7 and 11]. Larger, well-fixed sheeting elements such as steel decking generally performed better in high winds than individual shingles or tiles. This is because the peak wind loads are area averaged on the steel-deck roof and hence may be reduced due to the lack of load correlation over the bigger roof element area [Ref.7]. This reduced peak load correlation is augmented by the greater number of load paths available to the large sheeting elements.

Figure 9: Flow over a roof caused by the ridge vortex. This selectively removed the asphalt shingles from a home in Ledoux Circuit, Patterson, LA.

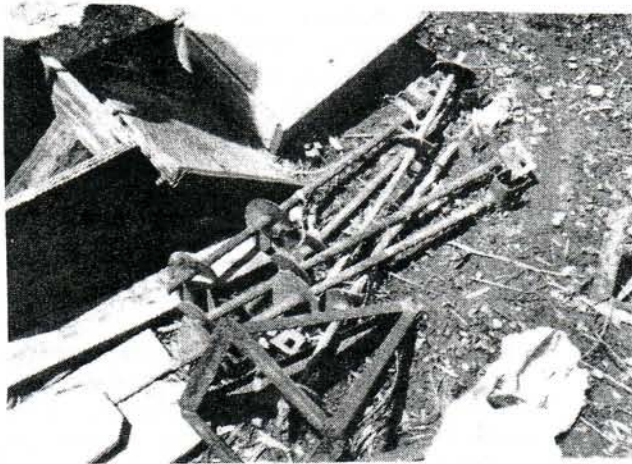
Figure 11: Uninstalled anchors that were found tossed beneath the mobile home in Figure 10.

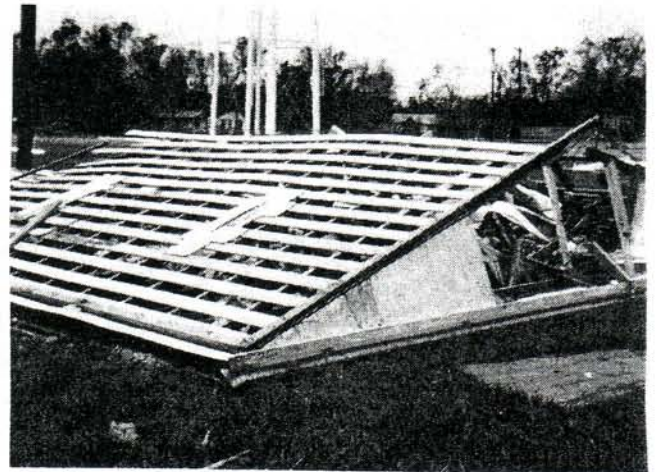
Figure 12: Roof was lifted off the Hattie A. Watts Elementary School in Patterson, LA.

- * The use of well-designed storm shutters to curtail missile damage to windows and doors would decrease the likelihood of wall damage or total roof loss (Figure 12) via the mechanism of large increases in the internal pressure.

- * The unwise practice of toe-nailing roof trusses to the walls was common. This contributed to the failure in Figure 12. The lessons learned in Cyclone Tracy [Ref.6], such as cyclone rods, triple-grips and straps, need to be applied to other hurricane-prone areas.
