Case Study of Structural Cracks in Irregular RC Tall Building During Construction

Dr. Taehun Ha
Principal Researcher
Daewoo E&C,
Suwon, South Korea

Sungho Lee
Principal Researcher
Daewoo E&C,
Suwon, South Korea

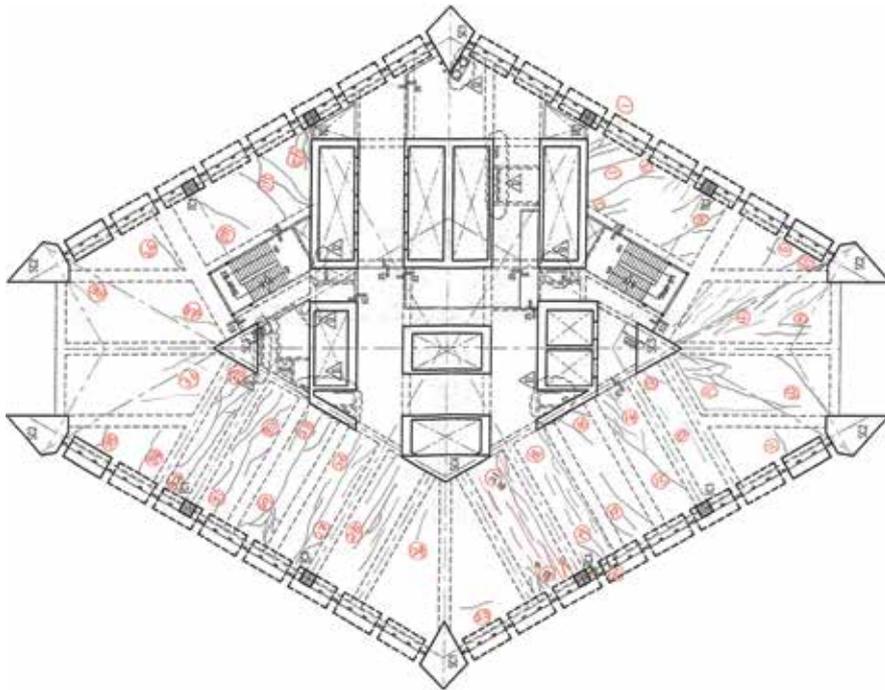
Figure 3. Map of cracks on the soffit of floor slab at Level 16 (Source: Daewoo E&C)

The cracks exist only on the soffit not on the above surface of the slabs outside of core walls. No crack is observed in the slab inside the core walls. As shown in the crack map in Figure 3, these cracks generally radiate from a core location in the direction of beams to the perimeter girders: most of the cracks are parallel to the beams but are deviated as they approach to locations of four SC2 mega columns. This pattern of cracks may happen when the slabs are in tension in the circumferential direction in the Tower's plan. Some cracks are connected with the cracks in the perimeter girders as shown in Figure 4.

Usual repair methods such as epoxy injection (see Figures 4 and 6) for cracks which have been already repaired with this method (or grouting) seem sufficient for these cracks. However, more detailed investigation of the diaphragm action during construction was recommended prior to the actual repair job, since a preliminary study on this subject has found that the cracks in these members might be closed due to in-plane compression as the construction proceeds toward its completion.

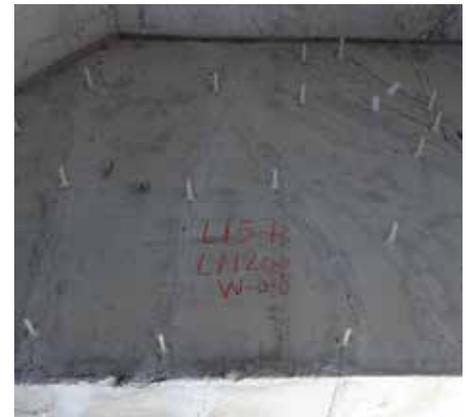
Large inclined cracks connecting the diagonal opposites of the girders exist with a series of vertical cracks under the girder (see Figure 2). The direction of the inclined cracks start from the joint of the girder and the slanting column (STC) and end at the joint of the girder and the tower column (TC). Although not shown in the figure, surface cracks are also found on the floor slab above in the location of TC. This is one of the typical crack pattern of a reinforced concrete beam or girder, especially with short span ratio (= span vs. depth), when it is overly stressed.

Of the four pairs of girders in each STC span, the girders located at upper levels are more severely affected by this mechanism of crack development, since they have a smaller span ratio than that of the girders at lower levels. For example, the cracks in the girders at Level 16 is more severe than those in the girders at Level 13. Actually, the cracks in the girders at Level 13 stay as vertical flexural cracks and do not develop into the inclined shear cracks. This tendency remains the same as STC

Figure 2. Diagonal shear cracks and vertical flexural cracks in perimeter girders under slanting column and dummy column location at Level 16 (Source: Daewoo E&C)

spans move up along the building elevation with diminishing severity in the crack development. For girder at higher levels of the Tower, most of the inclined cracks disappear (see Table 1).

in axial direction of the STC to the joint of STC and mega columns. However, the STC also exhibited flexural action, which in turn exerted vertical load on the perimeter girder. This load gets greater as the construction progresses and eventually makes the girder crack. In case of the girders at upper levels of each STC span, this mechanism of load transfer is made directly from STC to TC due to the girder's smaller span ratio – less than 2.0 – that the initial flexural cracks have developed to severe shear cracks as shown in Figure 12.

Considering the severe crack development in the girders at Level 16, these girders are judged to be best repaired by the method of section enlargement to compensate the insufficient contribution by the concrete. For other girders that are not severely damaged, repairing their flexural and shear capacity with carbon fibers might be sufficient. Actual retrofit was performed with steel members which provide sufficient strength to the cracked girders as shown in Figure 15. This was possible because the breadths of STC and TC are much greater than that of perimeter girder. The total number of perimeter girders reinforced with steel members was 12 at Levels 16, 25 and 34

excluding 4 girders at Level 48, which showed no sign of severe crack.

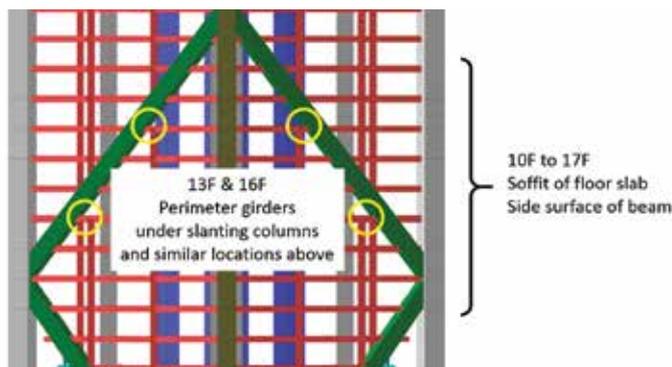
The cracks have occurred in perimeter girders, soffit of floor slabs and side surface of beams connecting perimeter girders and core walls as listed below and shown in Figure 1. These cracks are most severe at Level 16.

- Perimeter girders under slanting column and dummy column position: Levels 13, 16, 22, 25, 31, 34, 45 and 48. At first, only the cracks in Levels 13 and 16 were reported and the rest were identified by thorough investigation of the structure
- Floor slabs: from Levels 10 to 17

Figure 1. Crack locations marked in building elevation (Source: Daewoo E&C)

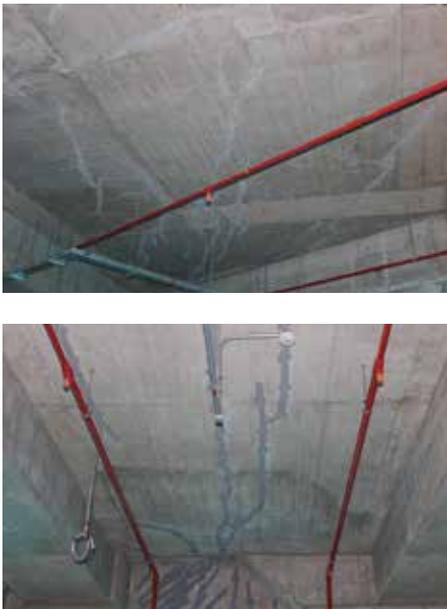
Figure 4. Cracks on the soffit of floor slab at Level 16: cracks in non-rectangular slab (above) and slab cracks connected with cracks in a perimeter girder (below) (Source: Daewoo E&C)

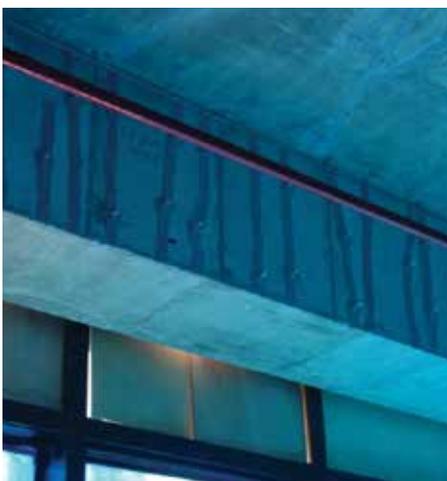
These cracks occurred on the sides of the girders/beams in a vertical direction and are generally evenly distributed along the length of the girders/beams. The crack width is constant along the crack length.

Cracks exist in most of the perimeter girders except for ones bound by STCs and TCs, and ones near SC1 mega column and core walls as shown in the crack map in Figure 5. These cracks exist on both sides of girders and are not seen on the bottom face. However there are some exceptions. The direction of the cracks generally coincide with those on the soffit of the floor slab. These cracks seem to have the same mechanism of cracking, i.e. circumferential tension in the Tower's plan. Also, the cracks in the perimeter girders are generally more closely spaced than the cracks (compare the two photos in Figure 6).

Figure 6. Cracks on the side of perimeter girders (above) and beams connecting perimeter girders and core walls (below) at Level 16 (below) (Source: Daewoo E&C)

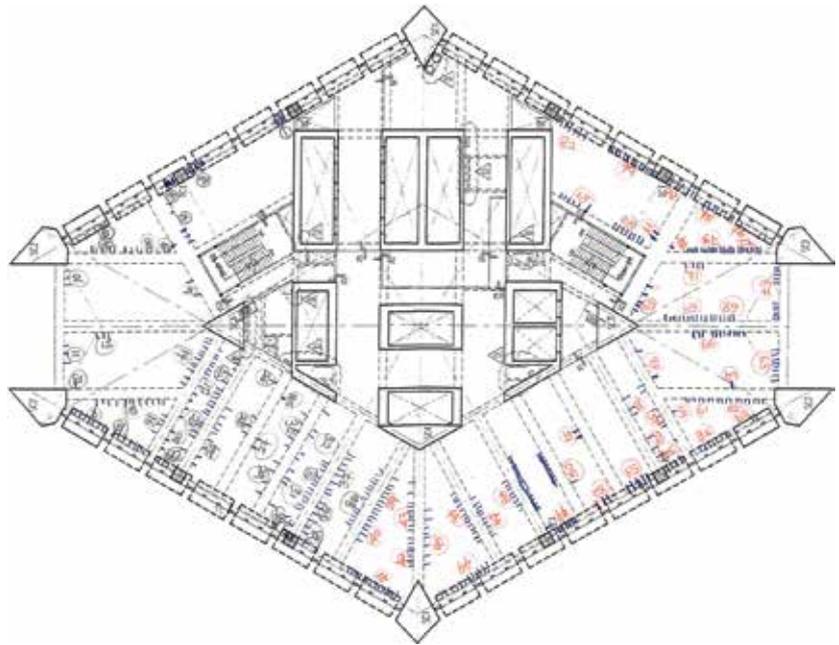
Figure 5. Map of cracks in perimeter girders and beams connecting perimeter girders and core walls at Level 16 (Source: Daewoo E&C)

Cracks in beams under floor slabs are similar in pattern and degree of development to those in perimeter columns but differ in the overall orientation of development in building plan. Their orientation is orthogonal to that of cracks in perimeter girders. Considering the orientations of the beams, these cracks may develop if the beams are under tension in the radial direction of the Tower's plan.

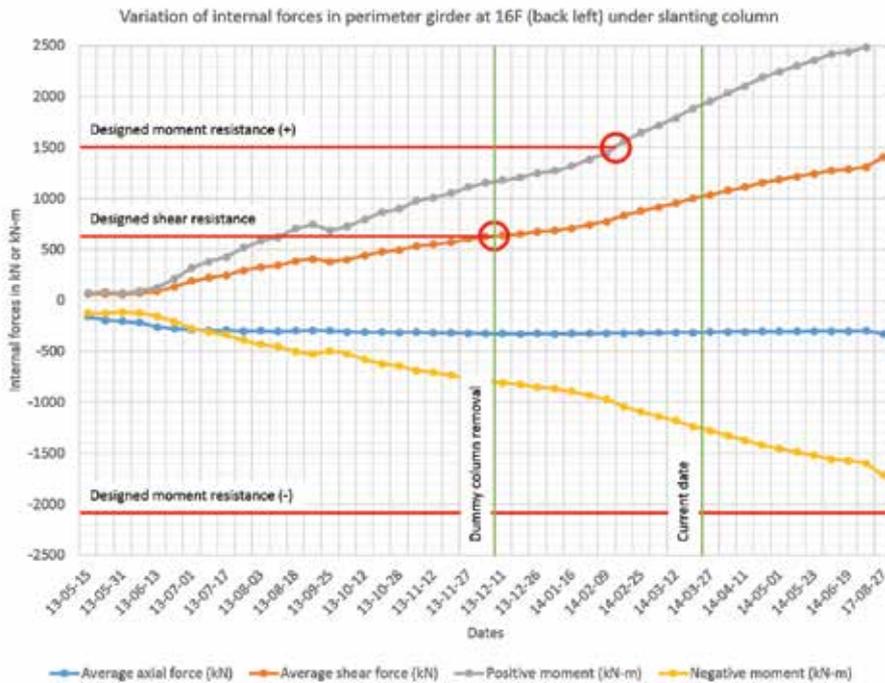
Figure 11 shows the variation of member forces, i.e. axial and shear forces and bending moment for the perimeter girder bounded by STC and TC at Level 16. The x-axis spans more than 4 years from the actual construction date of the member until the target time of the construction stage analysis, which was set at 3 years after the completion of construction. All the member forces except for axial force show ever-increasing tendency until the target time. Expected shear force in the girder has already reached its design capacity on the date of removal of the dummy column. Positive design moment on the tension side of the girder was also surfaced by the developed moment before the cracks were identified. Considering the basic function of beams and girders, this phenomenon deemed abnormal under gravity-only load condition.

The comparison of required and designed member forces for the perimeter girders under similar structural configuration is summarized in Table 2. The bending moment and shear force in some of the perimeter girders that have cracks already have exceeded the designed resistance of the member under the loading conditions during construction (1.0D + 0.5L)

Figure 11. Variation of internal forces in the cracked perimeter girder at Level 16 (Source: Daewoo E&C)

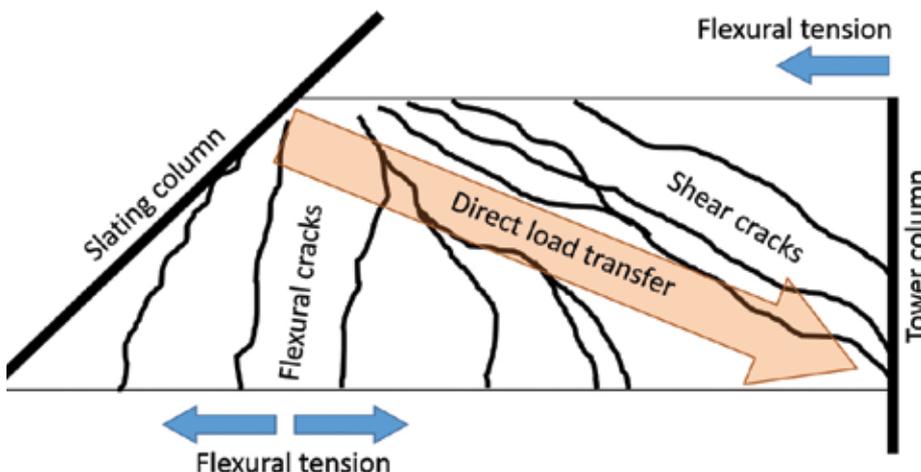
If this load were to be captured at the design stage, these girders should not have been released with hinges at both ends as usually done when high concentrations of internal forces are encountered during the structural analysis. Instead, more elaborate analysis and design are required considering the cumulative nature of the load and the mechanism of direct load transfer. It can be done by a sequential application of the construction stage analysis for applied load and the so-called strut-and-tie model for member design.

Figure 12. Assumed mechanism of direct load transfer from slanting column to tower column in the short perimeter girders (Source: Daewoo E&C)

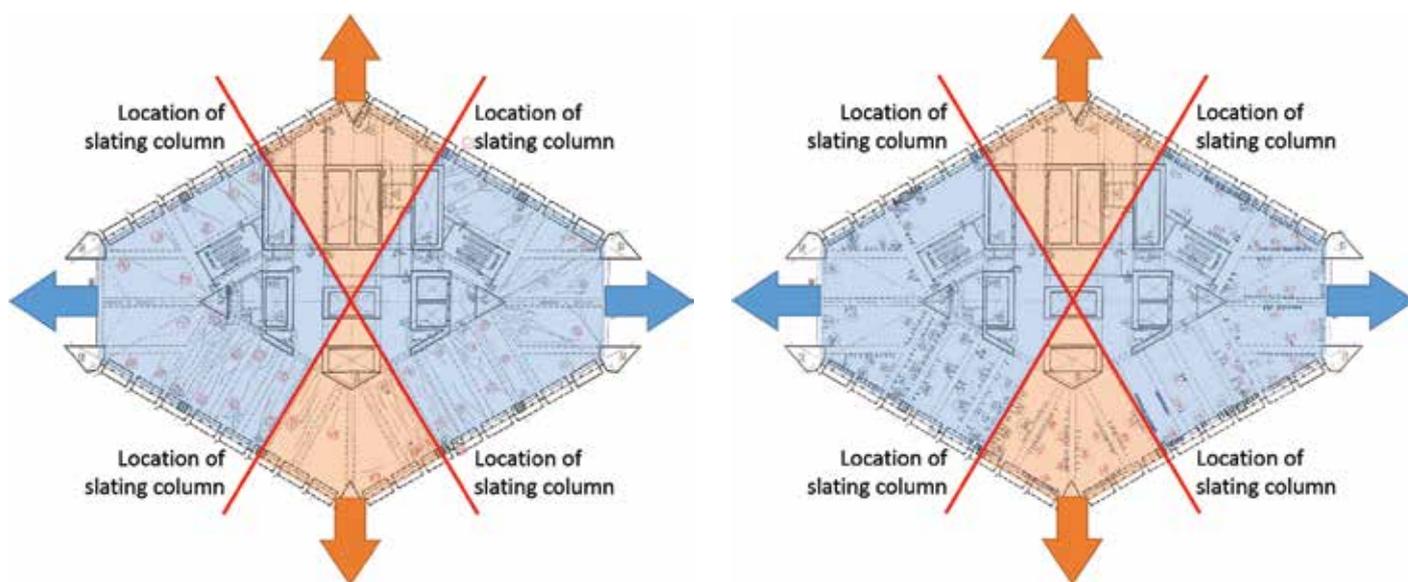
Except for the perimeter girders mentioned above, all the other perimeter girders, floor slabs and beams from Levels 10 to 17 exhibit cracks showing as if these structural members are under tension. This can be explained by the in-plane tension in the building plan due to the diaphragm actions exerted by the combination of slabs, girders and beams in the plan.

The directions of the diaphragm actions can be roughly divided into two directions – horizontal and vertical directions and the respective influencing area of each diaphragm action varies from Levels 11 to 20 depending on the location of slanting column in each level. As a result, the horizontal diaphragm action caused the cracks in the floor slabs where the perimeter girders and beams are oriented in horizontal direction. The vertical diaphragm action mainly caused the cracks in the beams oriented in vertical direction as shown in Figure 13. The vertical diaphragm action did not cause the cracks in the floor slab because the action was mostly resisted by the floor beams oriented in this direction.

The diaphragm actions were sufficient to cause cracks on the side of girders/beams but not enough to cause cracks under the bottom of girders/beams where most of longitudinal reinforcing bars are located. This is the reason why the cracks are observed only on the side of girders/beams.

Figure 13 Crack patterns and in-plane tension caused by overall building behavior: for floor slab (above) and for girders and beams (below) (Source: Daewoo E&C)
