Title: **Myth-busting: The Incredible “Shrinking” Washington Monument**

Author: Dru Smith, Chief Geodesist, National Oceanic & Atmospheric Administration

Original Publication: CTBUH Journal, 2015 Issue III

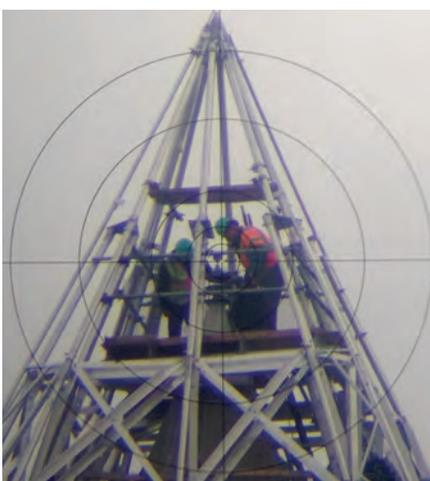
Figure 3. The view of the top of the Monument as viewed through the Total Station surveying tool.

Traverse uses a Total Station and Reflectors. A Total Station looks like a traditional survey instrument with a scope, but unlike historic instruments which could only measure horizontal angles and vertical angles, a Total Station can also electronically measure slope distances to a reflector as well (see Figure 4). The traverse survey measured angles and distances between about 10 different points around the monument. Using this data, we were able to transfer both orthometric and architectural heights to the peak, as well as determine its latitude and longitude.

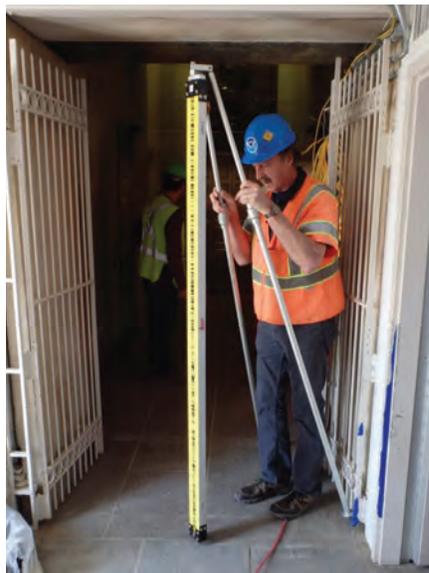
Figure 2. Height is measured from the level of the lowest, significant, open-air, pedestrian entrance to the architectural top of the structure (CTBUH criteria).

one point to another. The main equipment is a geodetic level and a pair of level rods. The process uses short, balanced sight lengths, back to one rod, then forward to another. This pattern continues, eventually connecting two points of interest. Using this method, two types of heights were determined at all points in and around the monument: North American Vertical Datum (NAVD) 88 "orthometric" heights (which are the official elevations used in all Federal geospatial products) and "architectural heights" (determined by adopting the CTBUH recommendation for where "zero architectural height" should be) (see Figure 3).

We had a pretty good idea of what CTBUH would consider the “level of the lowest significant open-air pedestrian entrance” at the WM (the standard to which architectural heights are to be determined), but to be meticulous, we identified four candidate locations in the WM that could ostensibly have fulfilled that criteria. We took pictures and videos and sent a full explanation of why we thought each point could be considered a candidate. The CTBUH reviewed the information we sent, and chose the point which we had named “W M FLOOR 3”. That was, in fact, our first guess, but it was reassuring that CTBUH concurred with this choice.
