Title: **Reinventing Woolworth: Adaptive Reuse of a Historic Skyscraper**

# Reinventing Woolworth: Adaptive Reuse of a Historic Skyscraper

This article presents a case study of structural and logistical issues involved in the adaptive reuse of an early 20th-century skyscraper, and outlines the case for achieving sustainability through such repurposing. Through skillful structural design, the redevelopment of the Woolworth Building serves as a case study of successfully repositioning an underutilized 1913 office tower to serve a new market – luxury residential. The Woolworth Building’s historic context, existing structural systems, and scope of the residential conversion are described, while particular technical concerns are explained.

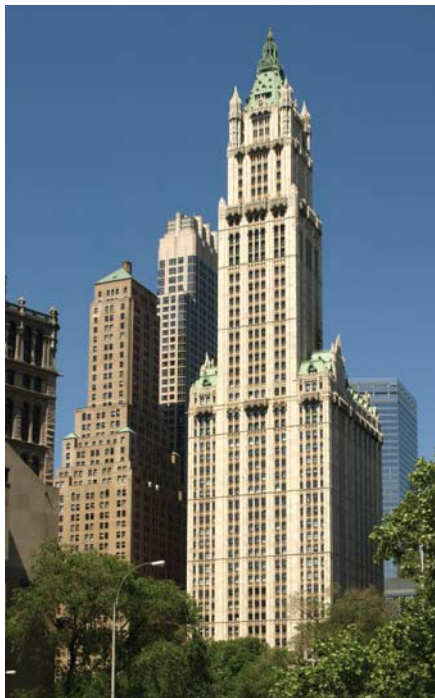
Figure 1. The Woolworth Building, New York. © Marshall Gerometta

Downtown Manhattan’s iconic 1913 Woolworth Building (see Figure 1) has seen multiple iterations of structural design and redesign over 17 years. These actions facilitated the conversion of a tower once tightly packed with office spaces for dentists and barbershops, into spacious luxury homes. The former “Cathedral of Commerce” will be home to some of the most luxurious in the city, including a six-story, US\$110 million “Castle in the Sky” penthouse. Construction methods were designed around 100-year-old documents; modern structural systems interact with historic riveted framing and structural terracotta. This redevelopment project was governed by strict landmark preservation guidelines and provided opportunities to enhance the building’s historical value through new construction.

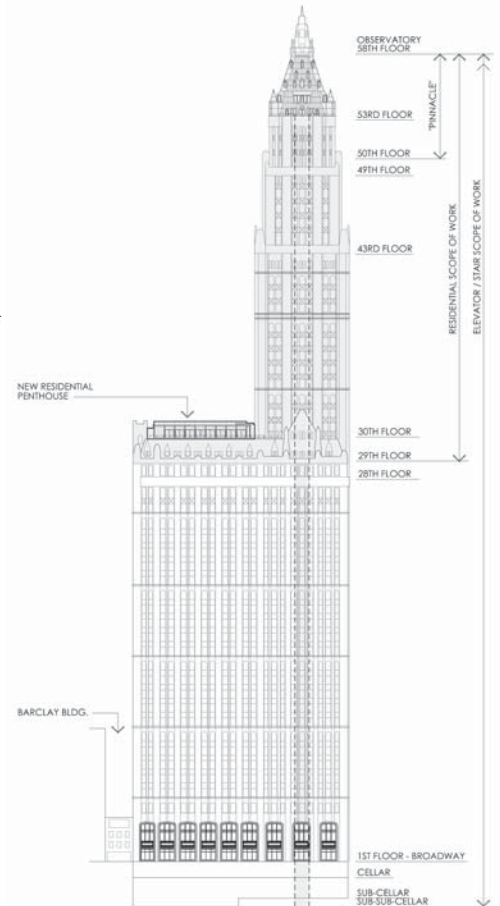
Figure 2. Scope of reconstruction work. © SLCE Architects

The fundamental objective of the project is to renovate and convert the upper 30-story “tower” portion to luxury condominium apartments, without disrupting ongoing office use of the lower 28 floors, which will continue to be occupied throughout the reconstruction (see Figure 2). The structure and proportions of the historic building lend themselves to an attractive, traditional apartment layout, yet a number of upgrades to building infrastructure and services, as well as the addition of new amenities are required. An abandoned basement swimming pool will be restored, in addition to the creation of a new wine cellar.

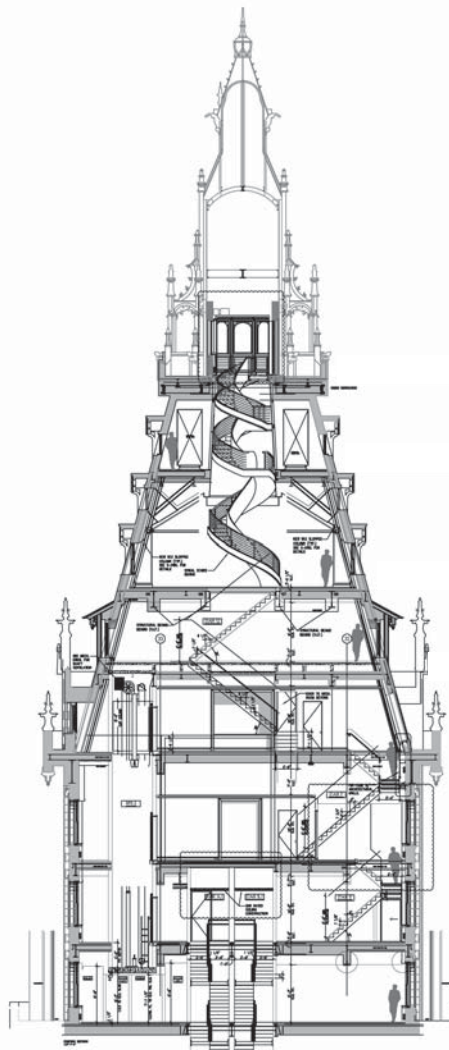
Figure 3. Section at pinnacle residence. © SLCE Architects

The six-story pinnacle will be converted to a single unique residence (see Figure 3). This involves removing a significant amount of floor area, adding an internal private dual-roped hydraulic elevator for that residence, replacing an existing spiral stair used to access the lantern with one that is code-compliant, and adding and enlarging windows and skylights within the landmarked pinnacle roof. Since a substantial portion of the floor diaphragm is

being removed, the frame must be strengthened to support lateral loads at the top of the building.

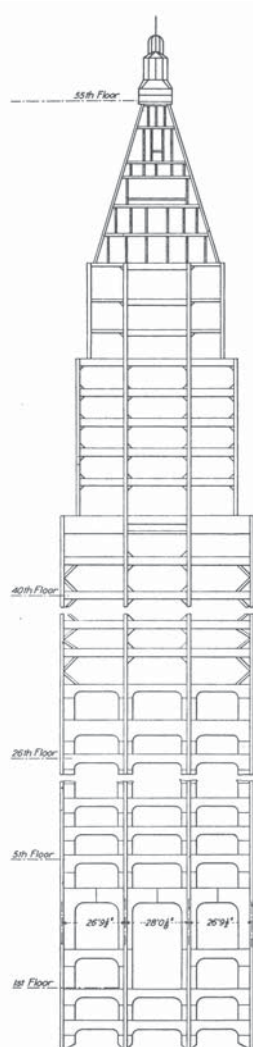
Figure 4. Overview of tower framing (1913). © Gunvald Aus

Wind loads drove the steel frame design, which integrates diverse types of bracing: portal arch bracing, full-story diagonal bracing, and knee bracing (see Figures 4 and 5) (Holtzman 1913). The central tower functions structurally as a highly rigid vertical cantilever and stabilizes the entire building. Where the tower meets the building's flanking wings at the lower 28 floors, portal arches span each structural bay at every story in the tower's front and back elevations. The remainder of the building base is reinforced by concentric chevron bracing and K-shaped knee braces. Between the 28th and 42nd floors, the tower frame is reinforced by diagonal knee braces. Up to the 47th floor,

additional perimeter columns connect to wall girders, and at the 47th to 50th floors, four interior columns join floor girders to resist lateral forces. At floors 50 and above (the pinnacle), inclined members of the pyramidal roof counteract the lateral forces of the wind (Wind Bracing 1912).

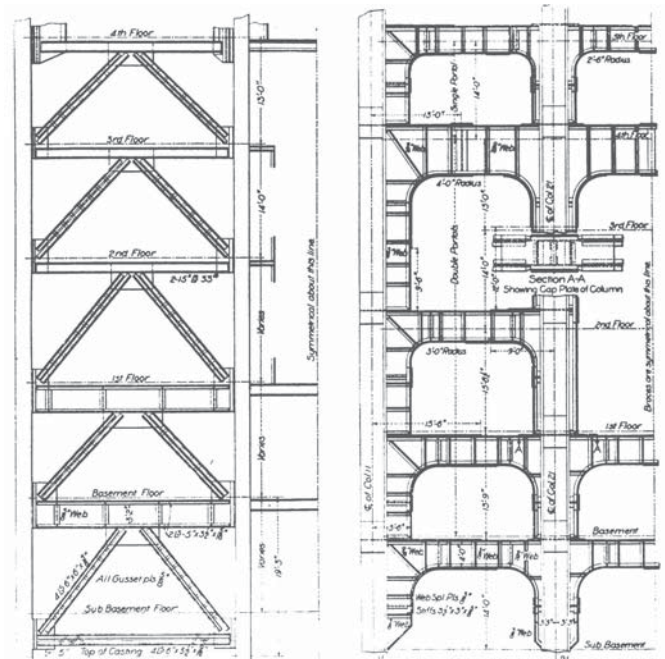
Figure 5. Detail of as-built bracing systems (1913). © Gunvald Aus

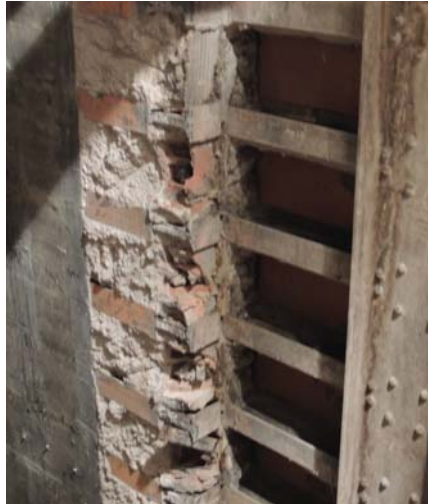
Figure 6. Existing shaft reinforcement.

elevators, a hundred years ago. Novel for its time, this mechanism consisted of large air-tight silo-like chambers at the bottom of the elevator shafts, within which the air beneath a falling elevator cab gets compressed, thus cushioning the drop (Six Hundred-Foot Drop 1913). These "silos" had to be removed, to make space for the new elevator shafts. This demolition was difficult, because they are made of a cage of horizontal web I-beams spaced at 381 millimeters, which is densely packed with terracotta or concrete (see Figure 6).

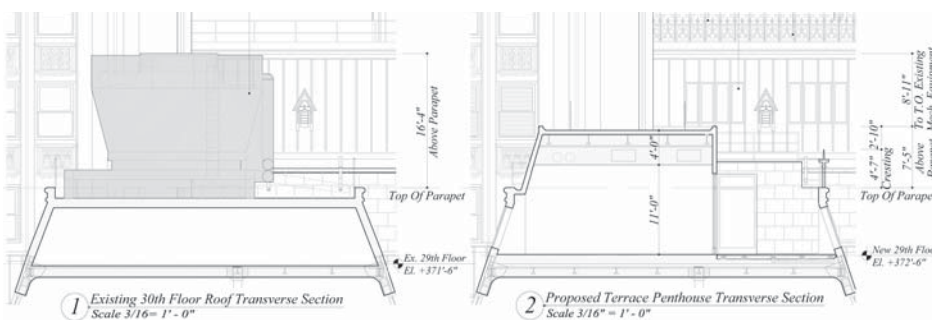
Figure 7. Residential conversion at 29th floor. © Thierry W. Despont

The wings of the 29th floor presented many structural challenges. The basic architectural goal was to take a mechanical space with 1.8 meters of head room and turn it into exclusive penthouse residences (see Figure 7). In order to do this, the architect had to convince Landmarks that the new, higher penthouse could not be seen from the street. The resulting architecture has the higher occupied space set back from the existing mansard roof to leave the sight line from the street unchanged. This meant the existing roof had to be removed, while leaving the mansard in place to hide the new structure. Additionally, the new structure had to be supported without reinforcing anything from below and minimizing the rise in the floor elevation. Complicating this further was the addition of cooling towers and an emergency generator at the far end on one of the wings, coupled with the need to maintain access to an existing elevator machine room and egress stair, also at the far end of the wings.

The fact that the lower half of the building was to remain in active use by office tenants over the duration of reconstruction limited the options for structural reinforcement and required careful coordination of the construction process. Any reinforcement of the slab at the 29th floor – the lowest residential level – had to be applied at top of steel only using WTs (structural tees cut from wide-flange shapes), because the bottom of the steel is not accessible, as that floor remains in use.

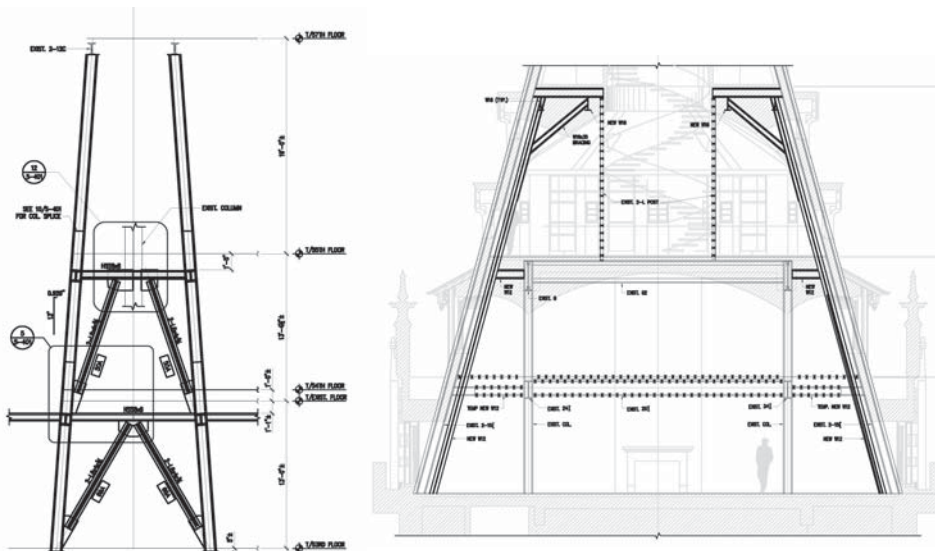
Figure 8. Pinnacle reinforcement.

At the pinnacle, existing posts are removed between the 55th and 57th floors to accommodate the installation of a new spiral staircase to the observation deck. The weight of a new doughnut-shaped, 56,781-liter, two-compartment stainless steel fire storage tank at the 57th floor must therefore be redistributed elsewhere. The supporting frame uses W8 braces to engage new sloped W12 corner columns that parallel the existing sloped exterior frame (see Figure 8).

Since more than half of the slab and floor framing at the 54th floor is removed to create a 7.9-meter-high open space known as the "Great Room," this level loses its diaphragm. Combined with the need to remove significant portions of the terracotta substructure of the sloped roof to increase the window openings, new chevron wind bracing is required at the new corner

columns to maintain stiffness and lateral capacity. New HSS8 frames are installed around the perimeter at floors 54 and 55 to engage existing structure with the new bracing system.
