Title:	<b>The High-rise as a Retirement Community</b>
Authors:	Bridget Lesniak, Principal, Perkins + Will Robert Neper, Senior Associate, Perkins + Will Donald Hamlin, Senior Associate, Thornton Tomasetti
Subjects:	Building Case Study Social Issues
Keywords:	Code Compliance Community MEP Mixed-Use
Publication Date:	2010
Original Publication:	CTBUH Journal, 2010 Issue III
Paper Type:	1. Book chapter/Part chapter 2. <b>Journal paper</b> 3. Conference proceeding 4. Unpublished conference paper 5. Magazine article 6. Unpublished

# The High-rise as a Retirement Community

The Clare at Water Tower is a Continuing Care Retirement Community developed by the Franciscan Sisters of Chicago Service Corporation on a parcel of land owned by Loyola University (the program for the tower also includes new education space for the university) at 55 East Pearson Street in Chicago. The project is the Franciscan's first high-rise and represents an urban living option for seniors. The project is unusual in that the functional elements, usually distributed in several buildings in a typical CCRC, have been stacked vertically. This unique combination created planning and engineering challenges on a constri

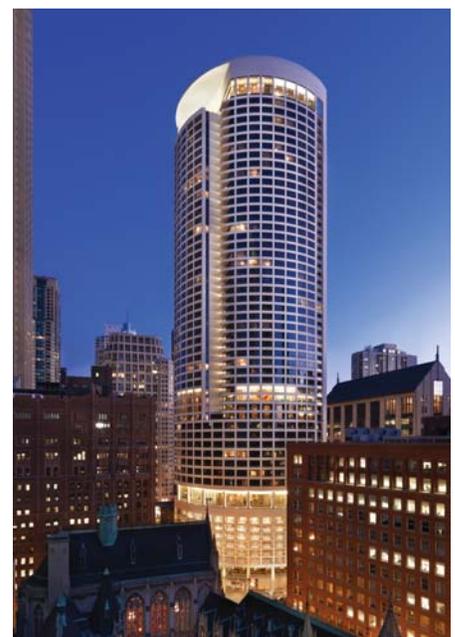
Figure 1. View of north and east elevations  
© James Steinkamp

floor-to-floor heights with multiple fenestration patterns, but rather a cohesive high-rise tower with base, shaft, and top. This was accomplished by a strong, single tower design reading from ground to level 53 and a subservient podium massing. The tower has a very rigorous, repetitive fenestration pattern that was designed to align with all of the varying functional plans. The ABA window module accommodates the various partition layouts of the different uses. The curve of the tower responds to the views of Lake Michigan and its single carved out slot was important in generating residential unit layouts. Below this, the curve is continuous and occupied by a sweep of healthcare rooms. The fitness level has an arcade along this curved facade, behind which a higher floor-to-floor and full height glass accommodates an indoor pool and fitness spaces (see Figure 5). The arcade is repeated below the parking levels for the ground and second floor levels, identifying the educational and lobby functions.

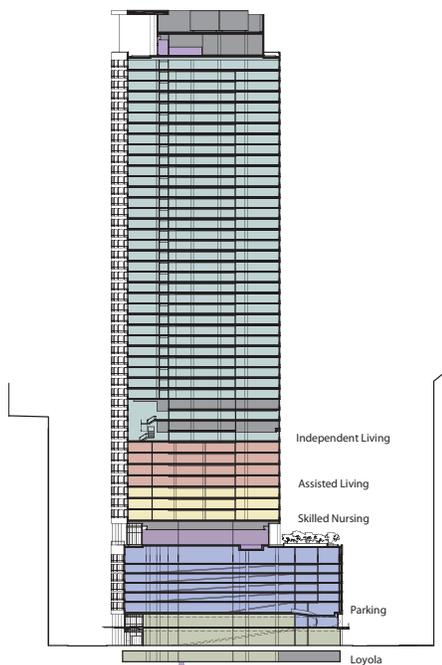
Figure 2. Building section © Perkins + Will

The Owner's program dictated seven major functional uses to be stacked vertically (see Figure 2). The first conceptual decision point was establishing the order of the layers. The educational program needed to be closest to grade for ready access to the student population of Loyola. Parking logically had to stack above the education floors. This massing allowed for a large outdoor roof garden (see Figure 3) and, therefore, the indoor pool and fitness spaces for the seniors belonged on this level. Above this podium roof level, the smaller tower footprint rises (see Figure 4). The

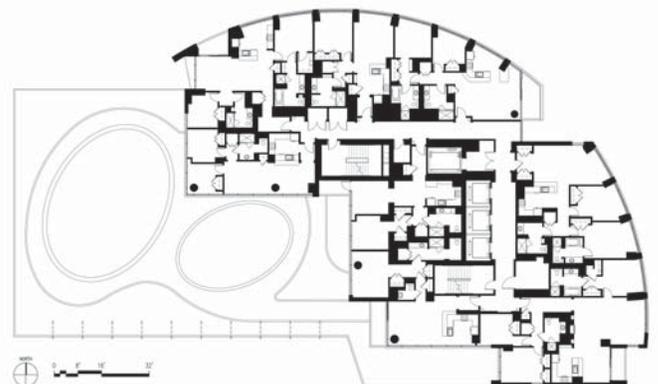
Figure 4. Typical "independent living" floor plan © Perkins + Will

marketability of the Independent Living Units dictated that they be located on the top floors of the tower. Associated with these residential units and the healthcare floors are common dining, social, and chapel spaces. These spaces were located on floors 16–19 to take advantage of the views above adjoining properties. Below these amenity floors, the Assisted Living and Skilled Nursing floors were

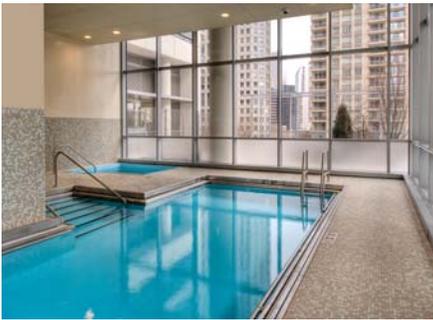
Figure 5. Pool room with increased floor-to-floor height  
© Marian Kraus

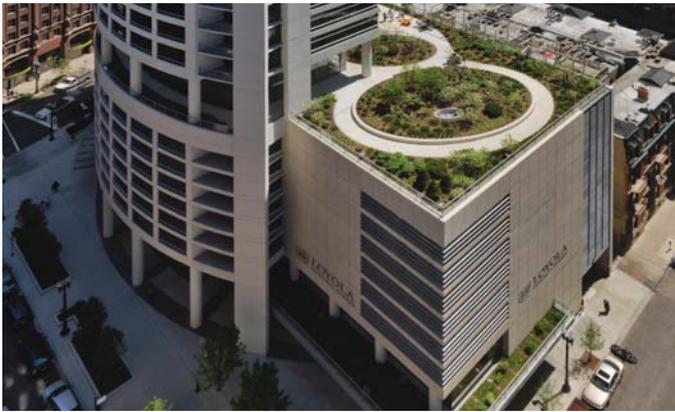
Figure 6. View of site from above. © James Steinkamp

The challenges regarding the site were the existing buildings and their caissons, the tight urban site for construction of a tower of this size, and the soil conditions in this area of Chicago (see Figure 6). Some of these challenges were foreseeable and others were not. Thornton Tomasetti, the structural engineers, designed a foundation system of belled caissons bearing on a very stiff clay layer known as hardpan. It is the most common foundation type for tall buildings in downtown Chicago. The largest bell diameters for the project were 17'-6" (5,330 millimeters).
