Title: **Performance of Post-Tensioned Slab-Core Wall Connections**

Original Publication: PTI Journal 2006 Volume 4 No. 2

PERFORMANCE OF POST-TENSIONED SLAB – CORE WALL CONNECTIONS

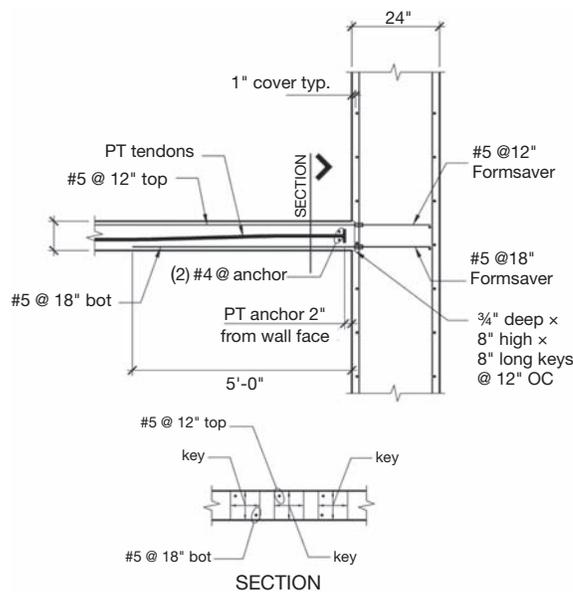
Fig. 1 – Typical Slab-Wall Connection and Detail for Specimen 1

The use of post-tensioned floor slabs and reinforced concrete core walls has become increasingly popular in high-rise construction in recent years. In many high-rise towers, it is common for the core walls to be constructed ahead of the columns and floor slabs to expedite construction. When this technique is used, a vertical cold-joint is introduced at the slab-wall interface. A common practice is to locate the anchors for the unbonded post-tensioning cables within the slab immediately adjacent to the wall. The slab-wall connection is made through reinforcing dowels placed near the top and bottom of the slab, with mechanical couplers, such as the Lenton® Form Saver, at the slab-wall interface, often supplemented with intermittent shear keys. Figure 1 shows a typical detail.

The construction details of both specimens were similar with the exception of the slab-wall connection. As illustrated in Figure 1, the slab-wall connection of Specimen 1 included:

- #5 by 7'-2"-long top dowels at 12" on center
- #5 by 5'-0"-long bottom dowels at 18" on center; the dowels were connected to the wall using Form Saver mechanical couplers
- 3/4"-thick by 8"-tall by 8"-long intermittent shear keys at 12" on center
- Post-tensioning tendon anchors placed within 2" of the face of the wall

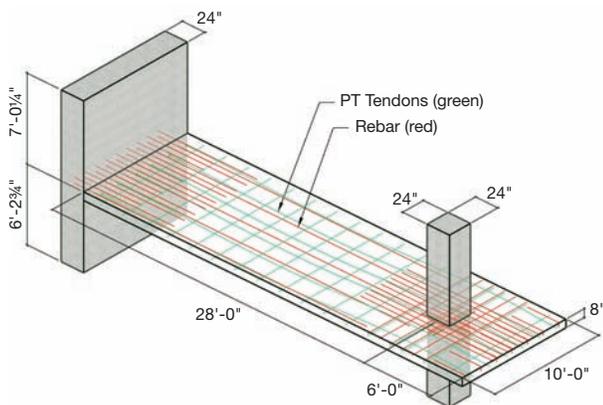
Fig. 2 – Isometric Illustration of a Specimen

Two full-scale specimens were sequentially constructed in the Structures Laboratory at the University of California, Berkeley. The geometry of each specimen was indicative of common architectural dimensions and construction details. Figure 2 illustrates the overall specimen geometry.

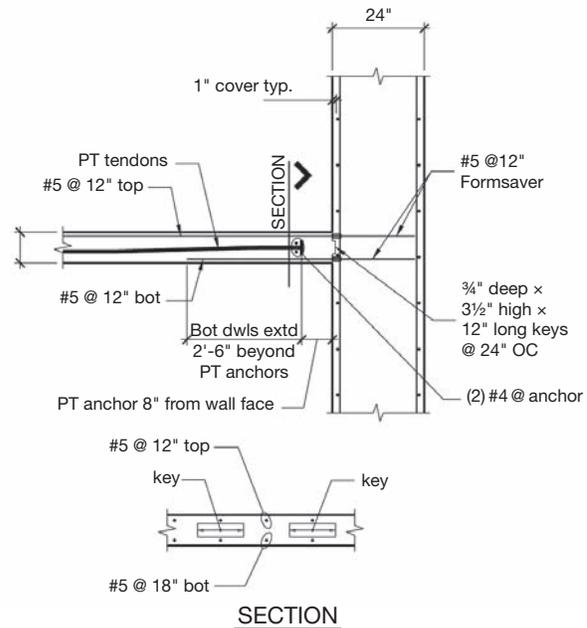
Fig. 3 – Slab-Wall Connection Detail for Specimen 2

The slab-wall connection for Specimen 2 was modified in an attempt to enhance the performance of the connection. As illustrated in Figure 3, the slab-wall connection of Specimen 2 included:

- #5 by 7'-2"-long top dowels at 12" on center
- #5 by 3'-2"-long bottom dowels at 12" on center; the dowels were connected to the wall using Form Saver mechanical couplers
- 3/4"-thick by 3.5"-tall by 12"-long intermittent shear keys at 24" on center, placed at the mid-depth of the slab
- Post-tensioning tendon anchors placed 8" from the face of the wall

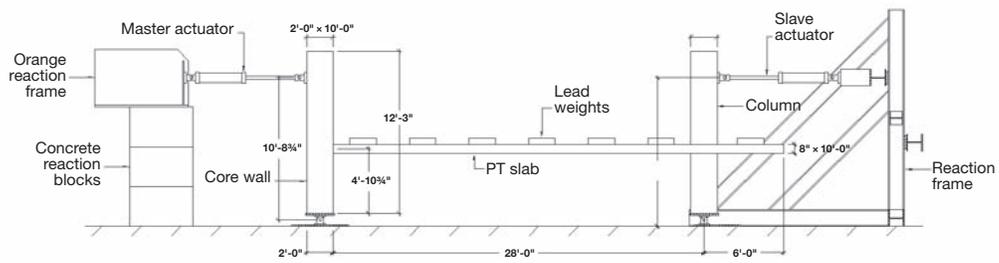
Fig. 4a – Elevation of Test Set-Up

The test setup positioned each specimen atop “pinned” clevises anchored to the laboratory strong floor, with lateral deformations imposed by actuators attached near upper ends of the wall and column (Figure 4). Specimen story height was 10’ 8¾”, measured from the center of the clevis pin to the centerline of the actuator. To securely connect the specimen to the pinned clevises at the base, additional headed anchor bars were installed at the base plate of the wall (Figure 5) and column (Figure 6). As shown in Figure 5, additional ties were also provided at the base of the wall to confine the headed anchor bars and U-hoops were placed at the edges of the wall along the entire height.

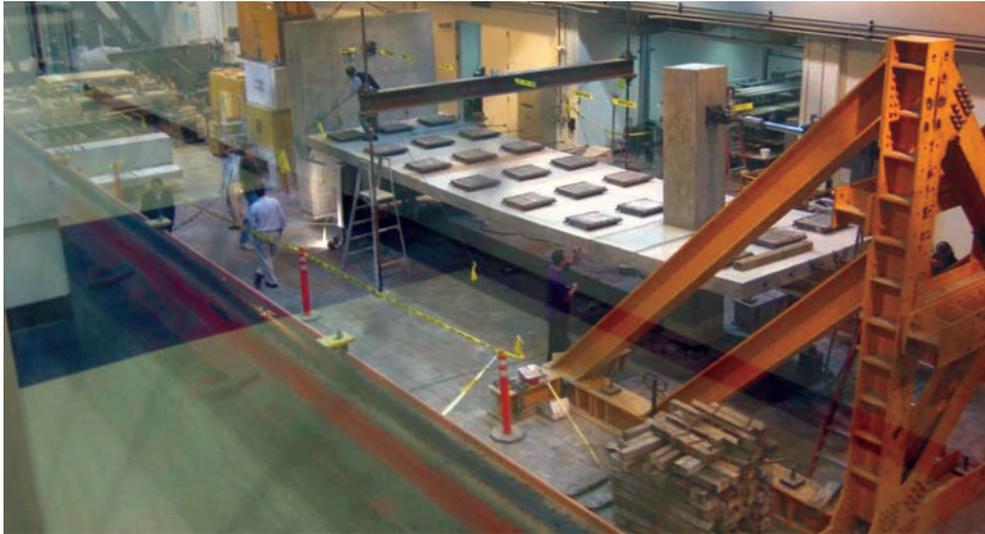
Fig. 4b – Test Set-Up

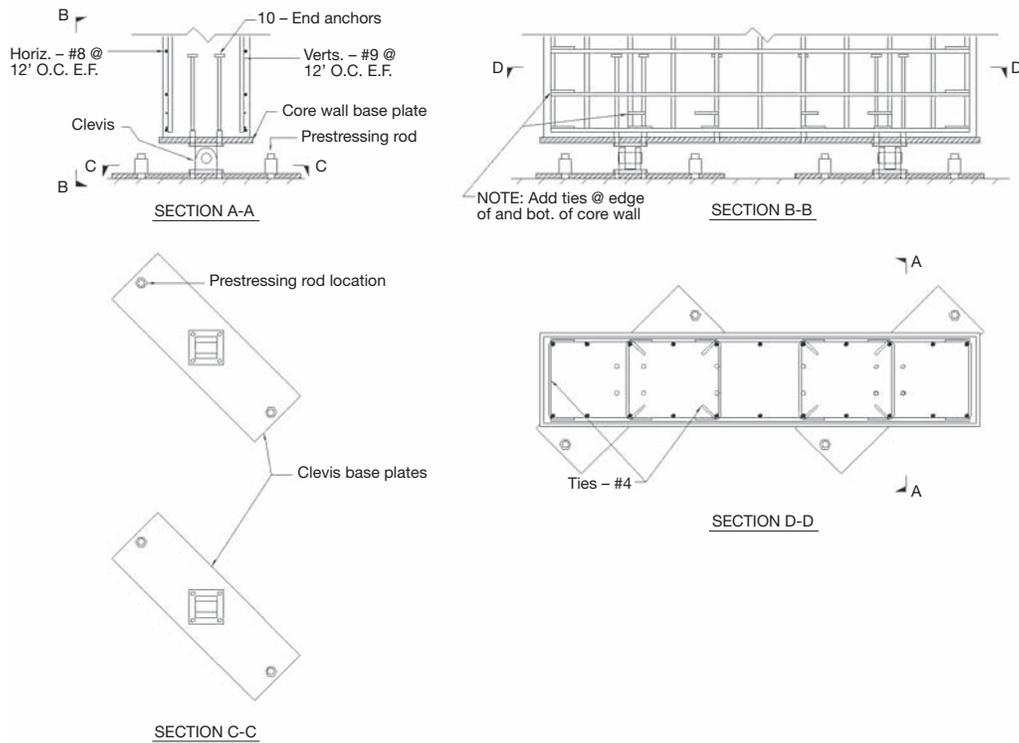
Fig. 5 – Wall-Clevis Connection Detail

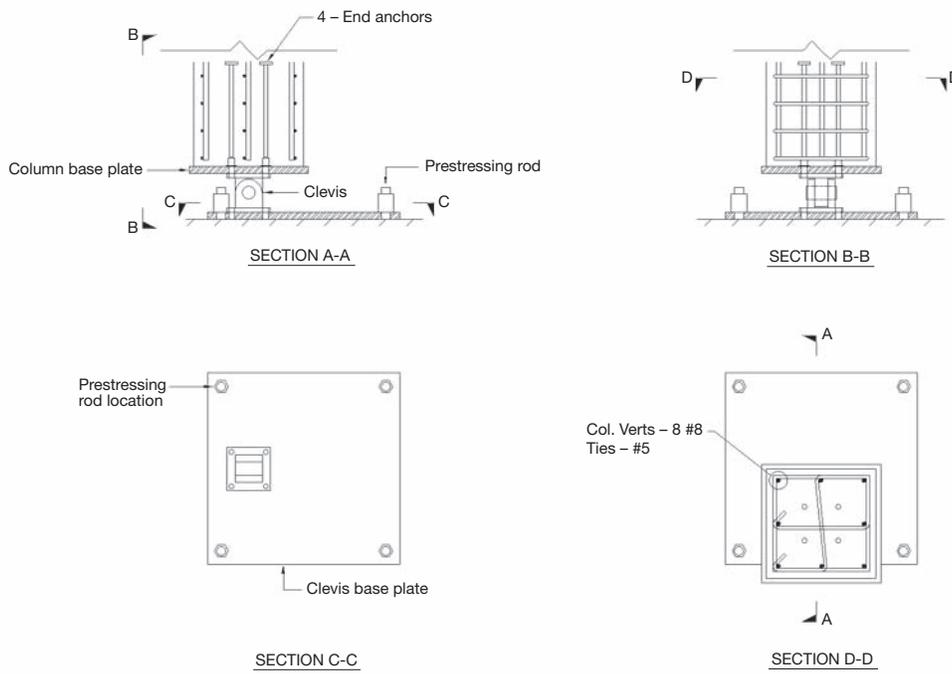
Fig. 6 – Column-Clevis Connection Detail

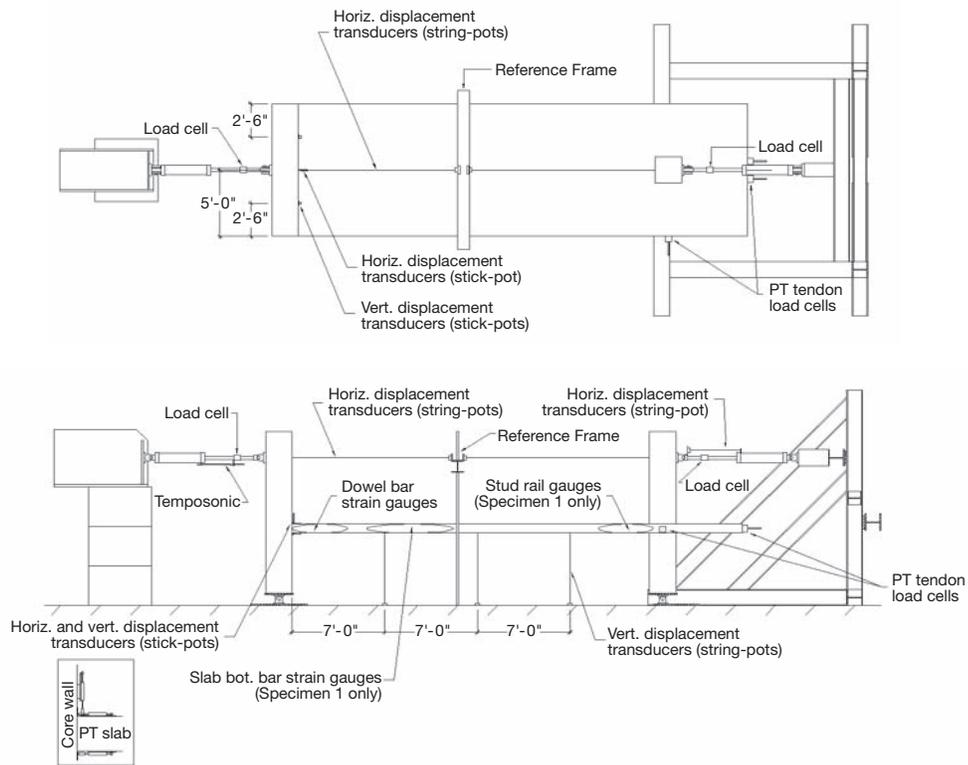
Fig. 7 – Instrumentation of Specimens

Table 3 summarizes the instrumentation used to gather test data. Figure 7 illustrates the locations of the instrumentation listed in Table 3. Strain gauges on slab bottom bars near midspan and on stud rails near the column were not used in Specimen 2.

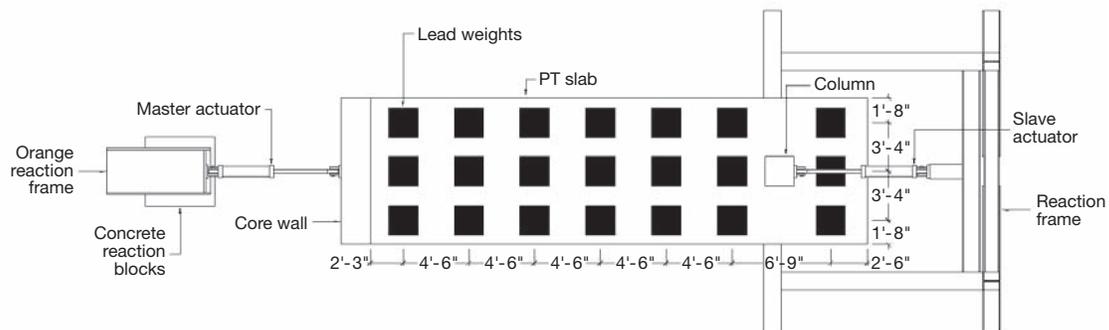
Fig. 8 – Plan of Test Set-Up Showing Superimposed Loads

Prior to applying lateral deformations to each specimen, 21 bundles of lead weights, each weighing 500 lb, were positioned on the slab, as shown in Figure 8. This corresponds approximately to a superimposed load of 30.5 psf, which is representative of expected loading in high-rise residential construction.

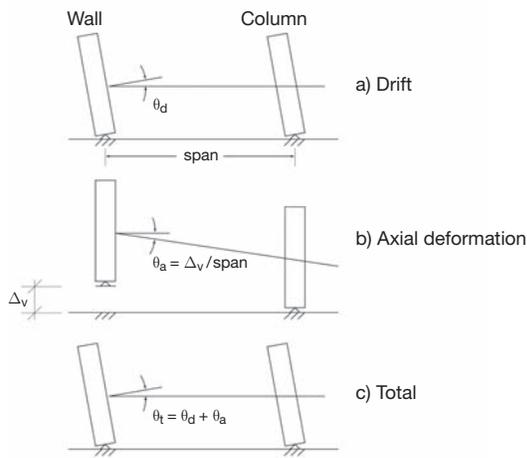
Fig. 9 – Supplemental Joint Rotation Due to Vertical Core Wall Deformation

In tall buildings, axial deformation of the core walls caused by the flexural behavior of the wall assembly increases rotational demands on the slab-wall connection. Considering a building approximately 400-feet tall and a slab span of approximately 30 feet, the effect of this building action causes rotations inducing tension on the top of the slab to be approximately double the rotations inducing tension on the bottom of the slab. This principle is illustrated in Figure 9.

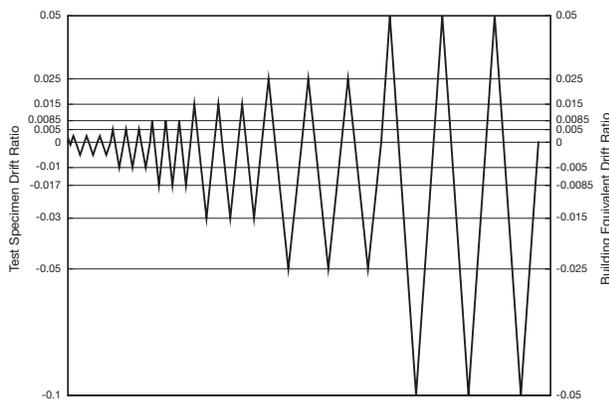
Fig. 10 – Drift Ratio History

To induce the target lateral displacement protocol, a “master” actuator connected to the core wall was commanded under displacement control with the drift ratio time history shown in Figure 10. The specimen was laterally loaded with a low-level symmetric cycle, followed by six asymmetric cycle groups of increasing drift ratio 0.0025, 0.005, 0.0085, 0.015, 0.025, and 0.05.

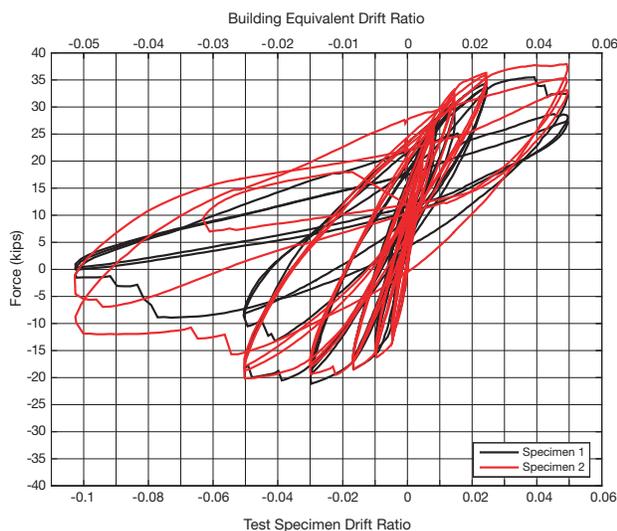
Fig. 11 – Total Lateral Force vs. Specimen Drift Ratio for Specimens 1 and 2

Figure 11 shows the total lateral force versus specimen drift ratio for both specimens. Specimen drift ratio is the displacement of the wall divided by the wall height, measured from the center of the pin to the centerline of the actuator. Test specimen drift ratio is equal to building equivalent ratio for positive drifts (drift toward the column side) and twice that value for negative drifts. The scaling factor 2.0 for negative drifts is to account approximately for wall axial (tension) deformation, as discussed in relation to Figure 9. The total lateral force is the sum of the force in the master actuator and slave actuator.

Table 4 summarizes the total lateral force required at the first and third peaks in the positive and negative directions for Specimens 1 and 2. As seen in Figure 11, and highlighted in Table 4, the most dramatic difference in the two tests occurred during the 0.025 and 0.05 building equivalent drift ratio cycles. The total lateral force required to reach the third peak in the negative direction of the 0.025 drift cycle was -7.8 kips and -16.6 kips for Specimens 1 and 2, respectively. The total lateral force required to reach the first peak in the negative direction of the 0.05 drift cycle was -0.9 kips and -8.8 kips for Specimens 1 and 2, respectively.

As seen in Figure 11, the connection remained essentially elastic in both specimens through three cycles of the 0.85 percent building equivalent drift ratio. Inelastic behavior was observed to occur in both specimens at approximately 1.0 percent building equivalent drift ratio. Thus it can be inferred that for building drifts experienced in conjunction with an overall Life Safety Performance Level, the connection will remain elastic or nearly elastic.

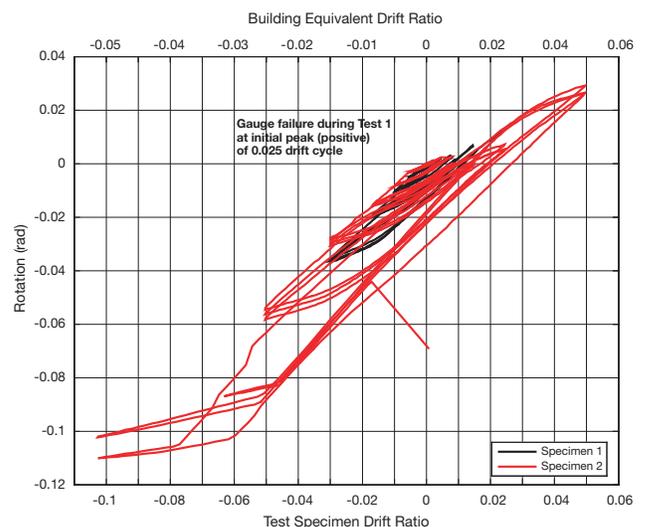
Fig. 12 – Slab-Wall Joint Rotation vs. Specimen Drift Ratio for Specimens 1 and 2

Figure 12 shows the slab-wall joint rotation versus specimen drift ratio for both specimens. To measure rotations, stick-pots were fixed to the top and bottom slab surfaces with targets to the wall face. Slab-wall rotation is defined as the difference in displacement readings from the stick-pots divided by the vertical distance between them. Referring to Figure 12, the stick-pot connection at the top of the slab failed in Specimen 1 due to spalling of the concrete slab during the initial peak positive displacement of the 0.025 specimen drift ratio cycle, limiting the test data necessary to compute the slab-wall joint rotation at larger drift ratios.

The stick-pot on the top of the slab in Specimen 2 moved off its target during the 0.05 specimen drift ratio cycle due to

spalling of the concrete slab. Thus, measured rotations beyond the 0.05 drift cycle should be considered as approximations.

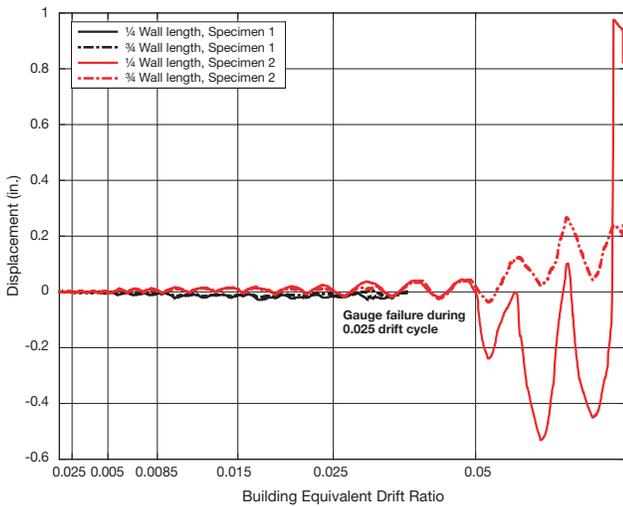
Fig. 13 – Slab-Wall Joint Vertical Displacement for Specimens 1 and 2

Figure 13 shows the variation of vertical movement at the slab-wall joint as a function of building equivalent drift ratio for both specimens. Vertical movement is defined as the vertical displacement of the slab relative to the wall, as measured by stick-pots fixed to the wall face and targeting the underside of the slab. The horizontal axis of the figure corresponds to the initial peak positive specimen drift ratio. Spalling of the concrete slab made the measurements inaccurate toward the end of the test for Specimen 1; therefore, data are shown only through the 0.025 drift cycle.

For Specimen 2, the variation in movement at the quarter and three-quarter wall locations during the 0.05 building equivalent drift ratio cycle was due to spalling of the slab at the location of the gauges.

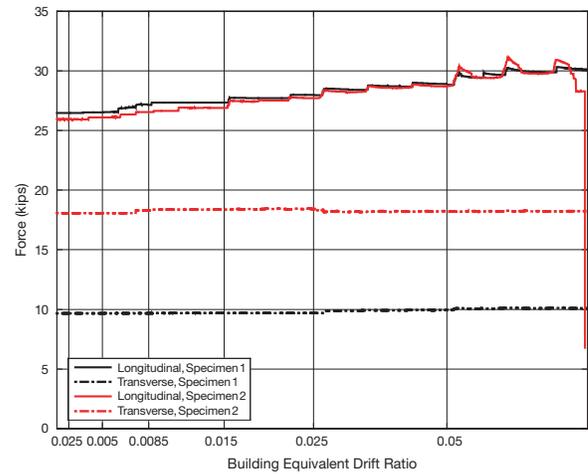
Fig. 14 – Post-Tensioned Strand Force for Specimens 1 and 2

Figure 14 shows the post-tensioned cable force as a function of building equivalent drift ratio for both specimens. The strand force in the longitudinal and transverse directions did not vary significantly at increasing drift ratios. The large dropoff in force in the PT tendon in Specimen 2 was the result of a large crack that developed in the specimen roughly 8 feet from the column during the third cycle of 0.05 building equivalent drift.

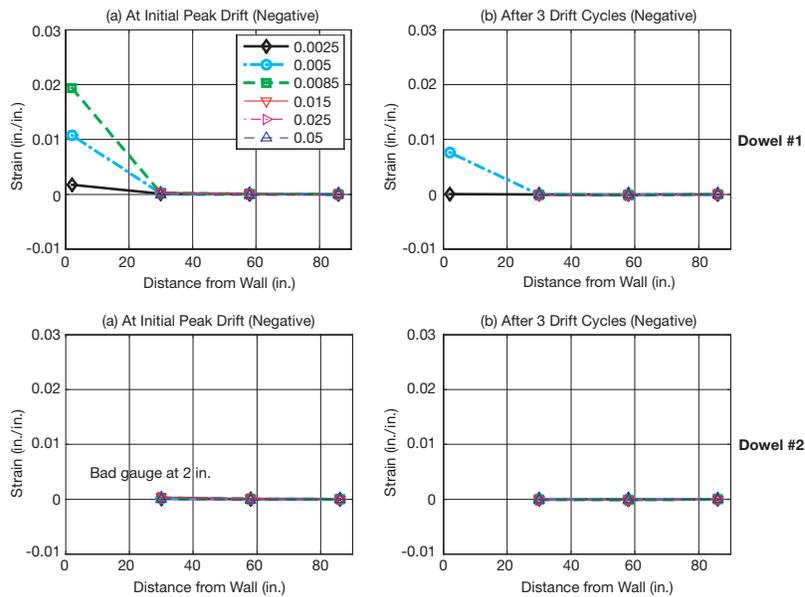
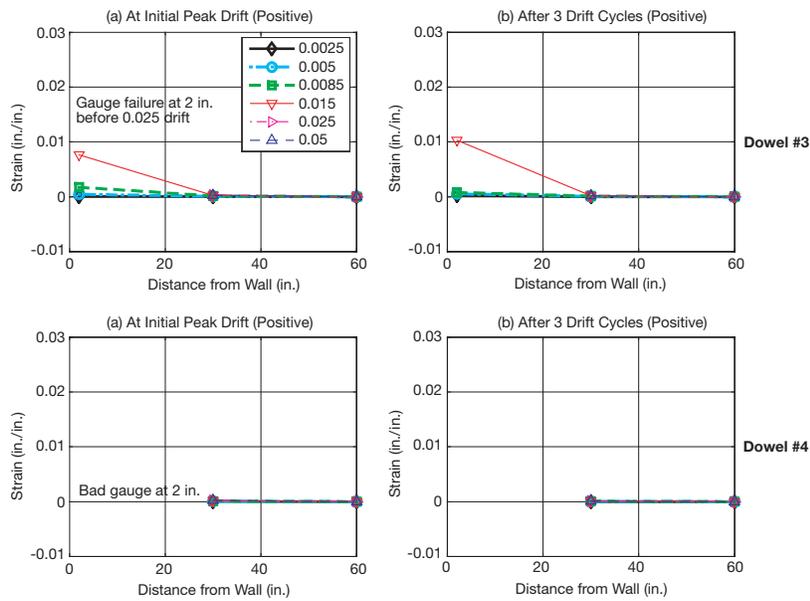
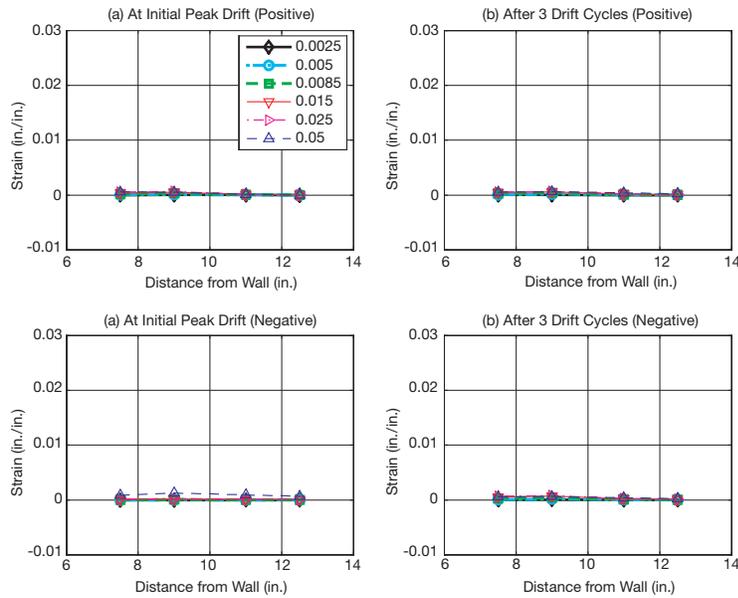
Fig. 15 – Specimen 1: Top Dowel Strain Profile

Fig. 16 – Specimen 1: Bottom Dowel Strain Profile

Fig. 17 – Specimen 1: Bottom Bar Strain Profile

Figures 15, 16, and 17 show the strain profiles along the top dowels (dowels #1 and #2), bottom dowels (dowels #3 and #4), and bottom bars at key equivalent building drift ratios (indicated in the legend), respectively. The largest strains in the top and bottom dowels occurred near the wall face; the strains were effectively zero at gauge locations 30 inches from the wall face and beyond. Referring to Figure 17, the bottom bars underwent very small strains along the bar length that was instrumented.

As shown in Figures 15 to 19, the strain levels in the reinforcing steel diminished rapidly only a short distance from the face of the core wall. There was no visual evidence in either test of any cracking or distress related to the “lap” condition between the dowels and the post-tensioning tendons. As shown in Figure 14 the force level in the post-tensioning cables increased by only 10 to 15 percent throughout the duration of both tests.

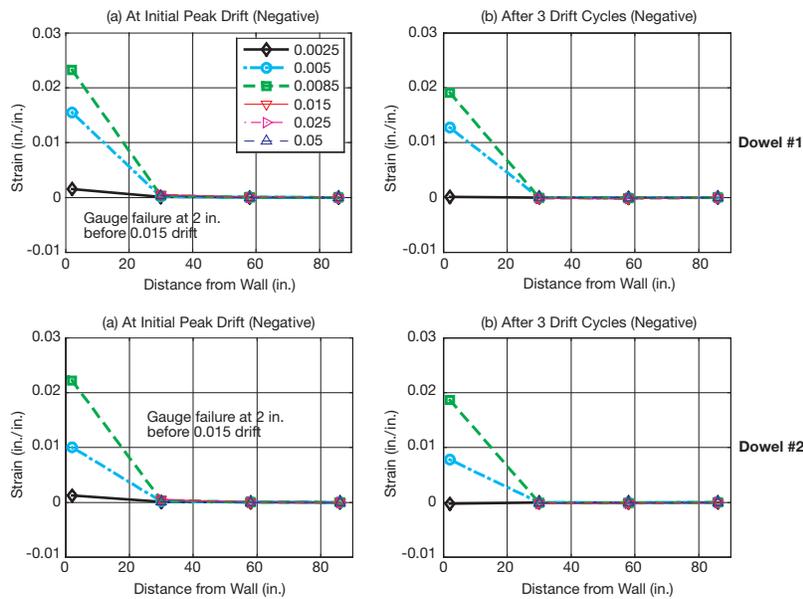
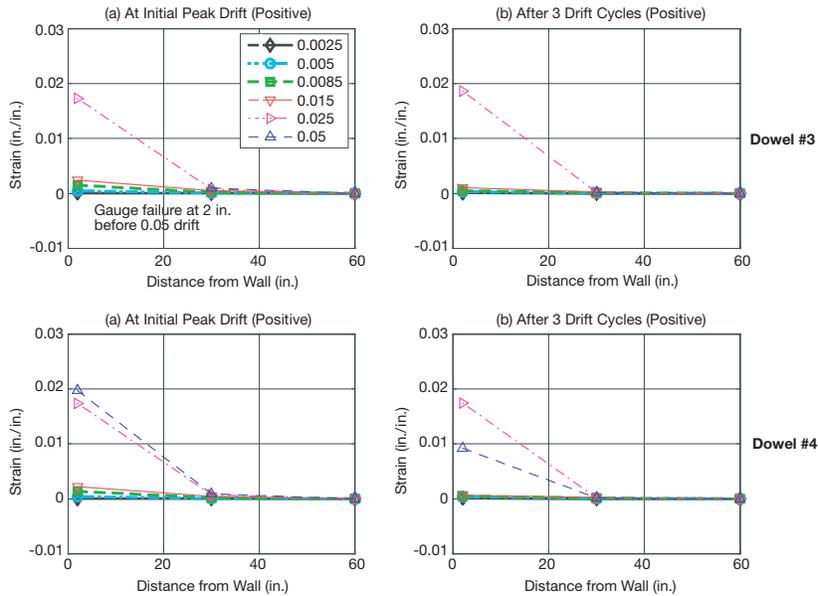
Fig. 18 – Specimen 2: Top Dowel Strain Profile

Fig. 19 – Specimen 2: Bottom Dowel Strain Profile

Figures 18 and 19 show the strain profiles along the top dowels (#1 and #2) and bottom dowels (#3 and #4), respectively. The highest strains in the top and bottom dowels occurred near the face of the wall, with effectively zero strain recorded at other gauge locations.

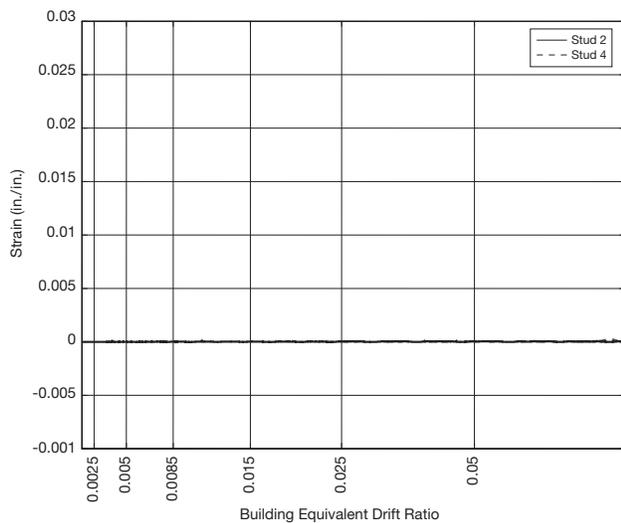
Fig. 20 – Stud Rail Strain for Specimen 1

Figure 20 shows the variation of strain on the studs near the column (see Figure 7 for location of instrumentation) as a function of building equivalent drift ratio for Specimen 1. The horizontal axis of Figure 20 corresponds to the initial peak positive drift ratio in each drift cycle. Clearly, the studs experienced very small strains during the test.

The low level of demand recorded on the shear studs at the slab-column connection is attributed to the limited width of the specimens. Each specimen's total width of 10 feet represents approximately one-third of a typical slab span, thus the gravity shear stress on the slab-column connection was approximately one-third of a typical condition. As the slab-column connection was not the focus of these tests, the lower level of loading was deemed acceptable and did not affect the results of the slab-wall connection assessment.

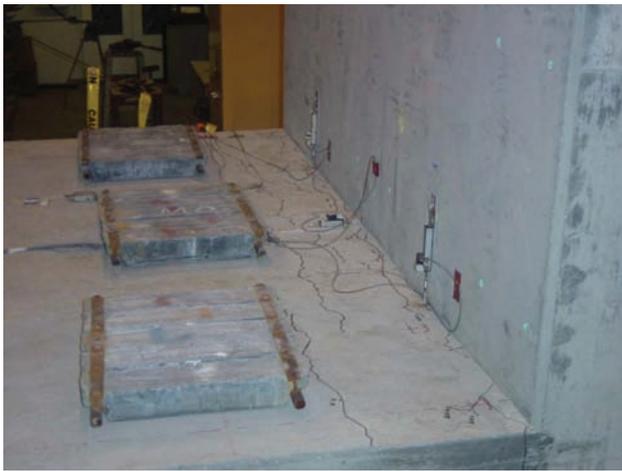
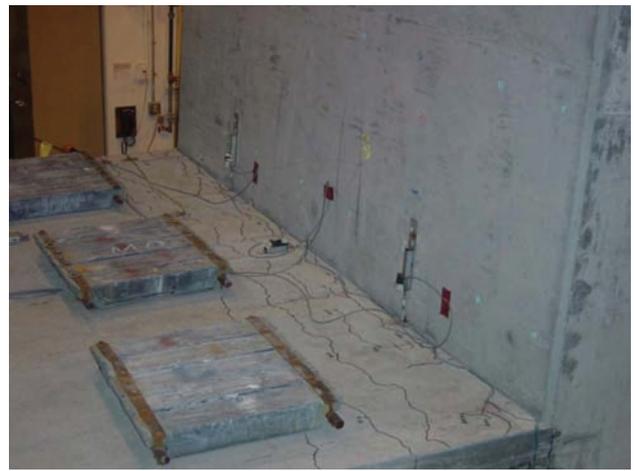
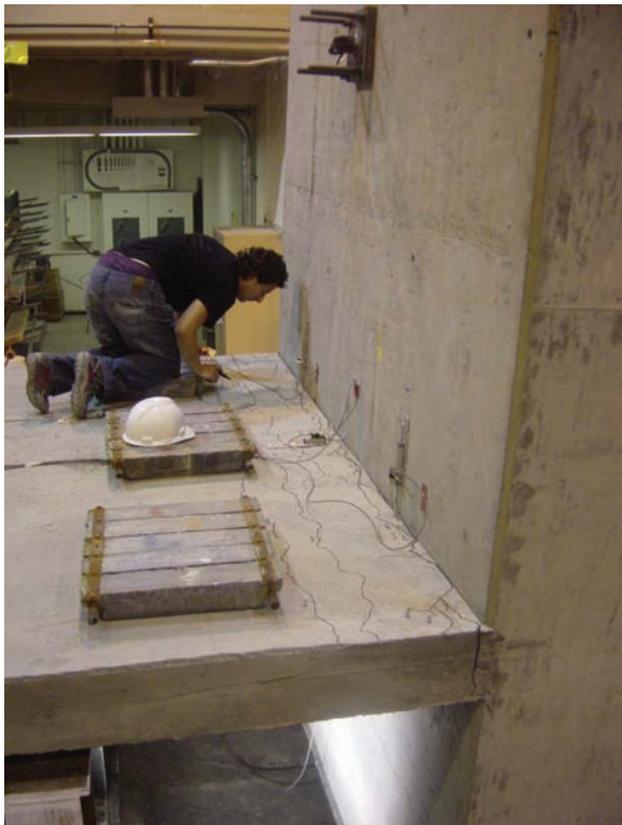
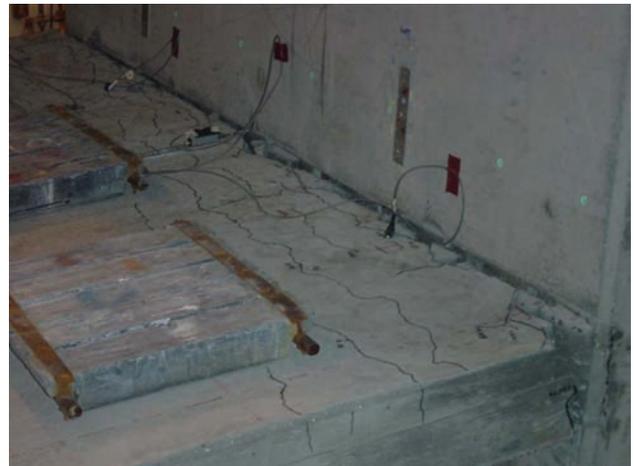
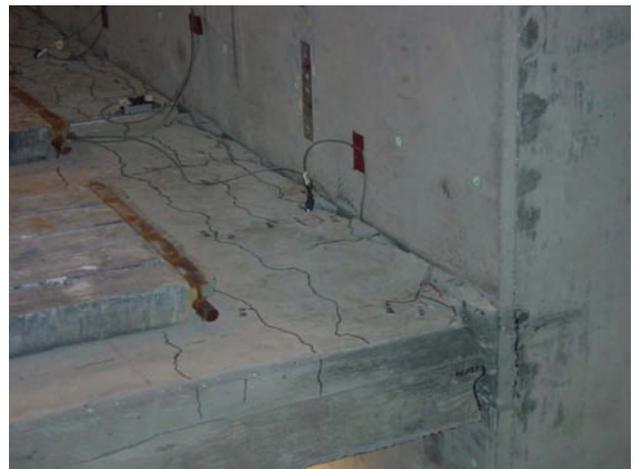
Fig. 21 – Cracking Patterns for Specimen 1 at Various Drift Levels

a) Cracking at Top of Slab at 0.5% Drift
(Specimen Held at Peak Rotation)

c) Cracking at Top of Slab at 2.5% Drift
(Specimen Held at Peak Rotation)

b) Cracking at Top of Slab at 1.5% Drift
(Specimen Held at Peak Rotation)

d) Cracking at Top of Slab at 5.0% Drift
(Specimen Held at Peak Rotation)

e) Zero Displacement After 5.0% Drift
(Specimen Held at Peak Rotation)

The type of failure, if any, of the dowel bars for Specimens 1 and 2 is summarized in Table 6 and Table 7, respectively. For Specimen 2, three top dowel bars fractured, corresponding to three popping sounds during the test, one pop en route to the first negative peak of the 0.015 drift cycle and two pops en route to the first negative peak of the 0.05 drift cycle. The dowel bar fractures can also be observed in Figure 11 where the total force drops sharply near (-0.023 specimen drift ratio, -18 kips), (-0.056 specimen drift ratio, -12 kips), and (-0.067 specimen drift ratio, -11 kips). The dowel bar marks are shown in Figures 21 and 22 for Specimens 1 and 2 respectively.

As building equivalent drift ratios increased beyond 2.5 percent, significant cracking and spalling of the top surface of the concrete slab was observed. The cracks in Specimen 1 were significantly larger and more concentrated than Specimen 2. Buckling and fracture of some of the top reinforcing steel dowels was observed in both tests at drifts exceeding 2.5 percent. Photographs of the cracking of the top of the slab follow at the end of this report.

The most significant difference in performance observed between Specimens 1 and 2 was the degree of cracking on the top slab surface near the face of the wall. In Specimen 1, where the anchors for the post-tensioning tendons were placed only 2 inches from the face of the wall, large cracks were concentrated between the anchor and the wall. In Specimen 2, the anchors for the post-tensioning tendons were placed 8 inches from the face of the wall. The cracks in Specimen 2 were more distributed and narrower.

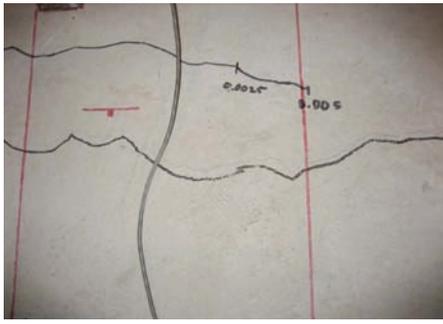
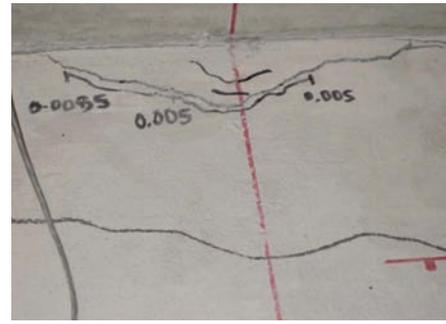
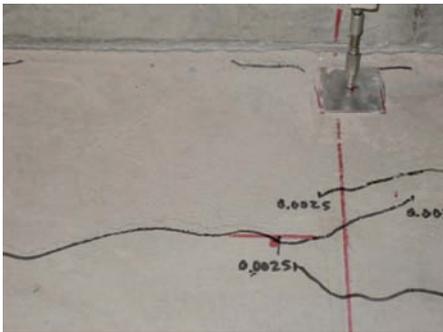
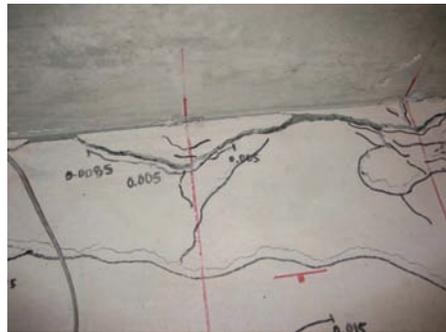
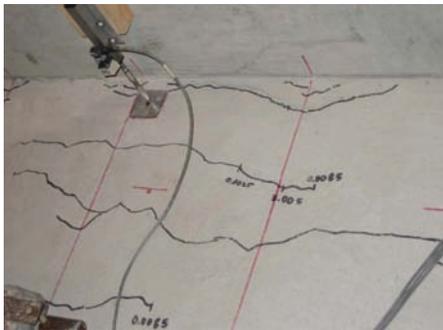
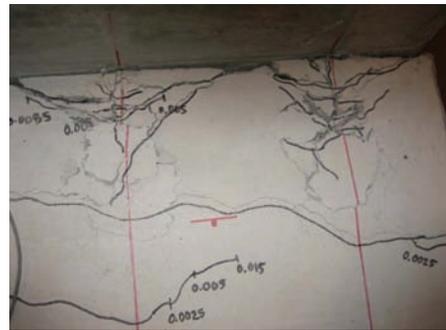
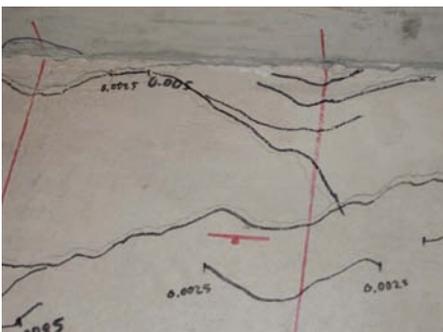
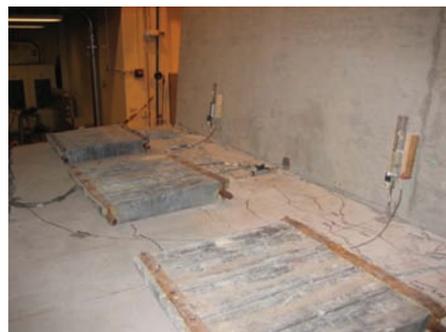
Fig. 22 – Cracking Patterns for Specimen 2 at Various Drift Levels

a) Cracking at Top of Slab at 0.5% Drift (Specimen Held at Peak Rotation)

e) Cracking at Top of Slab at 1.5% Drift (After 3 Cycles and Return to Initial Position)

b) Cracking at Top of Slab at 0.85% Drift (Specimen Held at Peak Rotation)

f) Cracking at Top of Slab at 2.5% Drift (Specimen Held at Peak Rotation)

c) Cracking at Top of Slab at 0.85% Drift (After 3 Cycles and Return to Initial Position)

g) Cracking at Top of Slab at 2.5% Drift (After 3 Cycles and Return to Initial Position)

d) Cracking at Top of Slab at 1.5% Drift (Specimen Held at Peak Rotation)

h) Cracking at Top of Slab at 5.0% Drift (Specimen Held at Peak Rotation)

As building equivalent drift ratios increased to 1.5 percent, additional cracks formed between the face of the core wall and the post-tensioning tendon anchors. When Specimen 2 was re-centered after the third 1.5 percent building equivalent drift cycle, the cracks closed and did not display evidence that repair would be required. In Specimen 2, the cracks remained “repairable” after the third 2.5 percent building equivalent drift cycle. The cracks also closed in Specimen 1 when it was re-centered, but the damage observed at the slab-wall interface after the third 1.5 percent building equivalent drift cycle would likely have required repair.

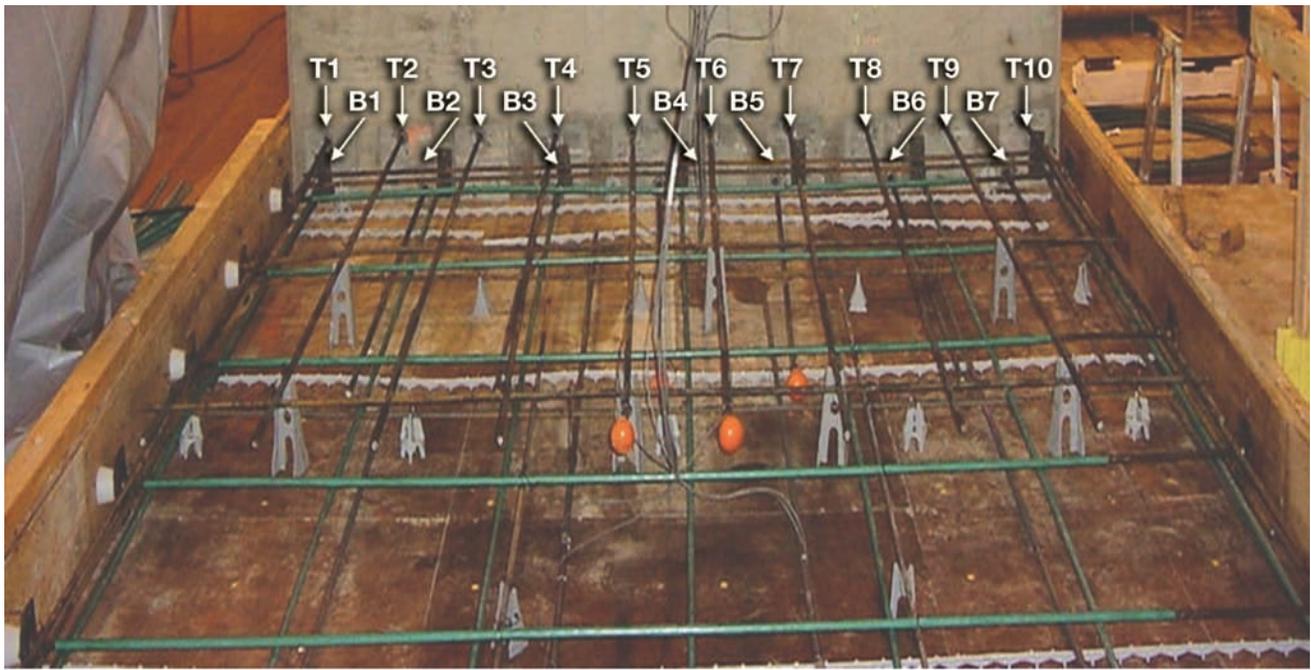
Fig. 23 – Dowel Bar Legend: Specimen 1

Dowel	Type of Failure
T1	Pull-out of dowel @ thread
T2	Pull-out of form saver
T3	Pull-out of form saver
T4	Pull-out of dowel @ thread
T5	Pull-out of dowel @ thread
T6	Fracture of dowel @ 3" from wall
T7	Pull-out of form saver
T8	Pull-out of dowel @ thread
T9	Fracture of dowel @ thread
T10	Pull-out of dowel @ thread
B1	Yielding of dowel
B2	Yielding of dowel
B3	Yielding of dowel
B4	Yielding of dowel
B5	Yielding of dowel
B6	Yielding of dowel
B7	Yielding of dowel

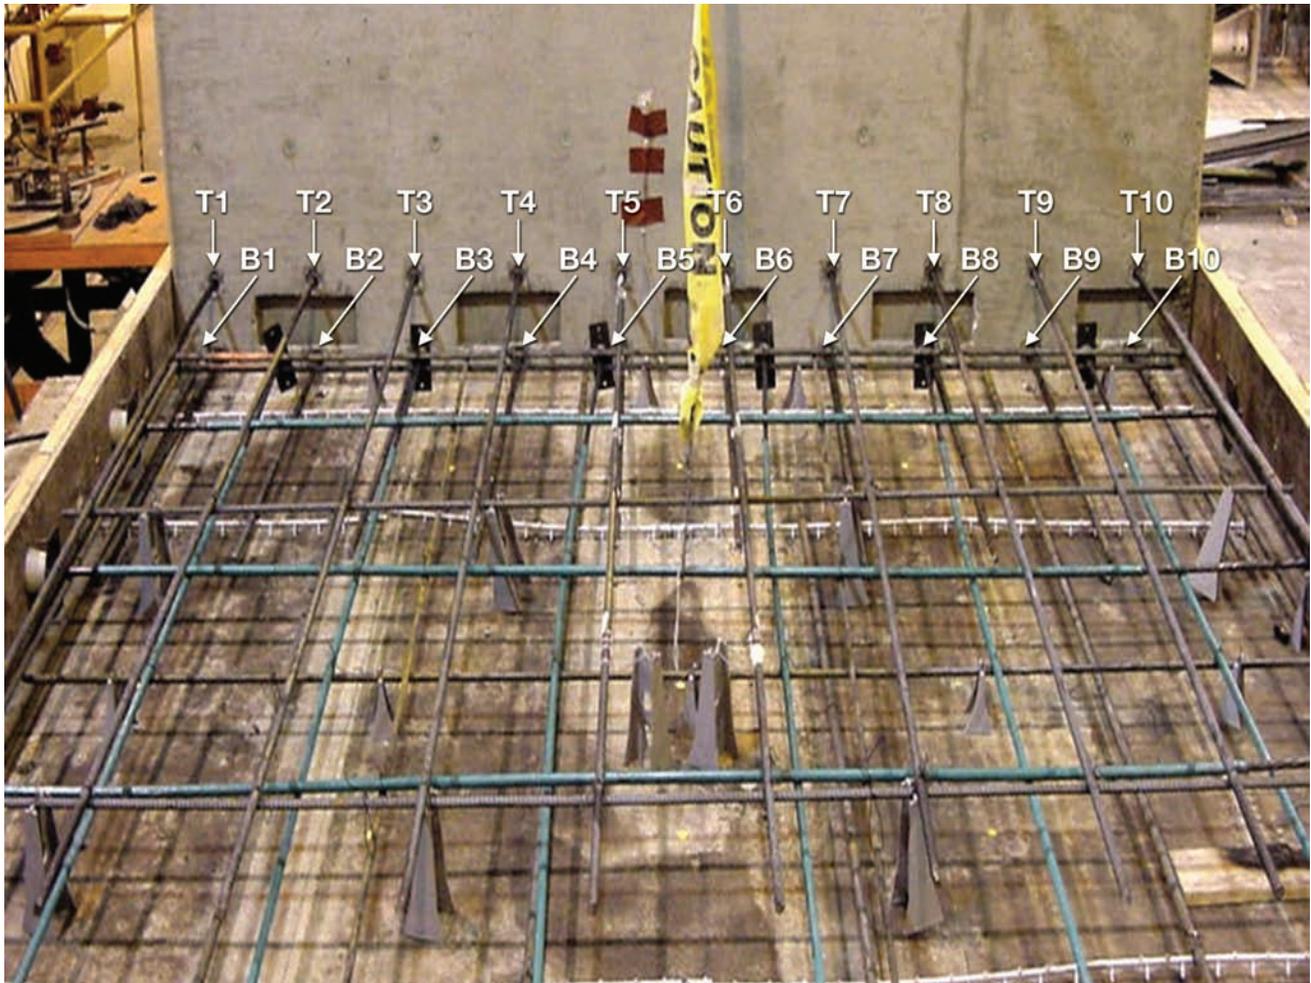
Fig. 24 – Dowel Bar Legend: Specimen 2

Dowel	Type of Failure
T1	Buckling and fracture of dowel @ thread
T2	Buckling of dowel
T3	Buckling of dowel
T4	Buckling of dowel
T5	Buckling of dowel
T6	Yielding of dowel
T7	Yielding of dowel
T8	Fracture of dowel @ thread
T9	Yielding of dowel
T10	Buckling and fracture of dowel @ thread
B1	Yielding of dowel
B2	Yielding of dowel
B3	Yielding of dowel
B4	Yielding of dowel
B5	Yielding of dowel
B6	Yielding of dowel
B7	Yielding of dowel
B8	Yielding of dowel
B9	Yielding of dowel
B10	Yielding of dowel

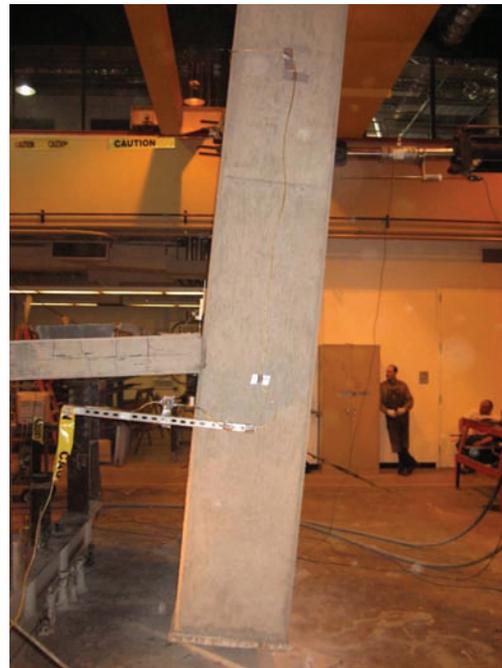
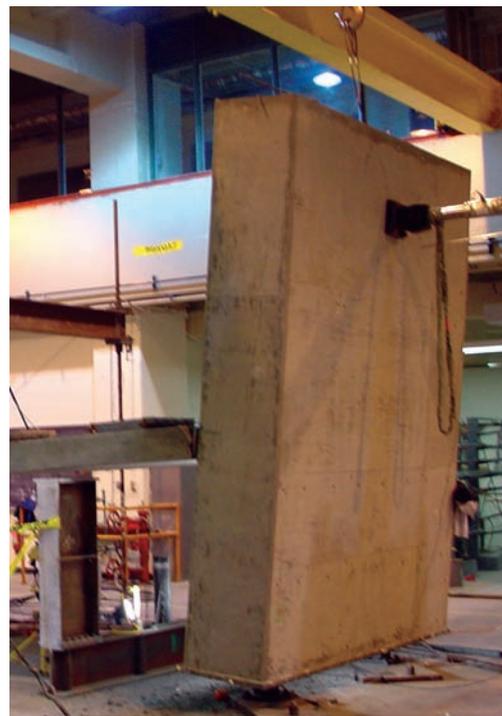
Fig. 25 – Minimum Rotation Demand in Specimens 1 & 2

One of the primary objectives of these tests was to demonstrate the proposed connection details achieved a Collapse Prevention Performance Objective at deformation levels consistent with drift limits specified in common building codes, typically a 2 percent interstory drift. Both specimens were subjected to multiple drift cycles of 2.5 percent and 5 percent drift without failure of the slab wall connection. See Figure 25.
