FIRE RESISTANCE OF STEEL FRAMES

This paper presents an analysis on the fire resistance of the World Trade Center's steel frames and examines precautions to be taken in designing skyscrapers.

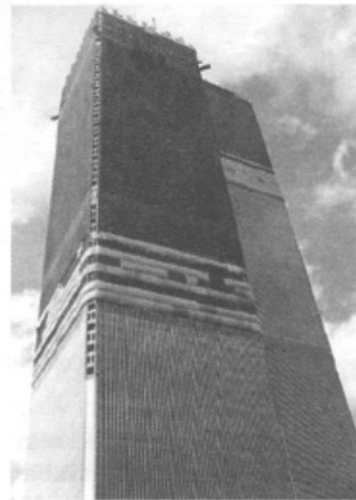
Photo 1 WTC under construction

The collapse of the World Trade Center Towers (WTC), ("WTC", Photo 1 : at the time of construction") was caused by damage to the structures due to aircraft impact and ensuing fire which led to the loss of the structures load-bearing capacity.

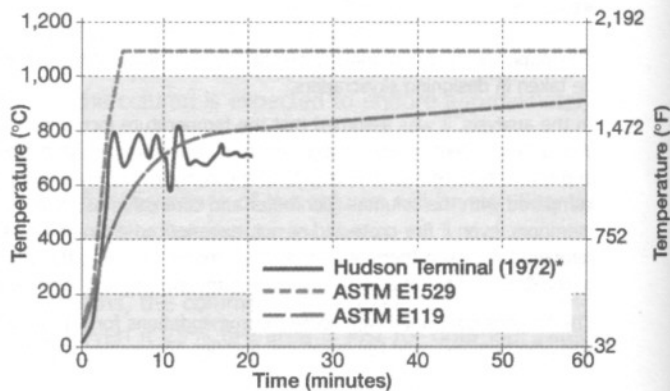
Fig. 1 Comparison between Standard Fire and Hydrocarbon Pool Fire

For buildings other than general buildings, the gas temperature for a petrol spill fire is also specified in the United States ASTM E1529 [5], also referred to as “hydrocarbon pool fire”. Fig. 1 shows the comparison of gas temperature between standard fire and hydrocarbon pool fire. In the case of a hydrocarbon pool fire, the temperature at the early stage rises rapidly to a high of about 1,100°C in the first five minutes than for the case of a standard fire and, afterwards, the temperature remains constant according to the U.S. specifications.

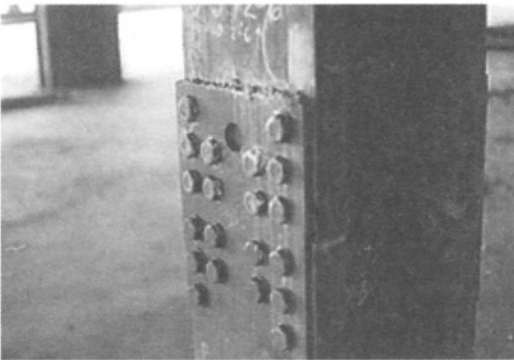
Photo 2 Core column (ultra-jumbo H-shape)

Photo 2 shows the core column of ultra-jumbo H-shape before fire protection and Photos 3 and 4 show the floor trusses before and after fire protection. The motion damper inserted between the outer wall and the end of the lower chord of the truss was not fire-protected, as it was not a load-carrying member of the main structure. It can be assumed from the photo that spraying, applied to such a small cross-section members posed great difficulties.

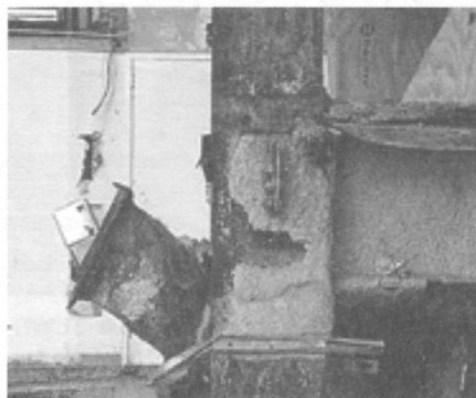
Photo 5 Fire protection at Bunkers Trust Building

According to the FEMA Report, the aircraft incursion supposedly blasted away the vast majority of fire protection on the impact floors. Photo 5 shows the steel frames of adjoining Bankers Trust Building that was hit directly by the columns falling from WTC2. The fire protection was largely blown away, and it is not hard to imagine that the same phenomenon occurred at the impact floors of WTC1 and WTC2.

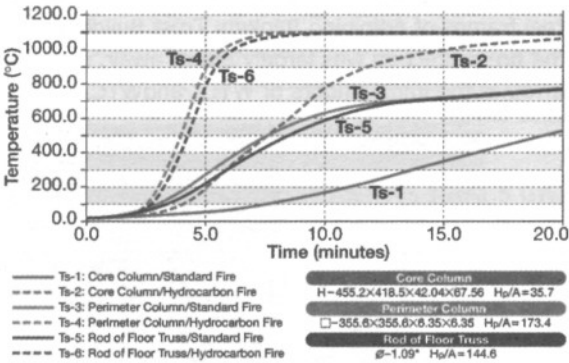
Fig. 2 Steel Temperature Rise Subjected to Heating (No fire protection)

In this study, an analysis similar to that of the FEMA Report was made on the columns plus the diagonal members (rods) of the floor trusses. The analysis results are shown in Figs. 2 and 3. The sizes of the members adopted are as follows:

- (i) The increase of the steel-frame temperature corresponds to thermal capacity (H_p/A), regardless of fire protection. In the case of the floor truss rod and the perimeter column with smaller thermal capacity (H_p/A is larger), the temperature rise more rapidly, reaching as high as 900°C in five minutes when the members are not fire-protected.

- (ii) By comparison, in the case of the core column that has extremely large thermal capacity, the speed at which the temperature rises is moderate even when it is not fire-protected (or when the fire protection is blown off). The temperature increases to about 600°C in approximately 20 minutes.

- (iii) In the case of a hydrocarbon pool fire, the temperature of steel frames (fire-protected or unprotected) increases faster than in the case of standard fire, especially in the first five minutes. A hydrocarbon pool fire causes the gas temperature to rise rapidly and that is why, when steel frames are not fire-protected, the difference between a hydrocarbon pool fire and a standard fire is more pronounced in terms of the rate of the steel-frame temperature increase.

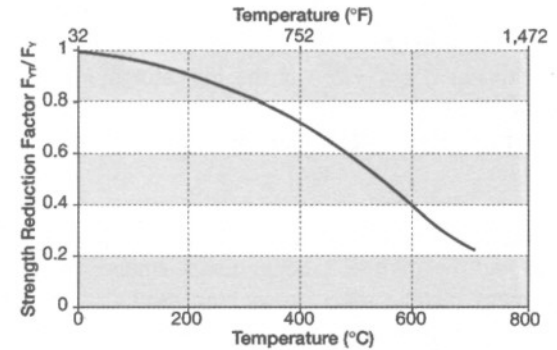
Fig. 4 Strength of A36 Steel at High Temperature

Steel strength is reduced at high temperatures. The strength and stress-strain relationship of A36 steel at high-temperature are shown in Figs. 4 and 5, respectively (FEMA Report). A36 steel's yield point lowers by nearly half at 550°C, as shown in Fig. 4 (A36 steel [6]).

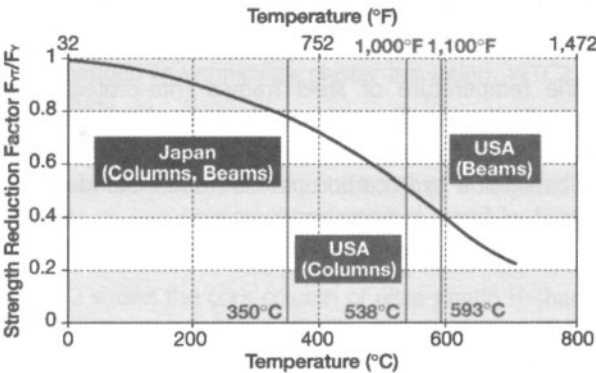
Fig. 6 Relationship between Strength of Steel Materials and Critical Temperatures

Fig. 6 shows the critical temperatures of steel between Japan and USA. The differences in temperature are about twice in the critical stage, eventually leading to a wide difference in the thickness of fire protection required.

A comparison between the above calculated results and critical temperature shown in Fig. 6 reveals:

- (i) The buckling temperature of the columns virtually corresponds to the steel strength at high temperature ratio of axial force in the column.
- (ii) The U.S. critical temperature, 538°C, is considered almost equivalent to the ratio of axial force of 0.5.

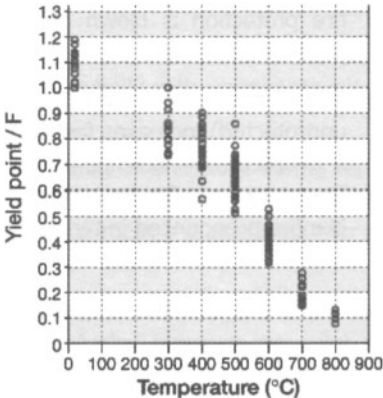
Fig. 8 Variation of Steel Strength at High Temperature.

Attention should also be paid to the fact that strength of steel materials at high temperature shown in Figs. 4 and 6 are average value Fig. 8 shows the results of examining [7] the strength of steel materials at high temperature undertaken by the Japan Iron and Steel Federation (JISF). As evident, the strength varies widely. In addition, there are cases where columns and beams are restrained by peripheral frames due to thermal expansion, resulting in failure at lower temperatures than expected, as discussed later. It is considered that, with such indefinite factors, the critical temperature of 350°C as adopted in Japan secures a relatively higher level of safety.

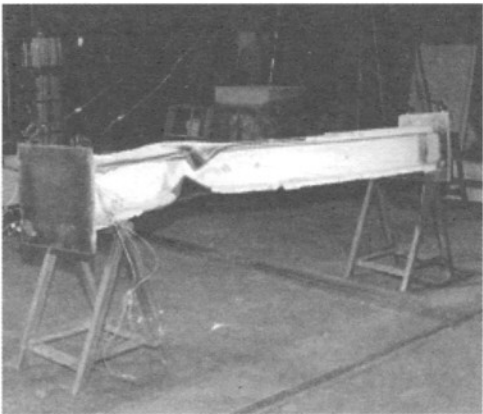
Photo 5 Buckling of Column due to applied load and subjected to heating (applied load-heat test)

The fire resistance of columns and beams can be verified by a fire test. There are two methods for fire test: one is to obtain the time of failure (fire resistance) for the case of load and subjected to heating and the other is to obtain the period of fire resistance from the temperature of steel materials only through heating (the heat test). The condition of failure immediately after a loaded heat test made on a column is shown in Photo 5. The proof stress of steel frames decreases with the increase of temperature, leading to the loss of the frame's load-bearing capacity.

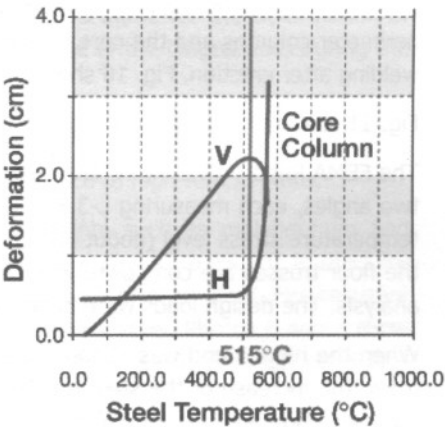
Fig. 7 Analysis of Fire Resistance of Column

Fig. 7 shows the results of the analysis. The columns underwent thermal expansion as the temperature increased (vertical elongation: V), buckled due to the lowering of steel strength and the loss of their load-bearing capacity (horizontal deflection at the middle of the columns: H). The calculated buckling temperatures were 515°C for the core column and 520°C for a perimeter column.

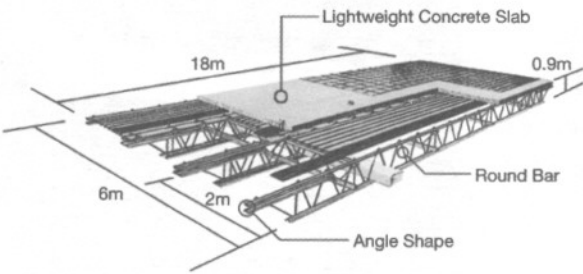
Fig. 9 Floor Structure

Fig. 9 shows the schematic diagram of the WTC floor structure. The floor was designed to support lightweight concrete (10 cm thick) on steel decking by trusses arranged at a spacing of 6 ft. 8 in. (about 2 m). The maximum length is 60 ft. (18.3 m). The trusses are lightweight, using angles for the upper and lower chords and round bars for the diagonal members. Their ends are linked to the perimeter columns and the core girders by two high-strength bolts (A325 bolt, 5/8 in. dia.) followed by welding after erection. Fig. 10 shows the details of the truss end (FEMA Report).

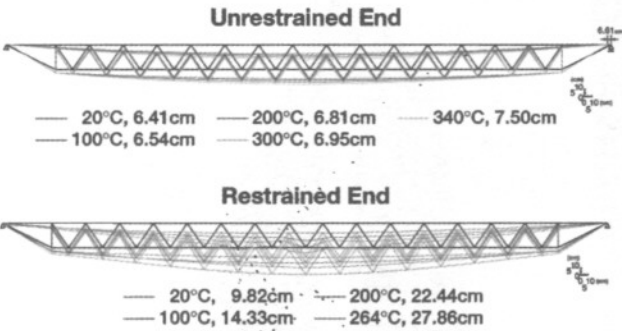
Fig. 11 Analysis of Thermal Deformation of Floor Truss

Fig. 11 analyzes the failure process of the floor truss by raising the steel-frame temperature.

When the hinged end was adopted for one end of the truss and the roller end for the other end of the truss, the increase of the steel-frame temperature caused the truss deformation to concentrate on the roller end side and the vertical members of the utmost end to buckle at 340°C. Deflection at the time of buckling was 7.50 cm in the middle of the truss, and horizontal deflection on the roll end side was 6.61 cm.

When each end of the truss was hinged, constraints on the thermal expansion of the truss resulted in the large deflection of the truss. Constraints concentrated on the upper chord, and the resultant buckling of the chord caused the failure of the truss at 264°C. The central deflection at the time of the failure was 27.9 cm. Fig. 12 shows the truss end's horizontal restraint load. The restraint load was pulled inward at normal temperature. Due to the thermal expansion of the truss, it then turned around but was eased by deformation of the upper chord. Maximum restraint load occurring outwards was about 30 tons. According to the FEMA Report, the shear strength of the high-strength bolts at each end (A325 bolt, 5/8 in. in inside dia. x 2) is as follows (the strength decreases by half at 550°C):

- (i) When lightweight steel frames are used, a thorough check should be made for the deformation of structural members and the failure of end supports (especially in the case of the hinged end) during the course of fire.
- (ii) Adequate fire-protection materials and construction methods should be selected.

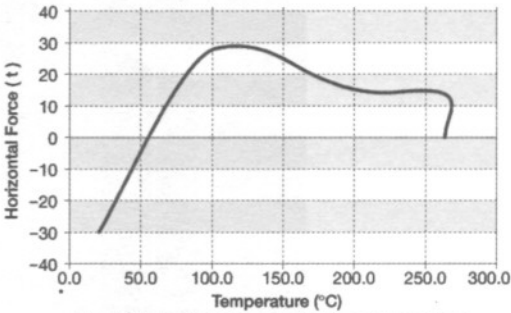
Fig. 12 Restraint Load at Floor Truss End

- Room temperature: Ru = 232 kips (105.2 tons)
- 550°C (1,022F): Ru = 116 kips (52.6 tons)

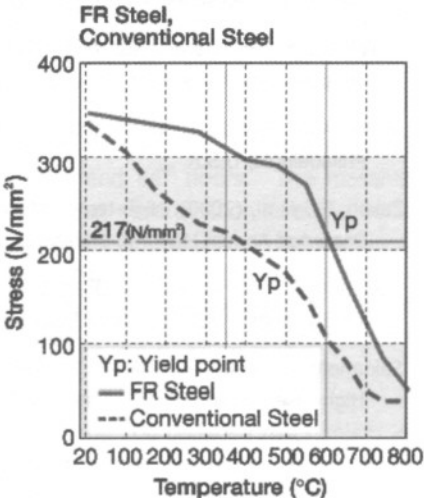
Fig. 13 Comparison of Strengths of Steel Products at High Temperature

Fire-resistant steel (Sakumoto et. al, 1992-1), containing alloy elements such as molybdenum and chromium, is superior in strength at high temperature components to ordinary steels. It is used for many buildings in Japan and Fig. 13 shows the high-temperature strength of each steel. Fire-resistant steel shows the excellent high-temperature strength, compared to ordinary steel. Photos 6 and 7 show the P&G building and Integral Tower Obayashi building (Sakumoto, et. al, 1992-2) which used fire-resistant steel for high-rise buildings.

Among other effective alternatives is the utilization of steel with resistance to high temperature.
