# Preventing Mega Disasters in Megacities - Code & Construction Challenges in the Indian Subcontinent

**Steven Baldridge**

**Anantha Chittur**

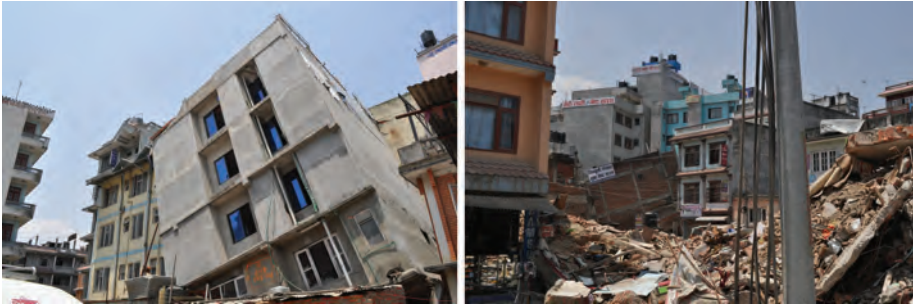
Figure 1. Earthquake damage in Kathmandu, Nepal (Source: BASE)  
图1. 尼泊尔加德满都的地震破坏 (来源: BASE结构工程公司)

The recent earthquake that struck Katmandu, Nepal brought to light some of the shortcomings of such building approaches (Figure 1). Many of the newly constructed high-rises in Katmandu suffered irreparable

在尼泊尔加德满都最近发生的地震，暴露出了一些建筑设计和施工方法的缺点（图1）。在加德满都的许多新建的高楼都遭到了破坏，使得一些建筑无法使用（图2）。如果这样的惨剧发生在印度、巴基斯坦和孟加拉国的人口更密集的城市，是不是将会造成更多的生命损失和对社会产生极大的不利影响？

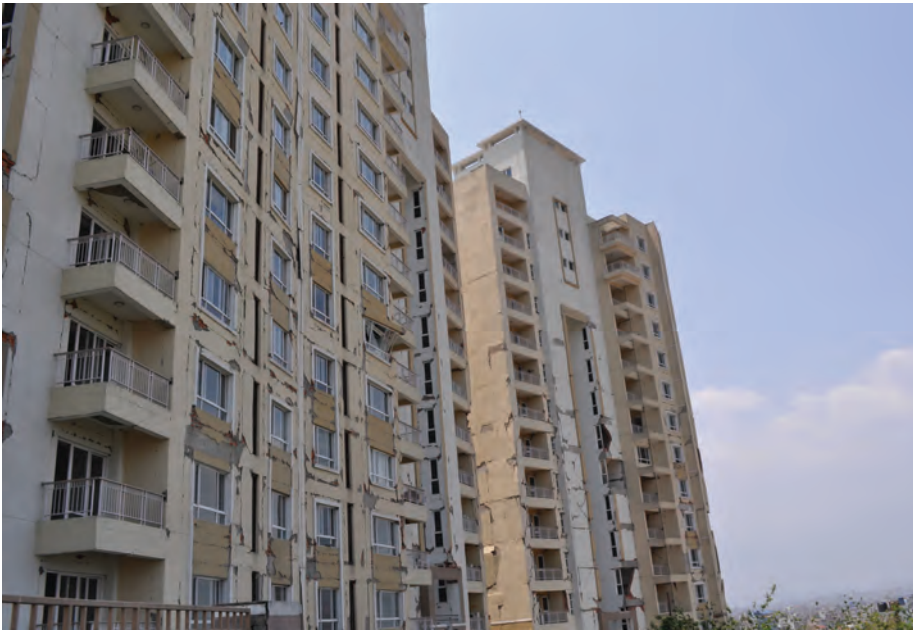
Figure 2. Earthquake damage to a modern apartment building in Kathmandu, Nepal (Source: BASE)  
图2. 尼泊尔加德满都的新建公寓楼遭受地震破坏 (来源: BASE结构工程公司)

damage that made the buildings unusable (Figure 2). Is this to happen in more densely populated cities in India, Pakistan, and Bangladesh, resulting in a greater loss of life and impact on society?

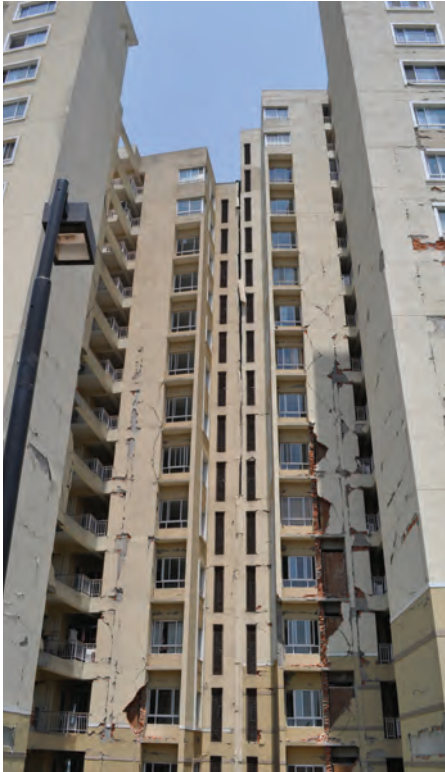
Figure 4. Narrow seismic separation joint (Source: BASE)

As this expression is based on the base dimensions of a building, designers often modify these dimensions by introducing seismic separation joints. This has the adverse effect of reducing the seismic redundancy and capacity of the original building configuration without a joint. This older version of the seismic code also underestimates the required width of this joint. This may lead to a gap that is too narrow, and the buildings can pound against each other in an earthquake (Figure 4).

因为这个经验公式是基于建筑物的基底尺寸的, 设计者经常通过引入抗震缝来修改这些尺寸。这具有减少地震冗余和结构抗震能力的不利影响。这个比较旧的抗震规范还低估了抗震缝所需的宽度。这可能导致太窄的抗震缝间隙, 建筑物在地震时彼此可能发生撞击 (图4)。

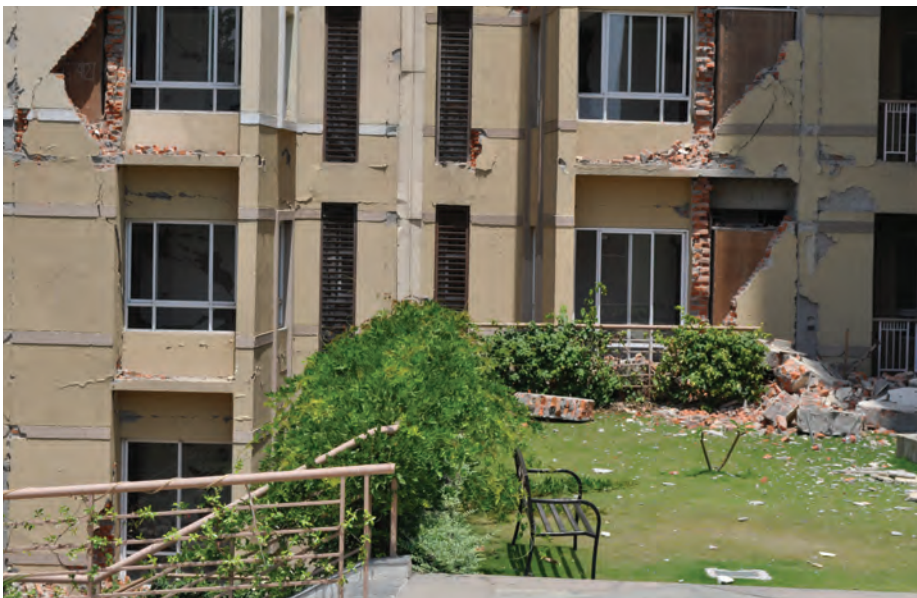
Figure 5. Masonry debris around the building exterior (Source: BASE)

1. Creating falling debris outside and inside of a building, which is particularly risky with unreinforced parapets and freestanding walls (Figure 5).

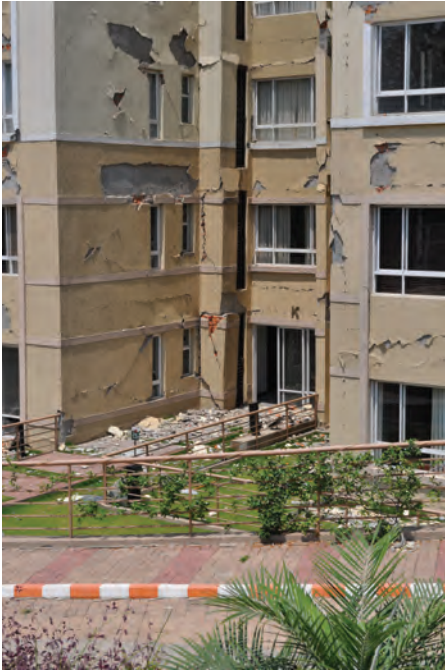
Figure 6. Masonry debris near the building exit, including precariously leaning masonry shaft wall (Source: BASE)  
图6. 临近建筑物出口的不安全的砌体管道井和砌体碎片 (来源: BASE结构工程公司)

2. Potential for blocking emergency egress pathways (Figure 6).
3. Increasing the seismic mass, and subsequently, forces on a structure.

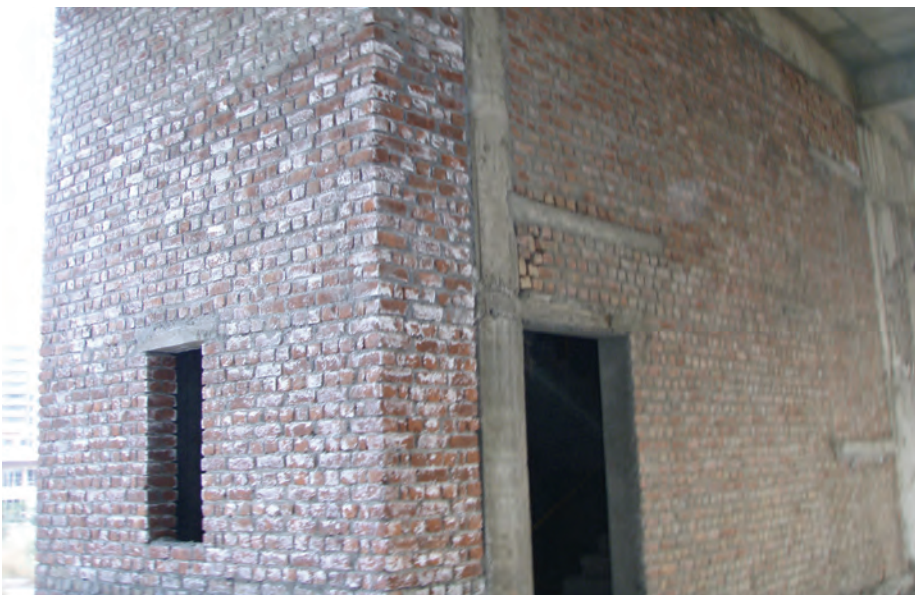
Figure 7. Un-reinforced masonry exit stairwell (Source: BASE)  
图7. 无配筋的砌体楼梯的出口井道 (来源: BASE结构工程公司)

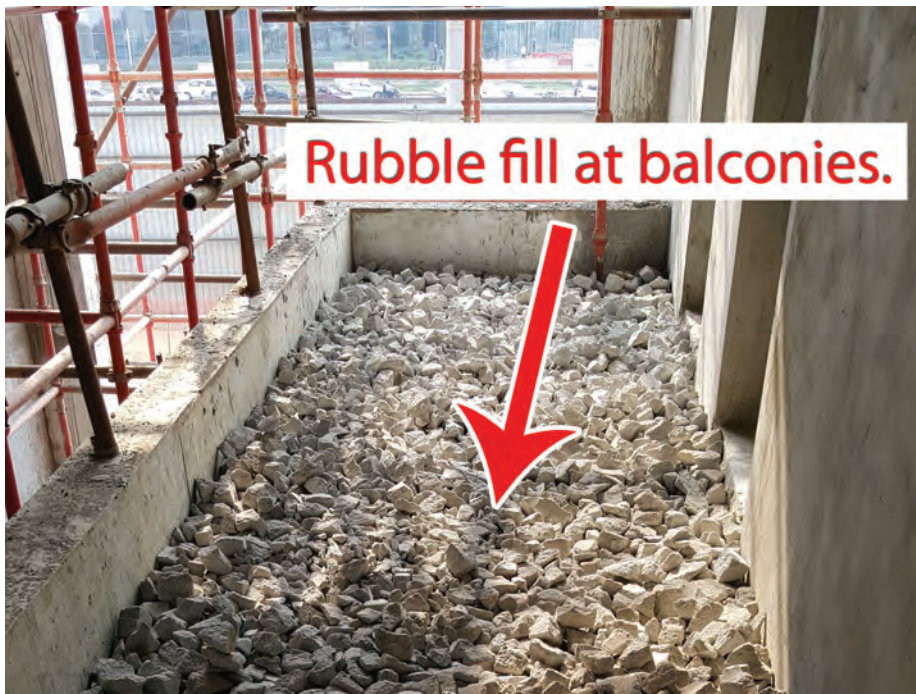
Figure 8. Thick rubble fill at balcony (Source: BASE)  
图8. 阳台上的碎石填充层 (来源: BASE结构工程公司)

4. Intended to address a lower quality plumbing installation and to simplify coordination between trades, wet areas such as bathrooms, kitchens, and balconies are often sunken by six to 12 inches (150 to 300 millimeters) and then filled back with brick or block rubble and grout. The weight of the structure in these areas is easily twice that of normal structures. This practice, unfortunately, rarely achieves the intended result as a plumbing leak, as in a sunken slab area, it will only be discovered in the ceiling of the unit below. In balconies, a sunken slab is often used to avoid drainage coordination during design. The final product ironically is often a flat finish with no slope to drain built on two layers of heavy materials: the supporting structure and heavy sunken slab infill (Figure 8).

排水。最终做法通常是在两层较重材料上的加没有斜率的面层：支撑结构和下沉重板的填充结构（图8）。

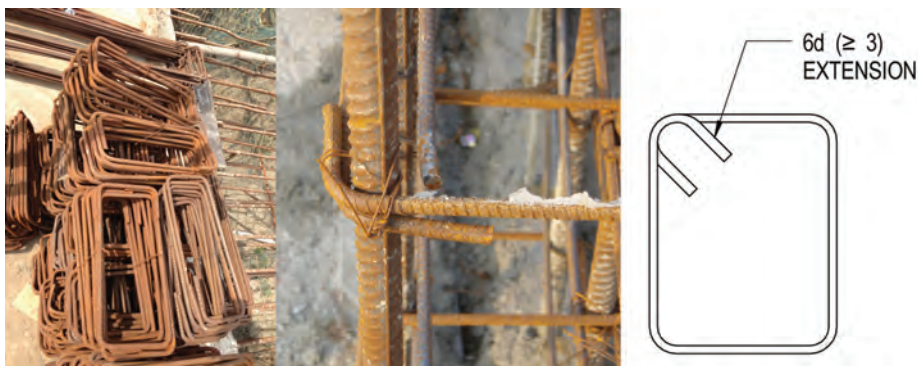
Figure 10. Non-conforming seismic ties at project site (Source: BASE)  
图10. 施工现场不符合规范要求的抗震箍筋接头 (来源: BASE结构工程公司)

One example is the mis-installation of a critical seismic detail, providing a closed tie with bar ends hooked into the core of a column. This detail, which is clearly indicated in Indian Standards and construction documents, is often missed on the job site (Figure 10). Independent inspections may catch this.

一个例子是框架柱的加密区闭合箍筋的错放, 通常情况下抗震的闭合箍筋的端头要深入到柱子里面一定的长度。这个抗震构造措施, 印度规范和施工文件都明确表明了正确做法, 但是在施工现场往往会放错 (图10)。独立的现场检查可能会避免这一错误。

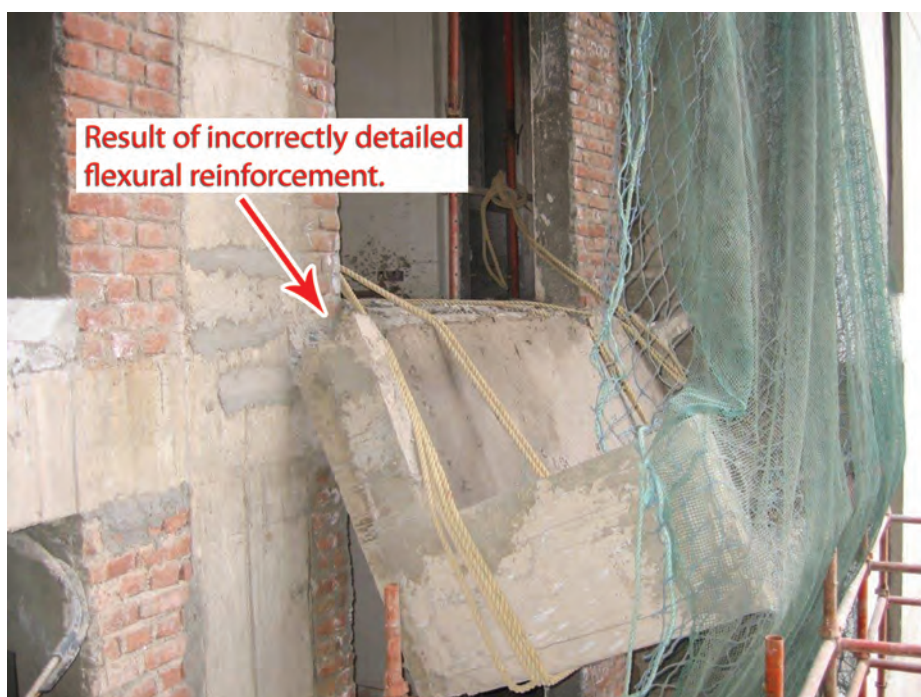
Figure 11. Balcony failure due to poor design detailing (Source: Dimitris Nikolopoulos)  
图11. 阳台由于低质量的细部设计倒塌 (来源: Dimitris Nikolopoulos)
