Rapid Diagnosis Systems Using Accelerometers in Seismic Damage of Tall Buildings

Toru Tsuchihashi and Masaharu Yasuda[†]

Architectural Design Department, Mori Building, Tokyo 106-6155, Japan

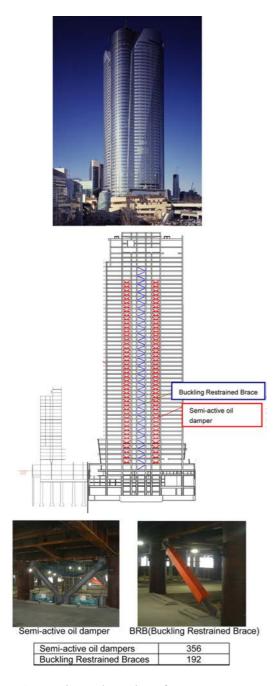
Figure 2. Location and Number of Dampers.

Two types of Damping devices (semi-active oil dampers, Buckling Restrained Braces with low yield point steel) are installed in Roppongi Hills Mori Tower (the office tower at the center of the facility) to reduce earthquake response (Fig. 2).

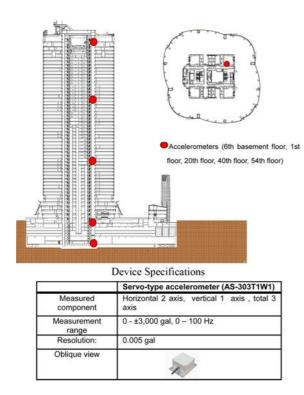
Figure 4. Accelerometer Location and Device Specifications.

Accelerometers were installed in Roppongi Hills Mori Tower on the 6th basement floor, 1st floor, 20th floor, 40th floor, and 54th floor at completion in 2003 (see Fig. 4). The accelerometers are of the servo type (AS-303 W1T1) manufactured by Tokyo Sokushin Co., Ltd. The purpose of the servo accelerometers is to determine the vibration characteristics of the building, to verify whether the damping effect as designed is obtained, and to acquire basic data for structural design of future skyscrapers. Figs. 5 and 6 show the seismic waveforms and pseudo-velocity response spectrum observed at Roppongi Hills on March 11, 2011 during the main shock of the Great East Japan Earthquake. It can be seen that the power equivalent to level 1 earthquake 'rare earthquake ground motion' corresponding to the damage limit generally used for structural design in Japan with a 5% damping pseudo-velocity response spectrum was observed.

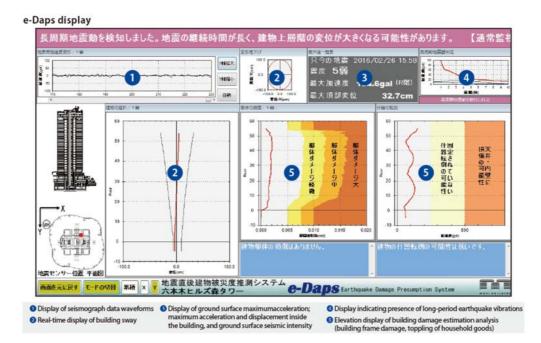
Figure 11. Screen Configuration of Damage Assessment System.

Foreign-affiliated companies also asked for objective explanatory materials on safety in the case of continued use of the buildings. As a lesson learned from this disaster, the operator of high-rise building with tens of thousands of workers concluded that merely improving the earthquake resistance of the building is insufficient, and that is necessary to determine to what extent the level of earthquake for which the building was designed approximated the actual earthquake, and based on objective indicators, determine whether safety is adequate, to prevent confusion in the initial stages of the disaster. On this basis, Mori Building developed the e-Daps system to instantaneously diagnose the safety of buildings using accelerometers that were already installed. Fig. 11 shows the screen configuration. When the ground surface acceleration exceeds 0.6 gal, it is determined that an earthquake has occurred, and the system is brought into operation. The safety of the building in terms of the severity of the disaster is evaluated according to whether the story drift angle is within the elastic range set at the design stage, or if exceeded, by how much. Damage to the framework and the possibility of fixtures in the room falling are displayed in real time on the graph (5) in Fig. 11 in terms of the ratio of the elastic limit displacement and whether the acceleration threshold value has been exceeded.

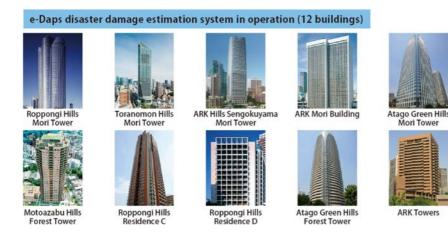
Figure 12. Buildings With Damage Assessment Systems.

Installing accelerometers in a building is an effective way to know how the building shakes when an earthquake happens. In this paper, we will introduce an example of an analysis that captures the acceleration reduction effect of the vibration damping device using data observed by the accelerometer at Roppongi Hills Mori Tower in Minato-ku, Tokyo, during the Great East Japan Earthquake on March 11, 2011. Moreover, as the latest effort, from the standpoint of a developer who builds and operates a number of high-rise buildings in Japan, where frequent earthquakes are experienced, a system for real-time processing of accelerometer data was developed to instantly diagnose the degree of damage to high-rise buildings, and the actual system of earthquake damage health monitoring is discussed. This system is currently in operation in twelve high-rise buildings including Roppongi Hills Mori Tower.

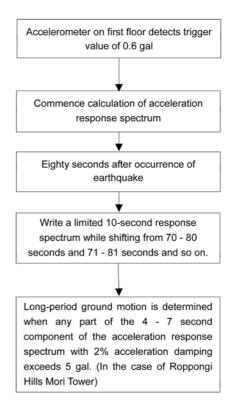
Figure 14. Long-period Ground Motion Evaluation Flow.

The system for diagnosing the severity of damage also incorporates a mechanism for detecting long-period seismic motion (as observed during the Great East Japan Earthquake) at an early stage of the earthquake and issuing alerts. Long-period seismic ground motion contained in the waveform is evaluated by calculating the acceleration response spectrum every 10 seconds when the primary motion decreases at 80 seconds after start of an earthquake. See Fig. 14. Observation using accelerometers over many years has shown that long-period components are already included in the initial component of the seismic motion. Long-period earthquake ground motion gradually increases in amplitude due to resonance in a skyscraper, and the building continues to shake for several tens of minutes. This long-period seismic-motion evaluation function allows resonance of skyscrapers and their continuing large-amplitude vibration to be forecast, and to provide useful assistance in evacuation to tenants on higher floors. The system also helps to prevent panic by issuing advance

warnings. It is known that elevator cables, the lifeline of a skyscraper, resonate due to the long-period seismic motion and may become damaged by being entangled with protrusions in the elevator shaft. The system can be used to prevent such damage by moving the elevator itself to a floor at which resonance does not readily occur.

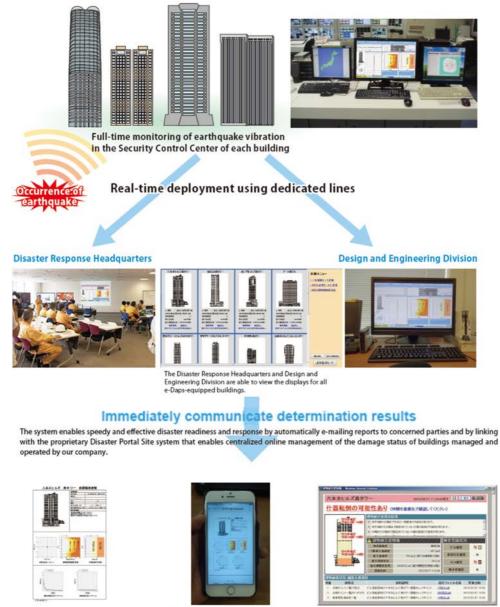
Figure 15. Disaster Assessment Information Output Flow.

This data is processed in real-time and displayed in the disaster prevention center of each building as shown in Fig. 15. Automatic voice announcements are issued to

Bulletins Assessment results are automatically converted to an A4-sized report for immediate use by tenants and other concerned parties as briefing materials

Linkage with the Disaster Portal Site By linking with our own disaster information collection system, the system indicates floors to be given high-priority checking, and is effective in wide-area damage estimation and support from neighboring buildings.

provide an understanding of the situation without checking the screen. The system is also connected to the Earthquake Headquarters of Mori Building via a private line to ensure that the damage situation of each building can be understood at the headquarters. The information is sent automatically by email to approximately 200 employees managing the building by converting the bulletin to pdf format. In the event of major damage due to a large earthquake, the structural engineer will eventually need to investigate the site, verify the damage situation in detail, and develop a recovery plan. An instantaneous diagnostic system available at the time of the earthquake becomes a useful disaster-prevention tool, allowing an extremely flexible understanding of safety at the time of the earthquake as primary screening in the confused situation immediately after the earthquake. This diagnostic func-

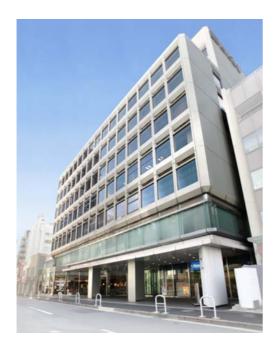
Figure 16. Medium-height Buildings Scheduled for Installation of the Damage Assessment System.

This system for estimating the damage on each floor using mode shapes is not applicable to all buildings. It is applicable to regular buildings such as skyscrapers where there are no extreme changes in rigidity between floors. Difficulties arise in application to low-rise buildings with sudden changes in rigidity between floors, large eccentricities resulting in torsional vibration, and brittle behavior, where mode shapes are easily disturbed. To enable application to medium and low-rise buildings of RC construction, a system for damage assessment in medium and lowrise buildings was developed in which inexpensive accelerometers (IT Strong Motion Accelerometers) are installed on each floor, enabling improved accuracy by providing an understanding of damage through the progress of cracks in seismic walls. As well as determining the story drift from the accelerometer data, cracks (recognized as an earthquake trigger indicator) in the seismic walls are photographed with infrared cameras installed in pipe

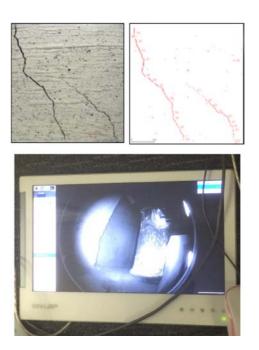
Figure 18. Infrared Camera-based Crack Detection System (under development).

spaces in the building. These photographic images are processed to color the cracks and to display crack width as a digital value. The interior of the pipe spaces provides bare concrete surfaces of shear wall as the most suitable areas for visualizing directly the severity of damage to the building. This system is scheduled to be installed in the Toranomon 30th building.
