**Title:** **Sustaining a Historic High-Rise Structure**

**Subjects:** Retrofit  
Seismic

**Original Publication:** CTBUH Journal, 2015 Issue I

# Sustaining a Historic High-Rise Structure

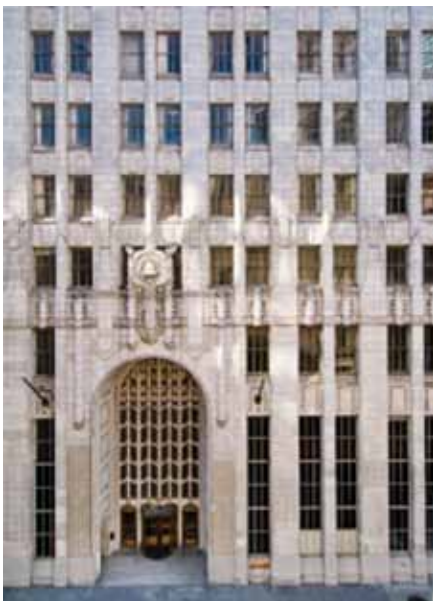
Figure 2. Terracotta façade along New Montgomery Street. © Stephen Schafer

The majority of the windows were replaced with high-performance glazing and will remain operable to promote natural ventilation. Some exterior restoration of the historic terracotta and historic glazed brick façade was undertaken, which included repointing of joints and patching/repainting individual units as necessary.

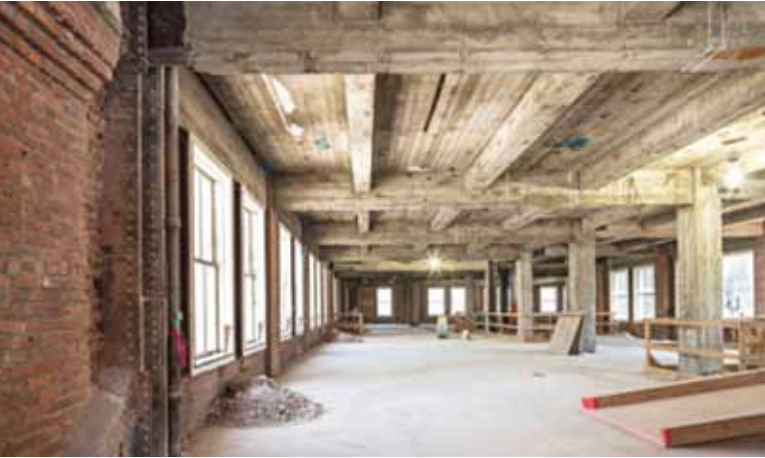
Figure 5. Typical interior floor after soft demolition. © Blake Marvin

But one of the most important components of 140NM's refurbishment was the full seismic retrofit. This retrofit was carefully designed and implemented to improve the building's safety and performance in the harsh seismic environment of San Francisco, while preserving the building's iconic historic fabric, including the exterior façade and grand lobby (see Figure 5).

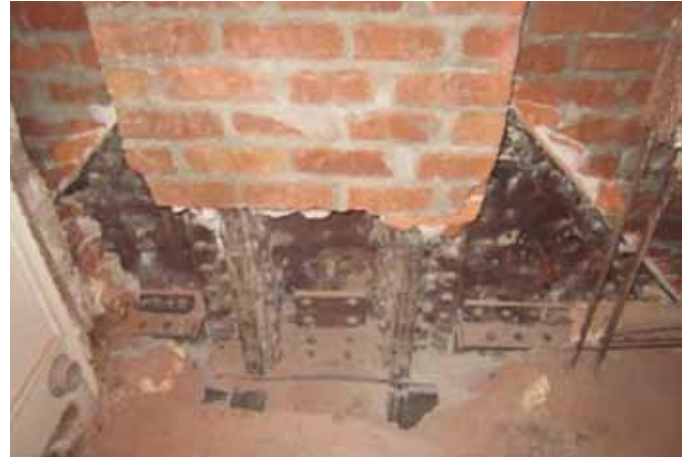
Figure 6. Typical existing wind brace moment-resisting connections.

The existing lateral structural system consists of steel beams and columns, classified as "partially restrained moment frames." The beams and girders, typically around the perimeter, are connected to the columns via riveted clip-angle connections (see Figure 6) and, in some instances, large gusset plates, denoted on the existing drawings as wind braces.

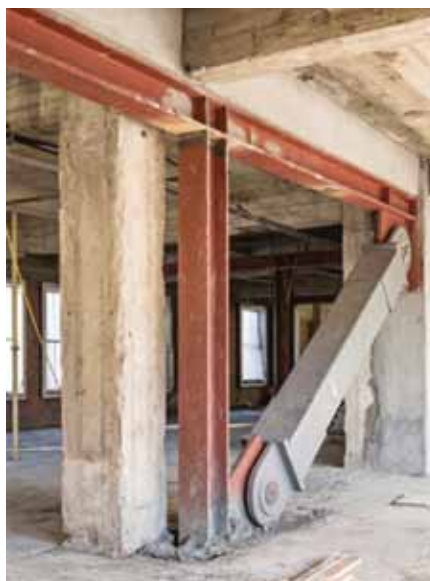
Figure 7. BRB at outrigger truss.

outrigger truss frame included one bay of diagonal BRBs which form a ductile fuse to absorb and dissipate the seismic energy in the form of heat. Figure 7 shows the BRB installed on-site. From Level 19 and below, new steel supercolumns were provided at the perimeter to transfer the load from each outrigger truss down to the foundation. Figure 8 shows the supercolumn during installation.

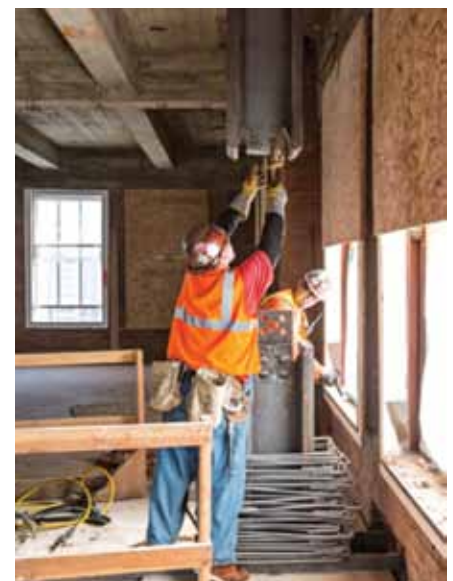
Figure 8. Supercolumn installation.

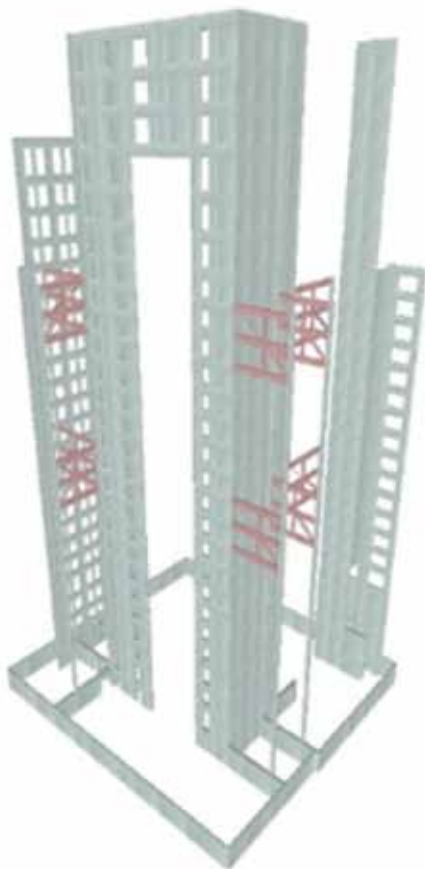
Figure 9. New seismic lateral resisting system.

The new reinforced concrete shear walls, with coupling beams, were located around the new stair and service cores extending from the basement level foundation to the underside of Level 27. The walls over the typical floors were connected to the existing adjacent steel columns to effectively provide a composite column, which strengthened the existing deficient elements. These new “core” elements provided not only a suitable location for new lateral load-resisting elements, but also a functional separation between the tenant spaces and service areas.

The core walls were stiffened with the two-story deep outrigger trusses located below Levels 8 and 19. They were located as high as practicable in the building without adversely impacting the usable floor space, as the building façade steps at Level 19. The

Figure 9 illustrates the new seismic load-resisting system as implemented in the analytical model.

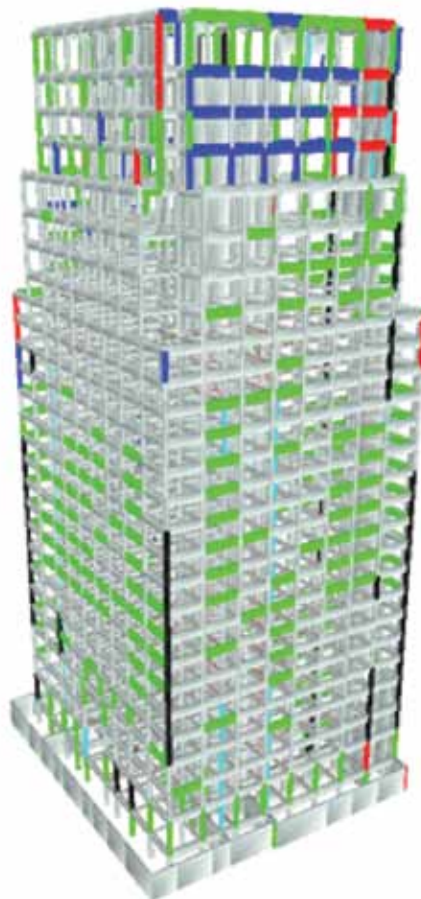
Figure 10. Combined model

The new SLRS and existing structure, each described in the preceding sections, were combined in a single analytical model (see Figure 10). This step of the analysis was crucial to verify the deformation compatibility of the two systems and ensure that they work effectively together during a large seismic event.

The combined model showed that the new SLRS added significant strength, stiffness, and ductility to the existing building while maintaining deformation compatibility with the existing lateral force resisting elements. This allowed the rehabilitated building to achieve Life Safety at the specified seismic hazard.

Story drifts were generally significantly less than 1%, with larger drifts at the corners and towards the top of the building (above the upper outrigger trusses) and maximum drifts less than 1.5%. Opportunities to strengthen of some existing components were identified, including reinforcement of the existing columns. The low drifts will provide added protection to the relatively brittle façade elements.
