Title:	<b>Confronting the Question of Demolition or Renovation</b>
Authors:	Dario Trabucco, CTBUH visiting researcher, IUAV University of Venice Paolo Fava, Architect, IUAV University of Venice
Subjects:	Architectural/Design Conservation/Restoration/Maintenance
Keywords:	Demolition Façade Life Cycle Analysis Renovation Vertical Transportation
Publication Date:	2013
Original Publication:	CTBUH Journal, 2013 Issue IV
Paper Type:	<ol style="list-style-type: none"><li>1. Book chapter/Part chapter</li><li>2. <b>Journal paper</b></li><li>3. Conference proceeding</li><li>4. Unpublished conference paper</li><li>5. Magazine article</li><li>6. Unpublished</li></ol>

# Confronting the Question of Demolition or Renovation

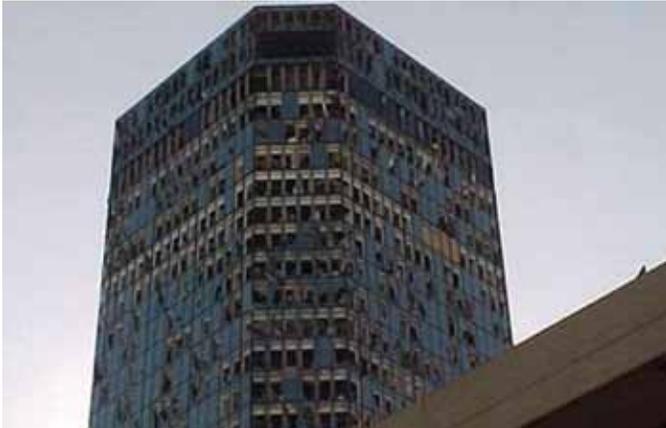
Figure 2. Bank One Tower, Fort Worth damaged by tornado in 2000. © Jesse Rangel

Notable examples of asbestos disposal in tall buildings include the interventions on the Bank One Tower in Fort Worth and the Tour Montparnasse in Paris. The Bank One Tower is a 149-meter-tall tower completed in 1974. On March 28, 2000, the building was hit by a tornado that severely damaged its curtain wall, causing most of the glazed panels to fall on the streets and surrounding buildings (see

Figure 2). The damaged building was scheduled to be torn down, but the widespread presence of asbestos required a complete elimination of the cancerous material before demolishing the tower. Instead the building owner decided to maintain the building, remove the asbestos, and transform the remaining structure into a residential tower. The removal required an investment of US\$65 million and took 10 months, with an average rate of 10 days per floor. In order to prevent the diffusion of asbestos fiber, the building was wrapped with a plastic envelope, and the operating crews removed the asbestos with pressurized water guns. The indoor air was constantly filtered, and the internal air pressure in the building was maintained at a lower level than the exterior pressure, avoiding leaks that would have sucked out the asbestos fibers. The building was subsequently refurbished and reclad, and it is now a successful residential development.

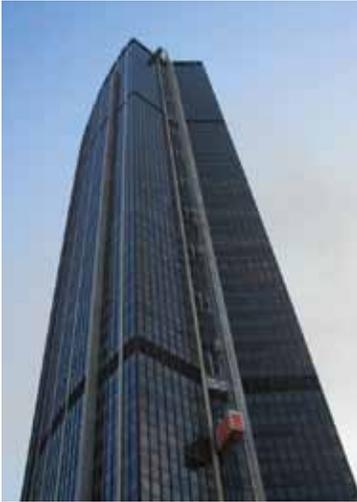
Figure 3. Montparnasse Tower, Paris – external elevator.

However, perhaps the best example of asbestos removal as an alternative to demolition is provided by the Montparnasse Tower. The building was determined to present an asbestos threat to its occupants, with several floors assessed at “Level 3” pollution, the highest degree of danger. The news sparked a sudden increase in the vacancy rate of the building and forced the owners to plan for the complete elimination of the asbestos.

to exceed 36 months. Therefore, the owners opted for a phased intervention. Sections of the building had to be emptied in sequence, in order to allow for the complex removal operations, without affecting the normal use of the remaining parts. The floors affected by the operations had to be sealed to prevent any diffusion of asbestos, particularly through the ventilation ducts. The elevator shafts presented a complex problem, as the stack effect proved to be particularly strong. The asbestos was disposed using two external elevators installed on the west elevation of the building, in order to avoid interaction with the building occupants (see Figure 3). The whole intervention, including an upgrade of the internal finishes of the building, will cost more than US\$140 million, while the costs related to asbestos-related operations is expected to reach US\$40 million. The phased removal strategy led to a longer renovation period, but it allowed the owner to retain most of the building's tenants.

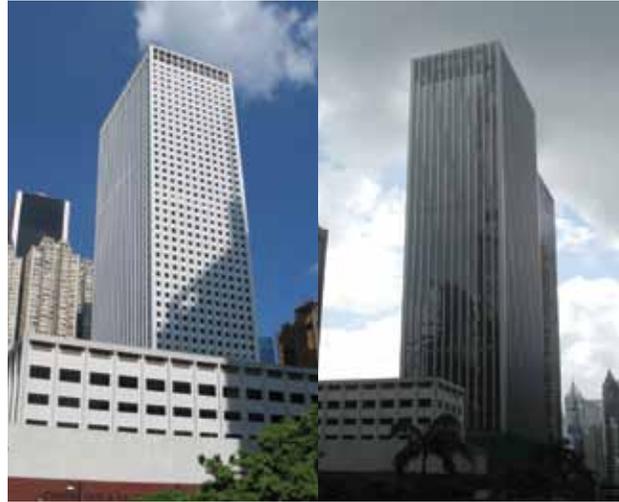
Figure 4. China Resources Building, Hong Kong – before (left) and after overcladding. ©©©WING / Peter0912

Overcladding is typically used to improve a building's environmental performance. The China Resources Building in Hong Kong is one example, where the façade elements were partially backed by a second layer of glass to enhance the environmental performance of the curtain wall (see Figure 4). Another notable example, based on the quality of the achieved results, is represented by the CIS Tower in Manchester, United Kingdom (see Figure 5). This building features an external service core. The solid concrete walls containing the elevator shafts where originally

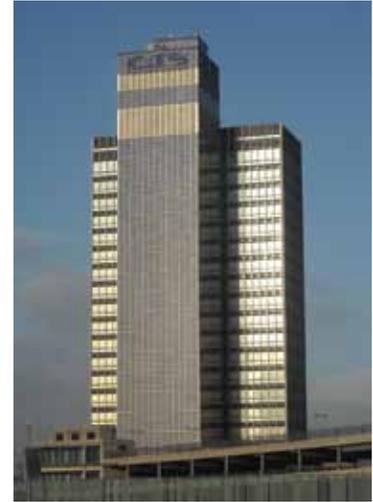
Figure 5. CIS Tower, Manchester – solar panel cladding. ©©©Gene Hunt

covered with small glazed tiles. After 40 years, the decorative surface was showing some structural deficiencies with missing elements, detached parts, and de-colored tiles. A layer of almost 4,000 square meters of photovoltaic panels were added to the façade, allowing the production of 180 MWh/year, at a total cost of £5.5 million.

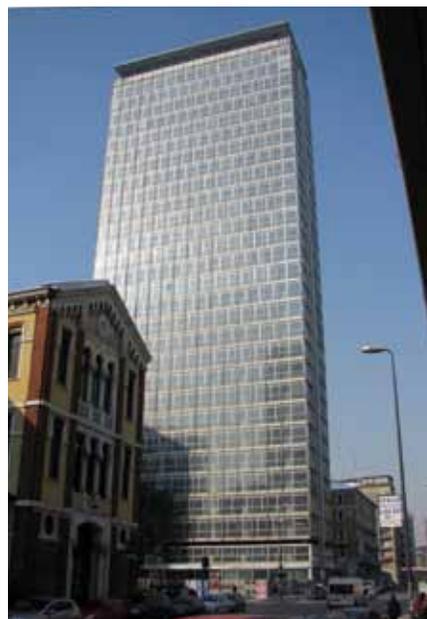
Figure 6. Torre Galfa, Milan transformation. © CTBUH/ Dario Trabucco

Torre Galfa, a 109-meter-tall building designed in 1956 by Melchiorre Bega, is an example of a building facing renovation vs. demolition issues (see Figure 6). Torre Galfa had been vacant since 2006. The building suffered from many of the common problems found in buildings of that era: poor energy performance, outdated elevator systems, asbestos (removed in 2007), and leaking façades.

The proposed intervention aims to maintain and reinforce the original structural system, expanding the floor plates on the west façade of the building. In order to maintain the proportions of the building, four floors are added, using lightweight polymeric load-bearing structures. The service core is entirely re-organized, into a system with two zones and more elevators. Calculations proved that this solution will allow the building to host a large single tenant in the upper 15 floors, and multiple tenants in the lower part.

The proposal maintains the same façade design of the original tower, but inverts its geometry, so as to solve the user complaints about mullions obstructing the view when sitting at their desks.
