Title: **Reinventing Woolworth: Adaptive Reuse of a Historic Skyscraper**

Reinventing Woolworth: Adaptive Reuse of a Historic Skyscraper

This article presents a case study of structural and logistical issues involved in the adaptive reuse of an early 20th-century skyscraper, and outlines the case for achieving sustainability through such repurposing. Through skillful structural design, the redevelopment of the Woolworth Building serves as a case study of successfully repositioning an underutilized 1913 office tower to serve a new market – luxury residential. The Woolworth Building’s historic context, existing structural systems, and scope of the residential conversion are described, while particular technical concerns are explained.

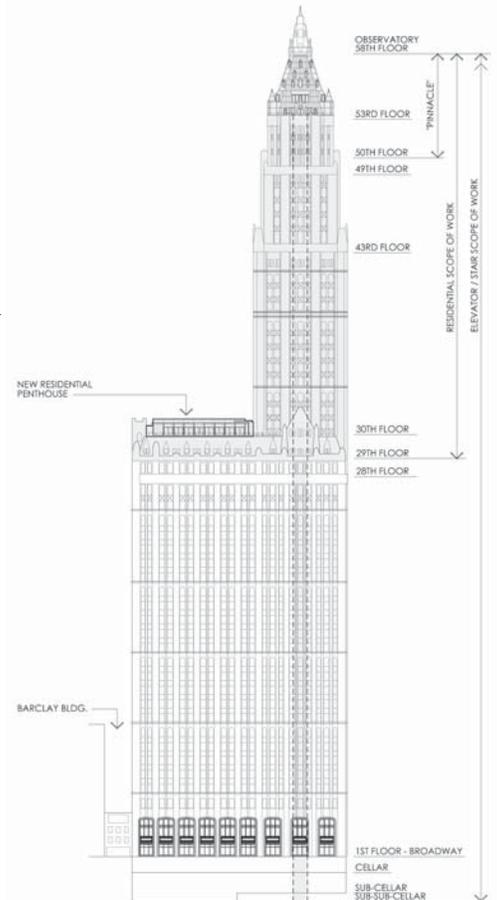
Figure 2. Scope of reconstruction work. © SLCE Architects

The fundamental objective of the project is to renovate and convert the upper 30-story “tower” portion to luxury condominium apartments, without disrupting ongoing office use of the lower 28 floors, which will continue to be occupied throughout the reconstruction (see Figure 2). The structure and proportions of the historic building lend themselves to an attractive, traditional apartment layout, yet a number of upgrades to building infrastructure and services, as well as the addition of new amenities are required. An abandoned basement swimming pool will be restored, in addition to the creation of a new wine cellar.

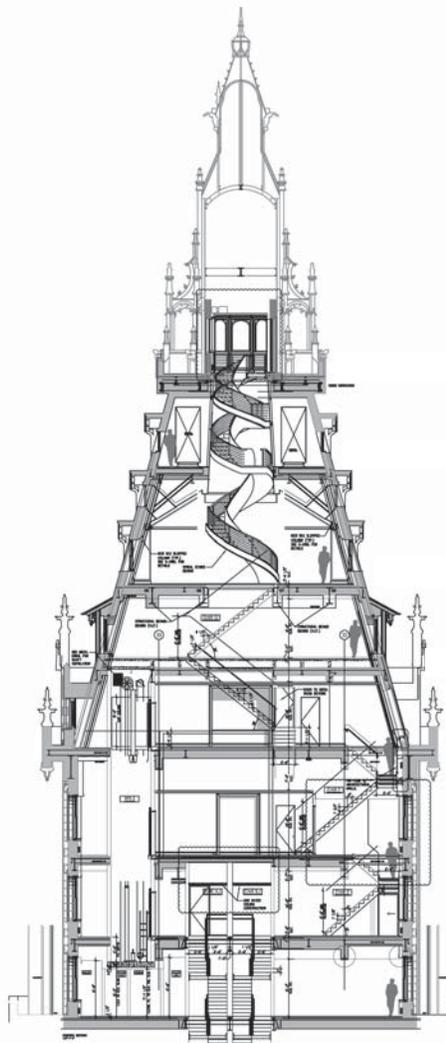
Figure 3. Section at pinnacle residence. © SLCE Architects

The six-story pinnacle will be converted to a single unique residence (see Figure 3). This involves removing a significant amount of floor area, adding an internal private dual-roped hydraulic elevator for that residence, replacing an existing spiral stair used to access the lantern with one that is code-compliant, and adding and enlarging windows and skylights within the landmarked pinnacle roof. Since a substantial portion of the floor diaphragm is

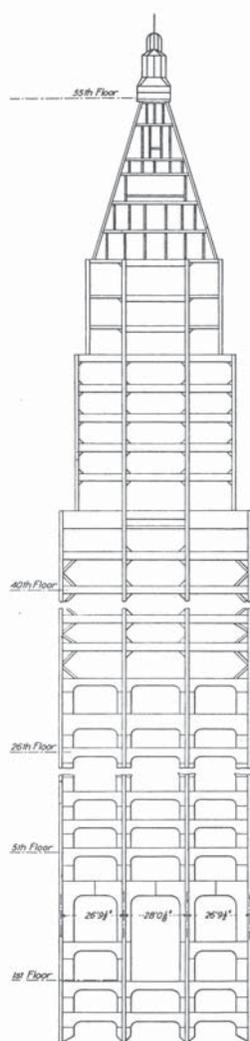
Figure 4. Overview of tower framing (1913). © Gunvald Aus

Wind loads drove the steel frame design, which integrates diverse types of bracing: portal arch bracing, full-story diagonal bracing, and knee bracing (see Figures 4 and 5) (Holtzman 1913). The central tower functions structurally as a highly rigid vertical cantilever and stabilizes the entire building. Where the tower meets the building's flanking wings at the lower 28 floors, portal arches span each structural bay at every story in the tower's front and back elevations. The remainder of the building base is reinforced by concentric chevron bracing and K-shaped knee braces. Between the 28th and 42nd floors, the tower frame is reinforced by diagonal knee braces. Up to the 47th floor,

additional perimeter columns connect to wall girders, and at the 47th to 50th floors, four interior columns join floor girders to resist lateral forces. At floors 50 and above (the pinnacle), inclined members of the pyramidal roof counteract the lateral forces of the wind (Wind Bracing 1912).

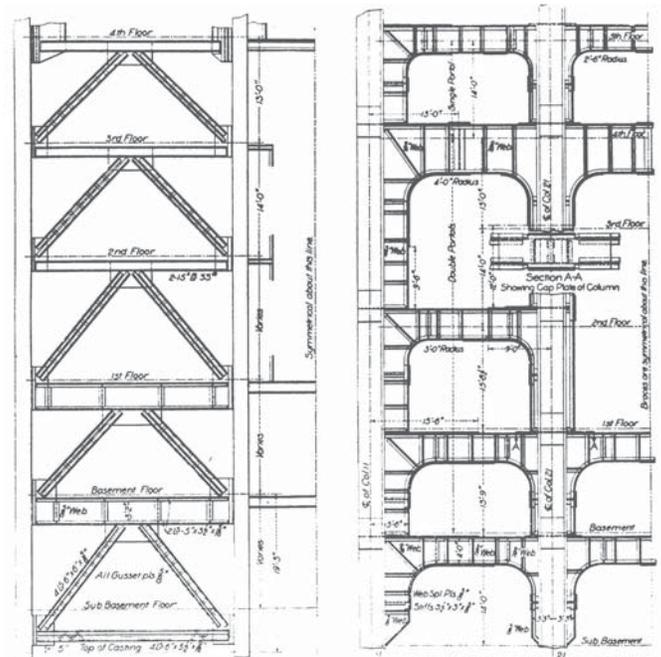
Figure 5. Detail of as-built bracing systems (1913). © Gunvald Aus

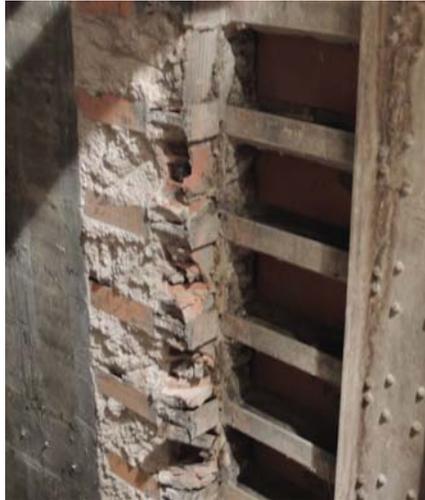
Figure 6. Existing shaft reinforcement.

elevators, a hundred years ago. Novel for its time, this mechanism consisted of large air-tight silo-like chambers at the bottom of the elevator shafts, within which the air beneath a falling elevator cab gets compressed, thus cushioning the drop (Six Hundred-Foot Drop 1913). These "silos" had to be removed, to make space for the new elevator shafts. This demolition was difficult, because they are made of a cage of horizontal web I-beams spaced at 381 millimeters, which is densely packed with terracotta or concrete (see Figure 6).

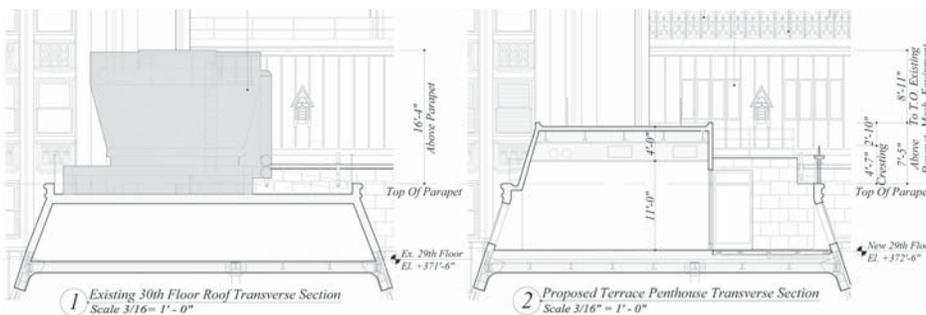
Figure 7. Residential conversion at 29th floor. © Thierry W. Despont

The wings of the 29th floor presented many structural challenges. The basic architectural goal was to take a mechanical space with 1.8 meters of head room and turn it into exclusive penthouse residences (see Figure 7). In order to do this, the architect had to convince Landmarks that the new, higher penthouse could not be seen from the street. The resulting architecture has the higher occupied space set back from the existing mansard roof to leave the sight line from the street unchanged. This meant the existing roof had to be removed, while leaving the mansard in place to hide the new structure. Additionally, the new structure had to be supported without reinforcing anything from below and minimizing the rise in the floor elevation. Complicating this further was the addition of cooling towers and an emergency generator at the far end on one of the wings, coupled with the need to maintain access to an existing elevator machine room and egress stair, also at the far end of the wings.

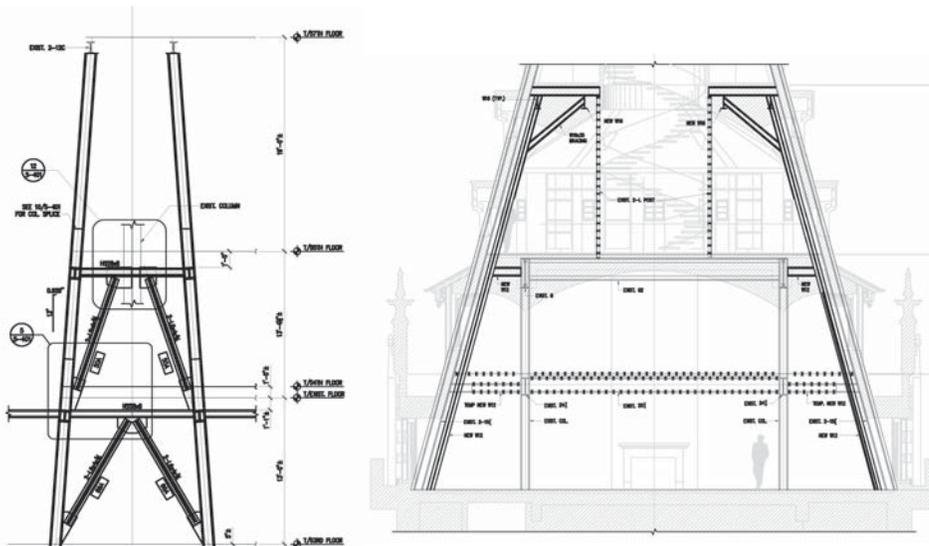
Figure 8. Pinnacle reinforcement.

At the pinnacle, existing posts are removed between the 55th and 57th floors to accommodate the installation of a new spiral staircase to the observation deck. The weight of a new doughnut-shaped, 56,781-liter, two-compartment stainless steel fire storage tank at the 57th floor must therefore be redistributed elsewhere. The supporting frame uses W8 braces to engage new sloped W12 corner columns that parallel the existing sloped exterior frame (see Figure 8).

Since more than half of the slab and floor framing at the 54th floor is removed to create a 7.9-meter-high open space known as the "Great Room," this level loses its diaphragm. Combined with the need to remove significant portions of the terracotta substructure of the sloped roof to increase the window openings, new chevron wind bracing is required at the new corner

columns to maintain stiffness and lateral capacity. New HSS8 frames are installed around the perimeter at floors 54 and 55 to engage existing structure with the new bracing system.
