STRUCTURAL INVESTIGATION OF THE NEW YORK WORLD TRADE CENTER COLLAPSE

DR. W. GENE CORLEY

Construction Technology Laboratories, Inc., Skokie, IL, USA
Leader, FEMA and SEI/ASCE Building Performance Study Team for the World Trade Center

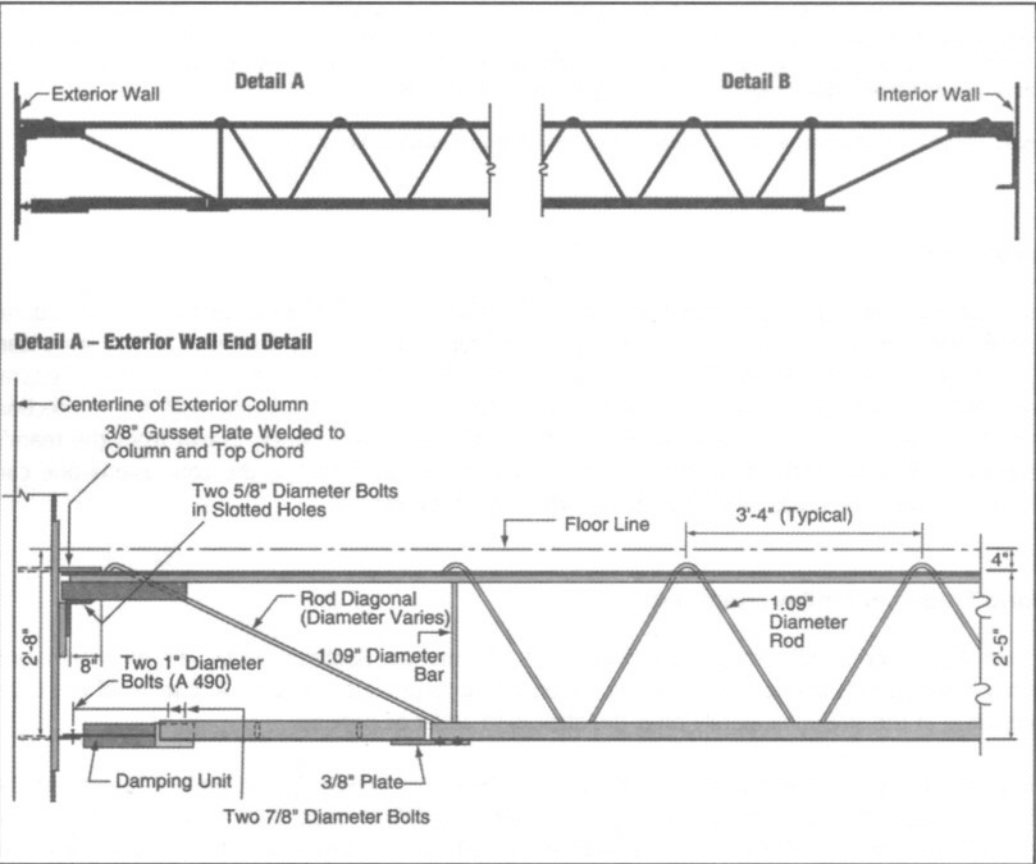
Structural design of the two main towers consisted of closely spaced (3 ft 4 in. o.c.) exterior columns connected to each other with deep spandrel plates. The columns and spandrel plates were prefabricated into panels, each three columns wide by three stories high. The columns and spandrel plates formed a load-bearing tube, stiff both laterally and vertically. Interior cores, formed by larger, more widely spaced steel columns, housed elevator shafts and stairwells. Floor slabs were lightweight concrete over steel decking, supported by a robust and redundant system of trusses. Double trusses spanned between the exterior wall spandrel plates and interior core columns (Fig. 1). Transverse trusses and intermediate angles also helped support floor decking.

Fig. 1. Floor truss member with exterior wall end detail
