Title: **Performance of Adhesives in Glulam after Short Term Fire Exposure**

Original Publication: International Journal of High-Rise Buildings Volume 7 Number 4

# Performance of Adhesives in Glulam after Short Term Fire Exposure

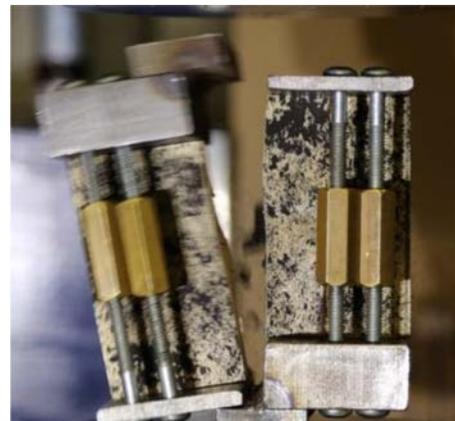
**Figure 8.** Typical failure mode of shear along an adhesive bond line.

The primary failure mode of the Glulam was by shear along the adhesive bond line, as intended by the test setup. A typical failure may be seen in Fig. 8. The area beneath the char layer was used to calculate the failure stress of each sample at the peak load reached in the test before failure. If the adhesive within the wood region below the char front of the samples was also unharmed, the failure stress of each sample should be equal (although the peak load would be lower due to loss of cross-sectional area). However, a general decreasing trend in adhesive strength with heating duration was seen. This indicates that the

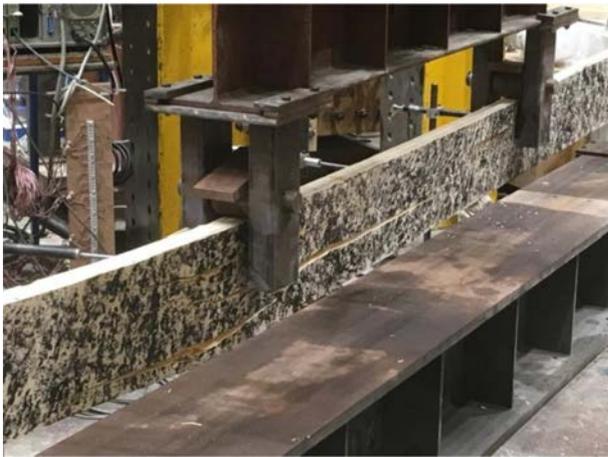
**Figure 12.** Failure mode of a Glulam undamaged control beam, whose failure originated along the adhesive bond lines within the moment region.

failed within the moment region, along both adhesive bond lines and finger joints. The failure mode can be seen in Fig. 12.
