Title: **Performance of Adhesives in Glulam after Short Term Fire Exposure**

Authors: Hailey Quiquero, York University  
Bronwyn Chorlton, York University  
John Gales, York University

Original Publication: International Journal of High-Rise Buildings Volume 7 Number 4

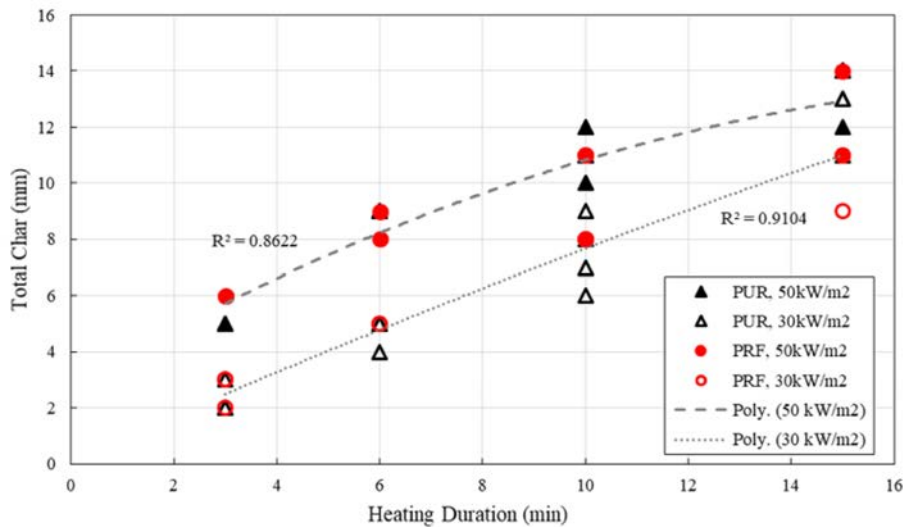
Figure 7. Total char depths measured on samples versus the heating duration.

testing, the average char depth at the centreline was also measured. The char depth was taken as the average of three points along the centreline (typically 1 mm of each other). The char depths of each sample versus their heating durations is plotted in Fig. 7. It can be observed that the char depths for the higher heat exposure were typically higher than those of the lower heat exposure. The trend for both the 50 kW/m<sup>2</sup> and 30 kW/m<sup>2</sup> exposures decreased in slope with longer heating durations, while this is more pronounced in the higher heat exposure. This indicates that the charring rates slow over time, as the char layer builds up and inhibits heat transfer as is expected. The higher heat flux charring rate trend tended to approach the lower heat flux constant rate, around a minimum value of 0.75 mm/min. This indicates that this might be a minimum rate of charring that may be seen in timber above the pyrolysis temperature for these incident heat fluxes. This corresponds well with recommended charring value of 0.7 mm/min for standard fire exposures. Overall, the charring behaviour of the samples was very uniform and predictable. Char depths seen were close to uniform along the surface of the specimens.

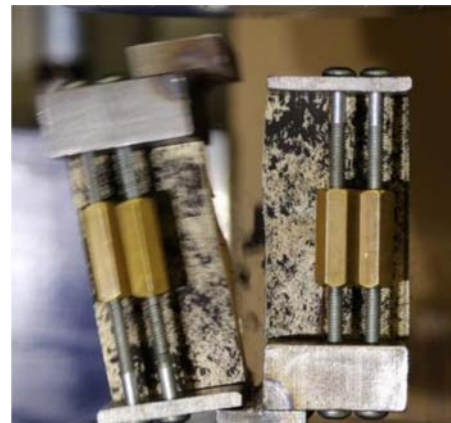
Figure 8. Typical failure mode of shear along an adhesive bond line.

The primary failure mode of the Glulam was by shear along the adhesive bond line, as intended by the test setup. A typical failure may be seen in Fig. 8. The area beneath the char layer was used to calculate the failure stress of each sample at the peak load reached in the test before failure. If the adhesive within the wood region below the char front of the samples was also unharmed, the failure stress of each sample should be equal (although the peak load would be lower due to loss of cross-sectional area). However, a general decreasing trend in adhesive strength with heating duration was seen. This indicates that the

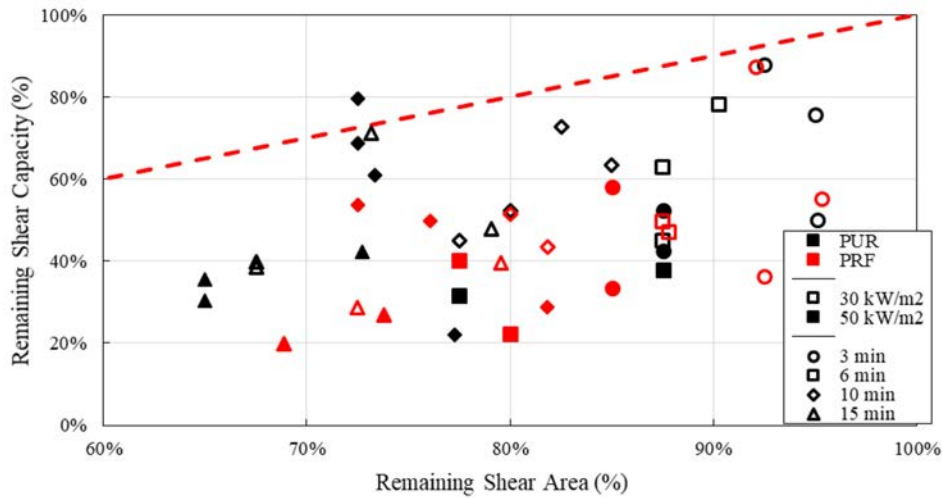
**Figure 9.** Comparison of remaining shear capacity versus area for all samples.

A correlation is made between the remaining shear capacity of the samples and their respective remaining shear area. In theory, if the adhesive held 100% of its strength after heat exposure, these two values would correlate exactly. That is, if a sample had 80% of its shear area left after heating, the remaining shear capacity should be 80%. This is shown as the red dashed line in Fig. 9. Any sample falling below this line represents a sample that did not retain its full adhesive strength – that is, the loss of shear capacity was greater than the loss of area. The figure illustrates a large amount of variance in the capacity of the samples. It can be seen that the majority of the samples fell well under the perfect correlation line, with most samples having a remaining area beneath the char of above

60%, but many samples falling to as low as 30% remaining capacity. On average, the samples had a remaining capacity 32% below their remaining shear area. Further, the capacity of the PRF samples fell an average of 40% below their remaining area while the PUR samples were 26% below. This could indicate a difference in the adhesives or in the way they were prepared, with the PUR bonds being produced by the manufacturer while the PRF bonds were produced in the lab.

Additionally, from Fig. 9, there is no clear trend or distinction developed within any of the heating durations or exposures, though it is clear that the adhesive performance falls below that of which should be expected. A comparison was made with the remaining capacity that the standard recommended sacrificial charring method would be predicted, using a charring rate of 0.7 mm/min plus a zero-strength layer of 7 mm. It should be noted, however, that these recommended charring rates are not validated for exposures other than a standard-fire, and are thus not totally applicable to a constant heat flux radiant exposure, but are included here for comparison (as it was observed to closely correlate to that seen for a 50 kW/m<sup>2</sup> exposure as stated above). As seen in Fig. 10, when compared with the actual remaining shear capacity, the standard's predictions still fall significantly below the correlation line. This new data set is plotted in grey in Fig. 10 compared to the original data set in black. There may be two possible causes for the reduced strength of the samples. The first is that, due to the small thickness of the samples, all of the adhesive beyond the char layer may be reduced in strength by a certain percentage corresponding to the lower capacities mentioned above. However, since the adhesives must have been tested to the standards discussed earlier in the manuscript, the adhesive should retain full strength for temperatures below the charring temperature of wood. Secondly, the adhesive may be full strength at a certain

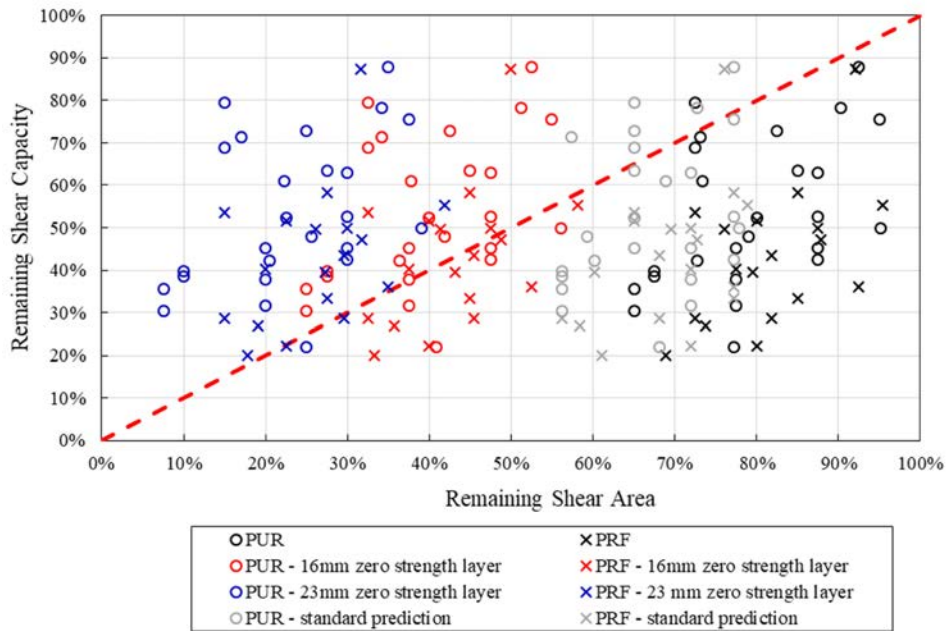
**Figure 10.** Remaining shear capacity of samples versus different predictions of actual remaining shear area at full adhesive strength, compared with the measured char depths and the standard predicted sacrificial char method.

Another factor that may contribute is the loss of strength of the wood above 100°C, as many of the failures were a combination of wood and adhesive failure. If the adhesive is assumed to have full strength at a certain depth beneath the char layer, then the area of that full strength zone may be computed using the peak shear capacity of each sample. It was assumed that this full-strength zone spans the full height of the samples, and that the width is measured through the thickness of the sample from the unheated face. In this way, the penetration of the zero-strength zone may be calculated and compared with the char layer measurement. On average, the zero-strength layer penetrated 13.3 mm beyond the base of the char zone. Separated for each adhesive, this value was an additional 16.2 mm for the PRF samples and 10.7 mm for the PUR samples. As a comparison, 16 mm was added to the measured char depth of each sample and a new remaining shear area was calculated. This new data set may also be compared to the original and standard-predicted data sets in red in Fig. 10. It can be seen that increasing the zero-strength zone to 16 mm below the measured char depth of the samples results in a much better prediction of the remaining strength, with the majority of the samples falling over the line. A more conservative value of 23 mm below the char depth could be used to give a 95th percentile of samples falling above the line, which is shown as the blue series in Fig. 10. The samples tested were very small scale, so larger

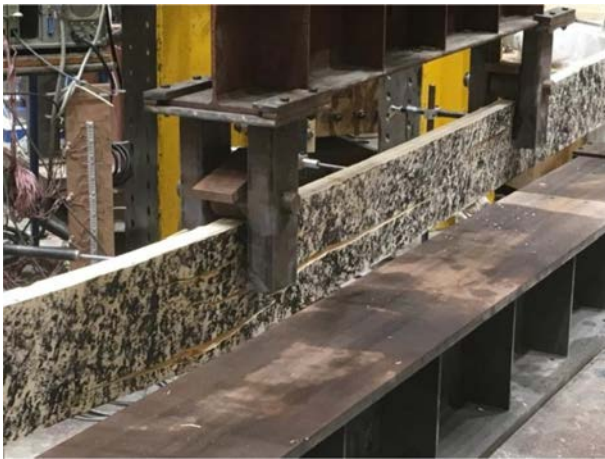
**Figure 12.** Failure mode of a Glulam undamaged control beam, whose failure originated along the adhesive bond lines within the moment region.

failed within the moment region, along both adhesive bond lines and finger joints. The failure mode can be seen in Fig. 12.

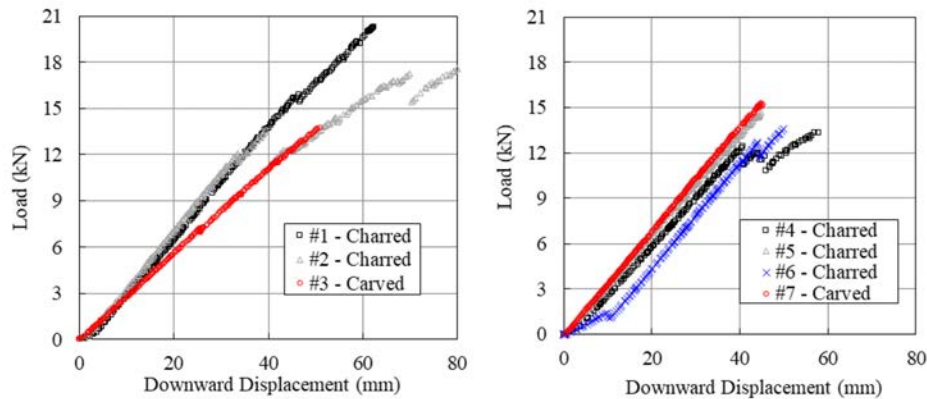
**Figure 14.** Load versus downward displacement beams damaged in the moment region (left) and shear region (right).
