# United Nations Secretariat: Renovation of a Modernist Icon

## Abstract

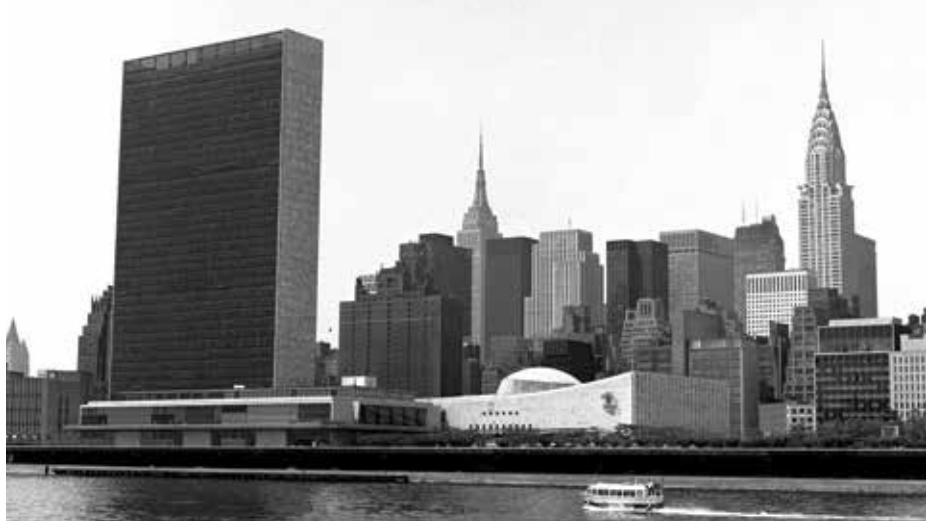
Figure 1. The UN Secretariat Building in front of the Midtown Manhattan skyline, 1964 (Source: United Nations)

The skyscraper of the newly renovated United Nations Headquarters, the Secretariat Building, with a mere 39 floors, may not be the most impressive skyscraper in terms of height. It is, however, the prototype for all modern curtain wall office towers (see Figure 1).

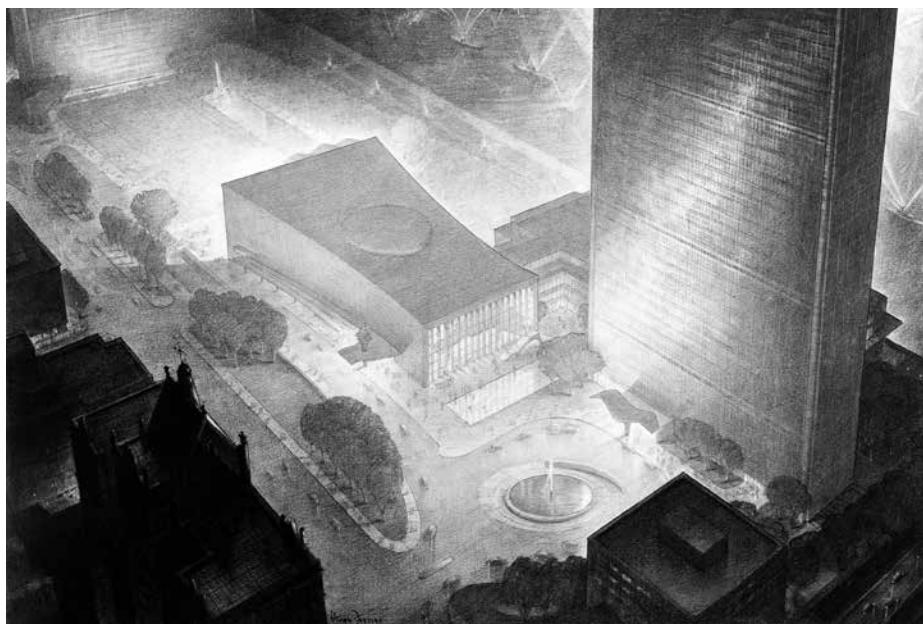
Figure 3. Rendering of the UN Headquarters, drawn by Hugh Ferriss for the Board of Design, 1947 (Source: United Nations)

The re-use of the X City plans, beautifully rendered by Hugh Ferris, was very influential with the UN selection committee, and also established the design character of the future headquarters.

was accepted by the Secretary-General, and legend has it that Le Corbusier was offered the opportunity to prepare the construction documents but refused to take the necessary licensing steps required by New York State. Wally Harrison prepared the construction documents and managed the construction of the United Nations Headquarters. The result is one of the few examples of 20th century architecture, Modern architecture, which is today recognized all over the world (see Figure 3).

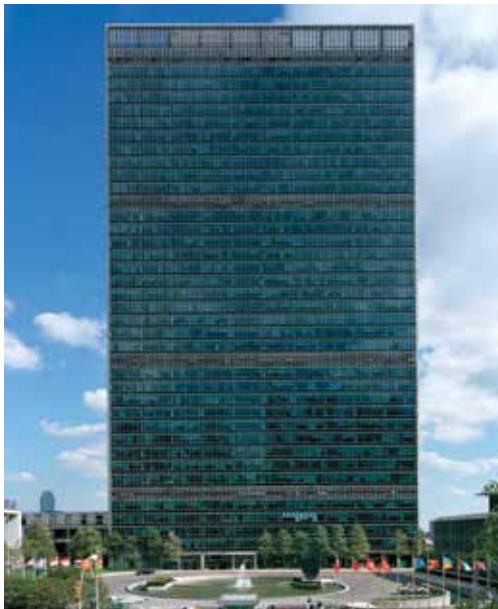
Figure 4. The curtain wall before the renovation - a patchwork in greenish hue, 2001 (Source: United Nations)

system. Its primary elevations were enclosed by free-hanging glazed facades. Although now much greener, more sustainable, and safer against blast than the original, the new curtain wall was designed to look like it did in 1951—sleek and taut, with its double-hung aluminum windows, glazed spandrel panels, and aluminum-clad steel mullions appearing as one continuous transparent form. However, the replaced wall's appearance was significantly altered after nearly 60 years of patches, caulkings, insulating and blast coatings, resulting in a patchwork and greenish hue (see Figure 4).

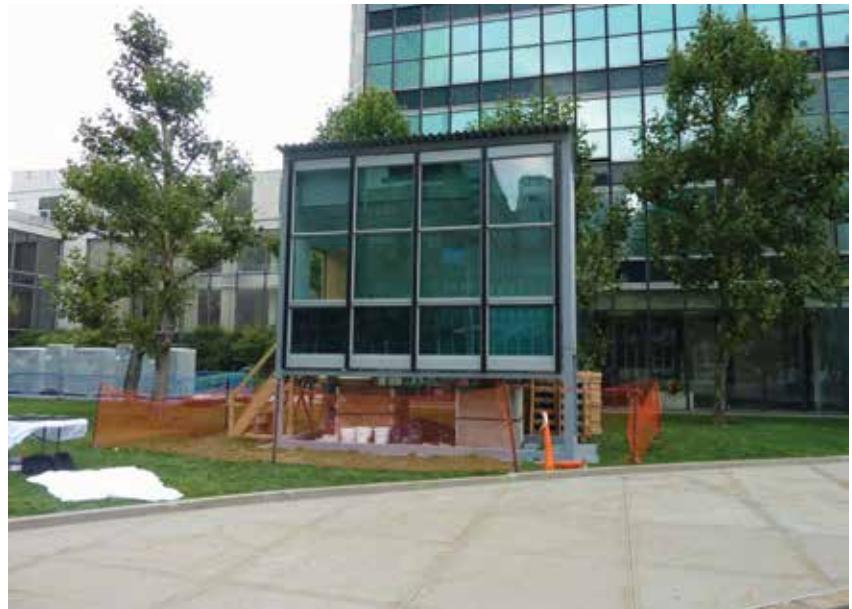
Figure 5. The curtain wall mock-up in front of the Secretariat Building, 2009 (Source: United Nations)

To rectify this, the project team conducted extensive testing to replicate the visual appearance of the original building, including reflection patterns at different times of day. The work included spectral analysis of glass types to identify viable formulas, computer model simulation, and, ultimately, a full-scale mockup tested on in front of the Secretariat Building on the United Nations compound (see Figure 5).

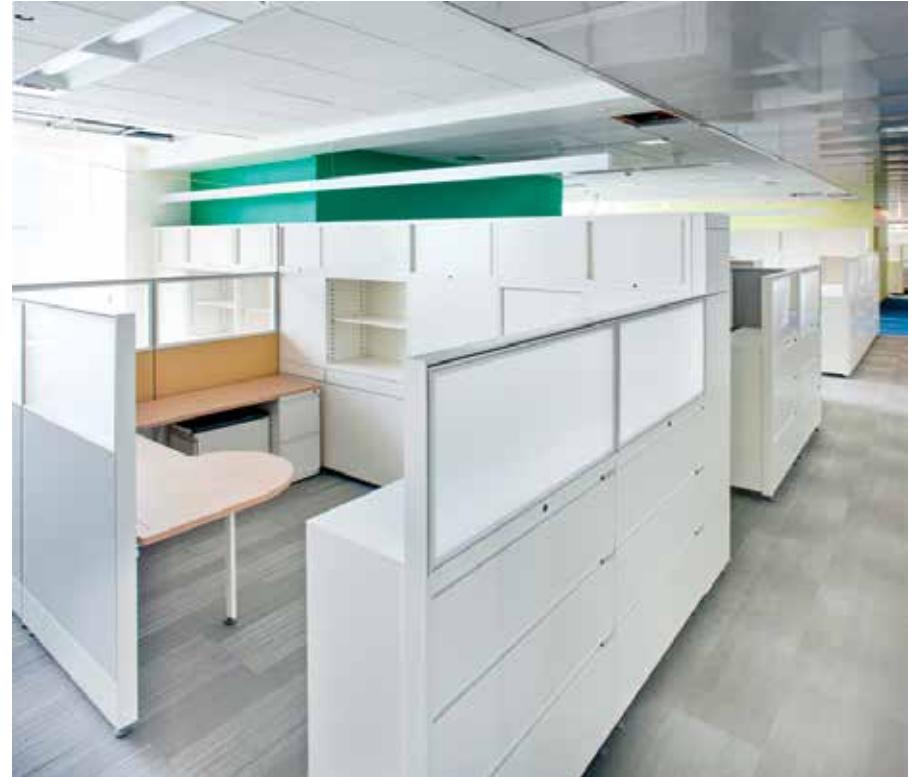
Figure 8. Open plan offices in the renovated Secretariat Building before reoccupancy, 2012 (Source: United Nations)

culture with open-office layouts, in addition to achieving a number of objectives for improving occupant comfort and wayfinding. Significantly more light and air now enter the interior of the 900,000 ft<sup>2</sup> building. The open plan also affords much flexibility and efficient use of space in the growing organization (see Figure 8).

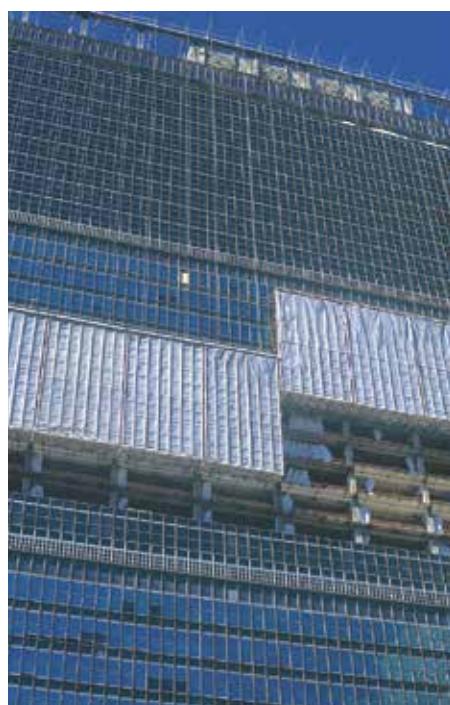
Figure 6. The new curtain wall being installed from the top of the Secretariat Building to the bottom, 2011 (Source: United Nations)

The project team executed the demolition of the original curtain wall and the installation of the new state-of-the-art pressure-equalized system in sections, proceeding from bottom to top in each 10-story zone sandwiched between the louvered mechanical levels. Unlike the original curtain wall, which had been attached to the concrete floor slabs, the new system utilizes outrigger plates to connect the wall to the now reinforced building frame. To mimic the appearance of

the original double-hung windows, the team strategically offset some of the aluminum extrusions (see Figure 6).

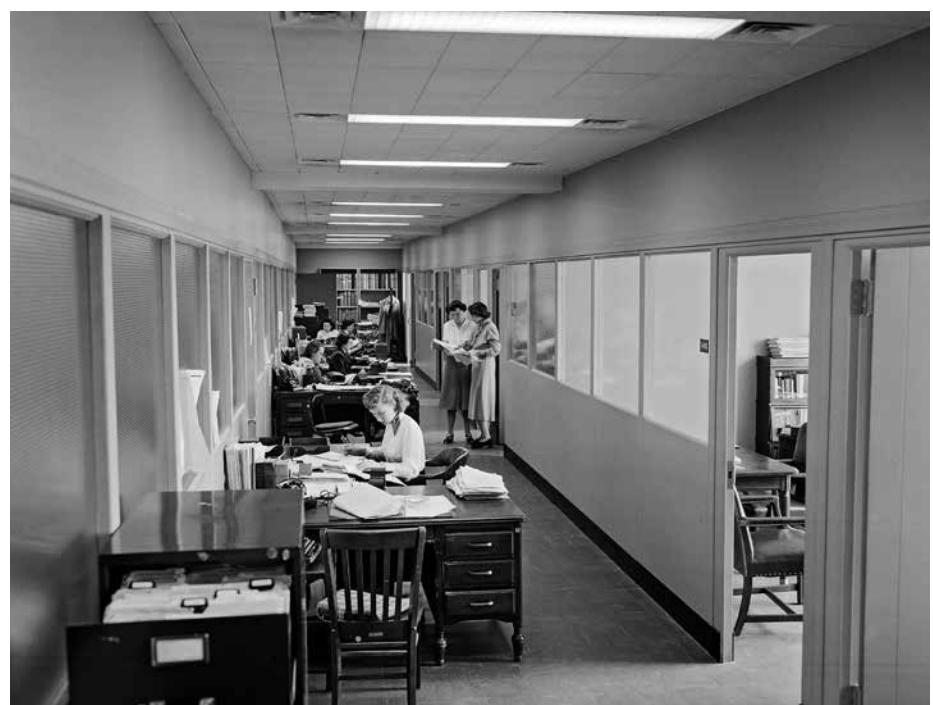
Figure 7. Floor-to-ceiling walls and doors for enclosed offices dominated the original layout of the floors in the Secretariat Building, 1951 (Source: United Nations)

The interiors strategy was about creating a 21st century workplace, while respecting the historic structure's Modernist origins. Previously, the majority of Secretariat offices had been completely enclosed with floor-to-ceiling walls and doors (see Figure 7). The new floor plan challenges this closed

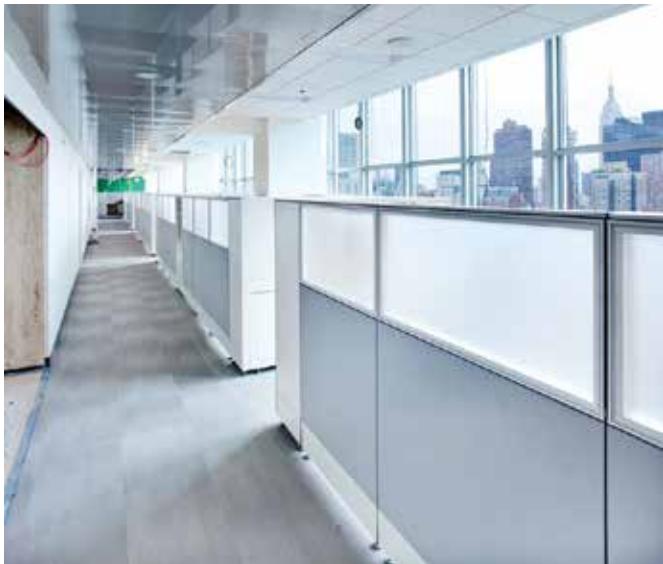
Figure 9. The higher ceiling near the windows allows for maximum daylight and views on the open plan floors (before reoccupancy, 2012) (Source: United Nations)

The sustainability approach for the Secretariat Building employed a number of the proposed initiatives, including installing energy-efficient lighting systems with room sensors, incorporating demand-control ventilation and a sophisticated building management system, and maximizing daylighting through an open-plan. The latter includes 78" tall furniture-work walls that extend from perimeter columns without blocking natural light. The ceiling is 8' tall but gradually steps up to 9'6" at the windows, allowing for a circulation path around the core, while supporting the equitable distribution of mechanical services (see Figure 9).

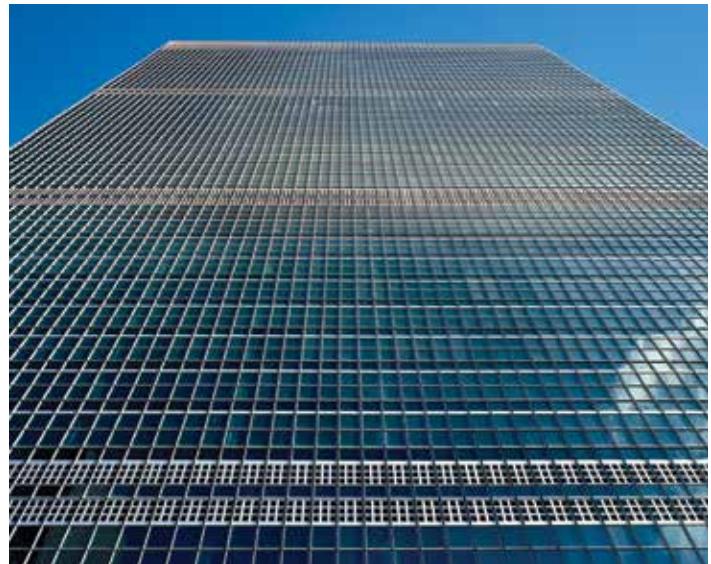
Figure 10. The renovated curtain wall returned the facade of the Secretariat Building to its original hue and transparency, 2012 (Source: United Nations)

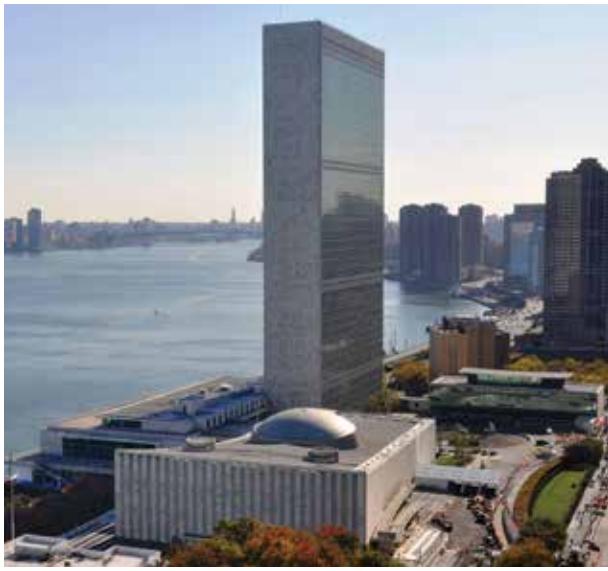
Figure 11. The Secretariat Building, with the General Assembly Building in the foreground, the Conference Building on the left and the Library Building on the right towards the end of the renovation of the UN Headquarters compound towards under the Capital Master Plan, 2014 (Source: United Nations)
